BAT SURVEY

Yard and Garage/ workshop buildings to the rear of  
St PAULS TERRACE and ST PAULS STREET  
LOW MOOR  
CLITHEROE

21<sup>st</sup> may 2015 3.30pm and 9.30pm

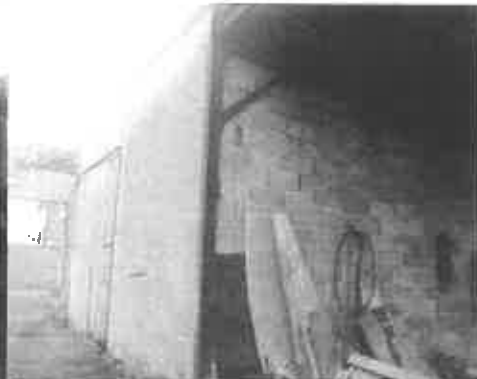
North east elevation

**COMMENTS:** The render on the original workshop is in poor condition with cracks and voids behind. The doors the north east elevation have gaps at high level allowing access to the interior.

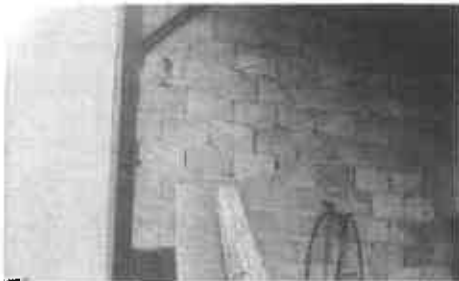
Newer workshop walls

**COMMENTS:** The original workshop has brick walls with a render finish. The more recent workshop which is attached has block walls with render to the front and the rear wall is brick.

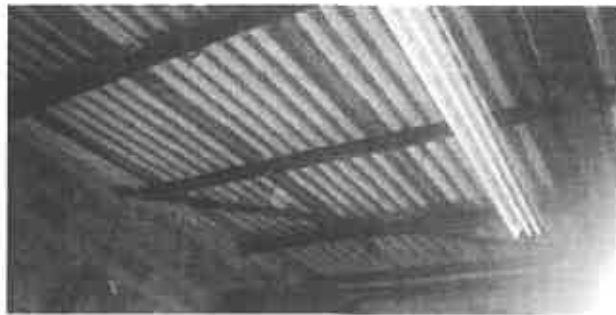
**COMMENTS:** The roofs were open to the underside, the original workshop have a conventional roof construction with Trusses, purlins and rafters all in timber. The timbers were in reasonable condition with no cracks or crevices. The slates were pointed at the junction with the timbers. The newer workshop has steel beams and purlins.
