28 Dilworth Lane, Longridge

Bat Survey Report – Version 1

Ref: JE 6536a 18

Bat Survey Report

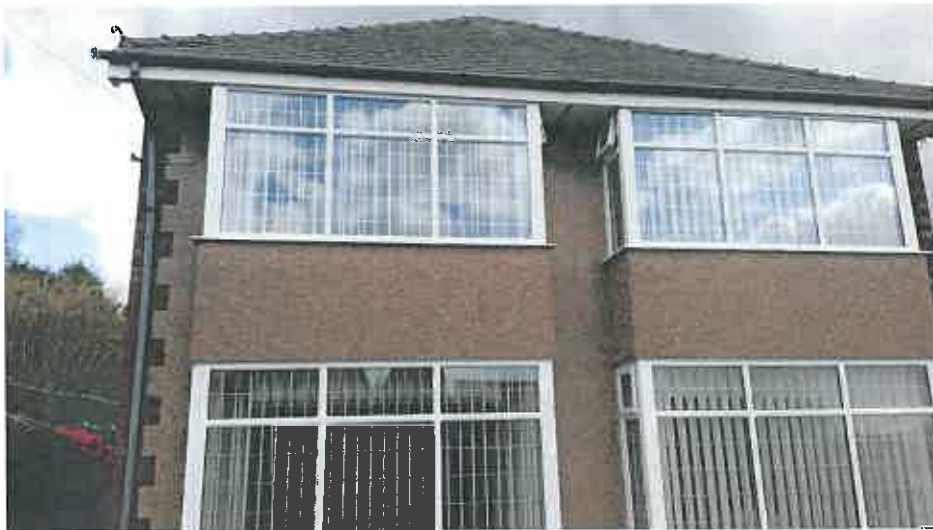
Photograph Two: Front view of house

The house is a post-war, brick-built structure with a four-sided hipped roof, with a single slate skin. There was a lean-to along the length of the rear of the house with a pitched roof.

- The pebbledash exterior-wall covering was in good condition. The doors and windows and accompanying lintels were in good condition, sealed and no droppings were present. The slate roof was largely well-sealed and no ridge tiles were lifted or missing, however, there was some light penetration into the loft, with gaps enough for bats to enter.

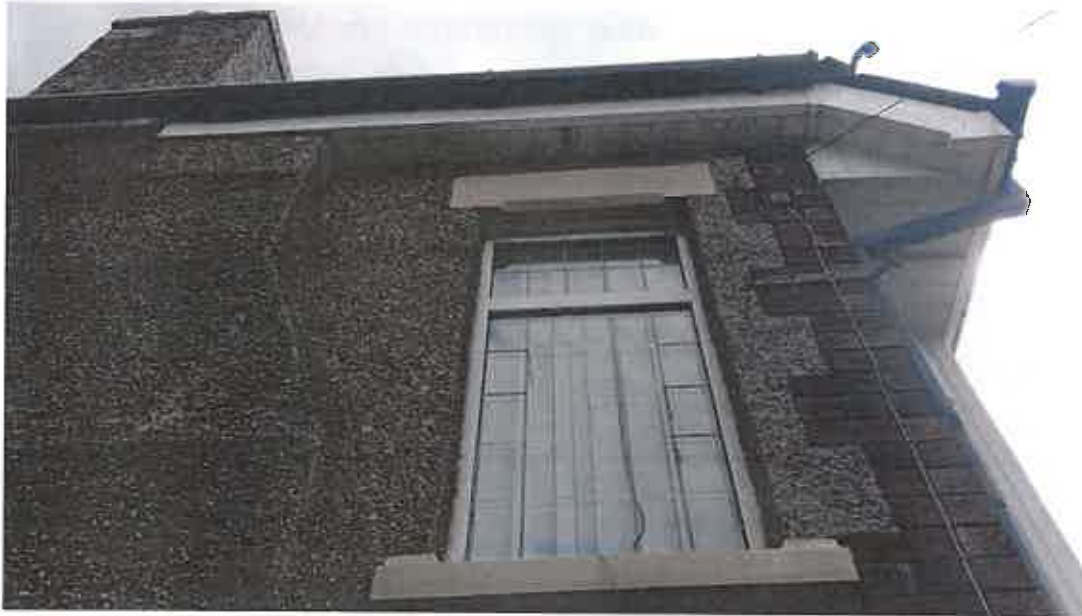
Photograph Four: The eaves were in good condition

- The fascias and soffits were of wood and in good condition.

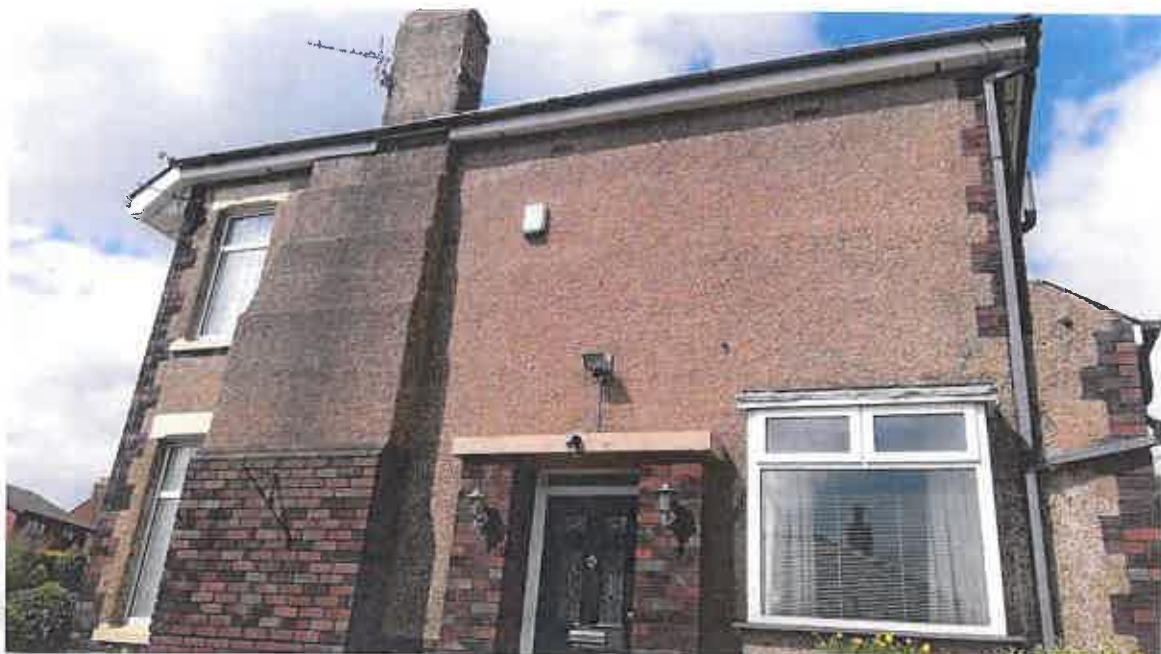
Photograph Five: Side View (east), showing door lintel and chimney breast

- Pebbledash was sealed around the external chimney breast and the front-door lintel and recess, it was in good condition with no obvious entry-point for crevice-dwelling bats.

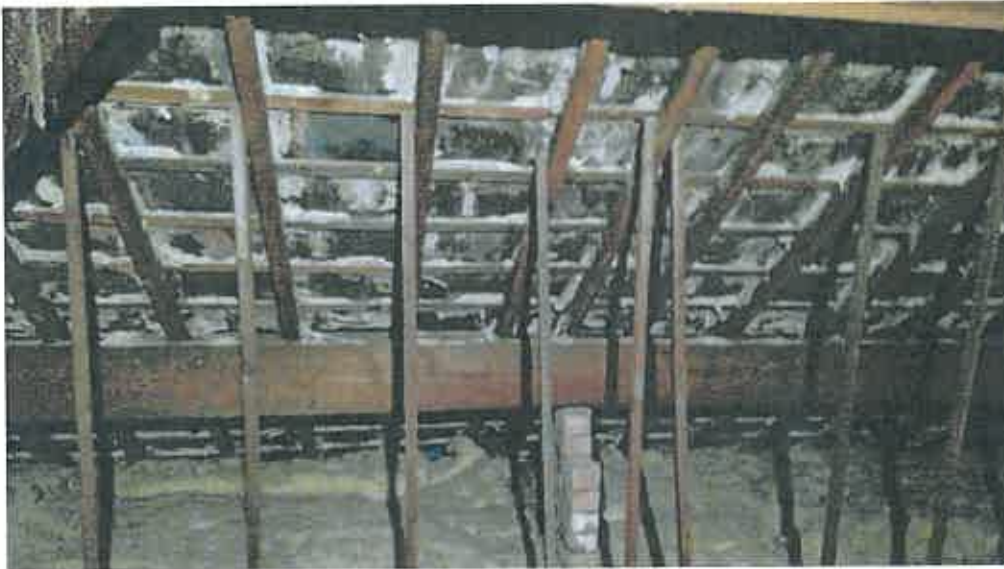
Photograph Six: Single-skinned slate roof and wooden purlin and rafters

The loft was undisturbed, clear and accessible. There was some light penetration, especially at the front centre and in the NE corner. There was extensive cobwebbing and no signs of droppings. As the roof was single-skin all gaps between slates could be inspected and no bats or bat evidence was found.

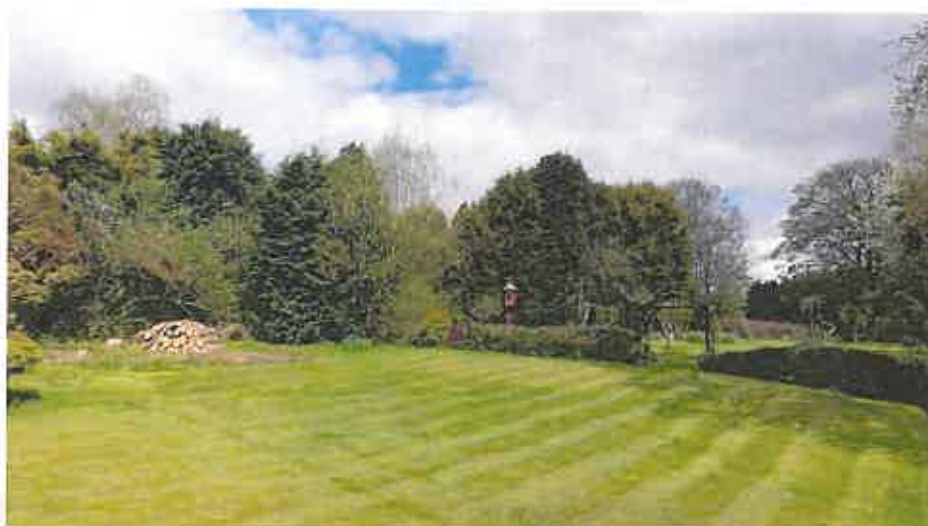
The garden was not the focus of the survey. However, the quality of habitat in and around the garden affect the desirability of potential roost sites and were part of the Bat Roost Trigger Index metric. The garden contained good quality linear habitats leading from the house into the wider pastoral landscape.

Photograph Nine: The garden, looking NNE, showing a combination of linear and open habitat

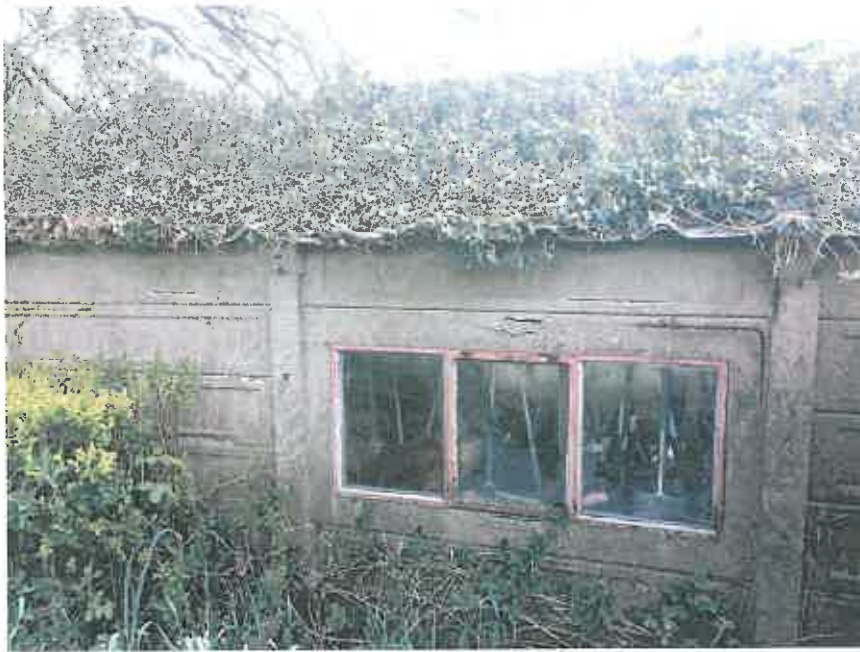
Photograph Ten: Western side of garage

The garage is a single-leaf concrete structure with an ivy-covered corrugated concrete-asbestos roof. There were windows on the western and eastern sides and a metal up-and-over door at the front. The garage was regularly used as a garden storage area. Ivy covering the roof gappy enough to enable adequate inspection.

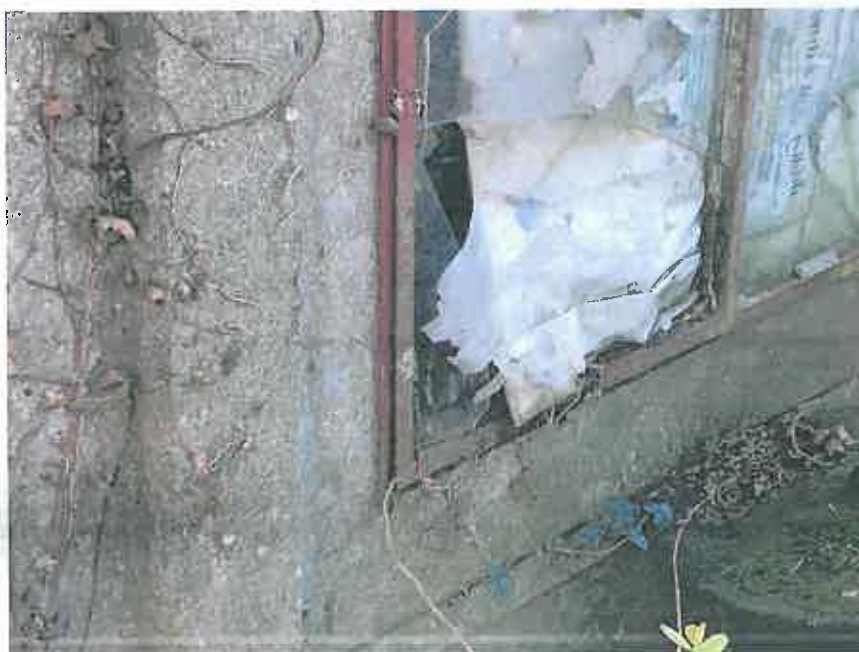
Photograph Eleven: Eastern side of garage, with broken window

The poor thermal properties of concrete and asbestos, the high light levels enabled by windows and the regular usage from spring to autumn and occasional during winter all contributed to this being a structure of negligible use to bats and as such was scoped out of the need for emergence surveys (see Table Five, p20).
