BAT SURVEY AT -

DAIRY FARM
GOOSE LANE
CHIPPING

DATE AND TIME OF VISIT
23rd Feb 2018 11.30 am

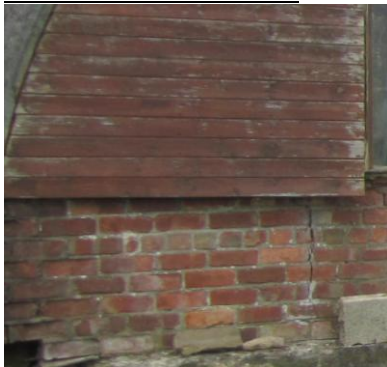
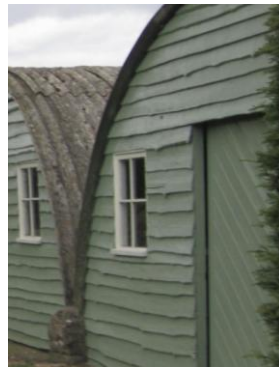
WALL CONSTRUCTION

The base walls are brick, the east gable walls are also brick with one hut having timber boarded cladding. The gables to the West have timber boarding fixed over a timber frame.

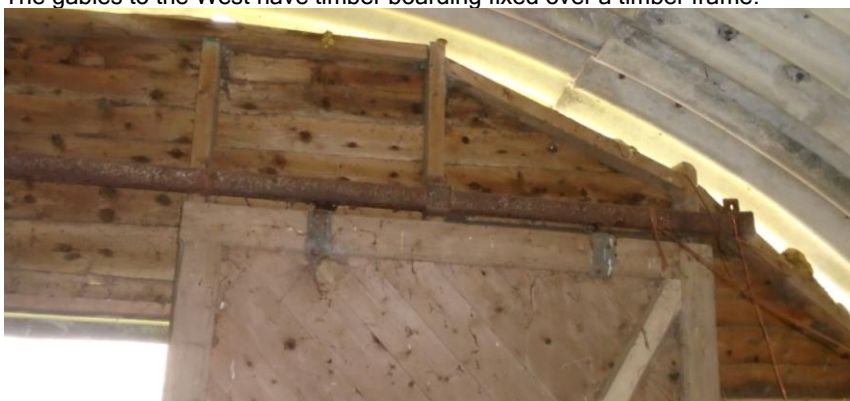
BAT ACCESS POINTS IN WALLS

The interior of the buildings are easily accessible particularly the west gables where there is a large gap at the abutment of the roof sheet and boarding. The brick walls whilst not in very good condition do not provide any cracks or crevices which bats could use.

The framed timber boarding does not provide any suitable habitat for bats.

The brick wall faced with timber boarding has a void between, it was possible to examine the gap and whilst it doesn't provide a suitable hibernation roost it could potentially be used by bats during the summer months, however no signs of historic use was evident.

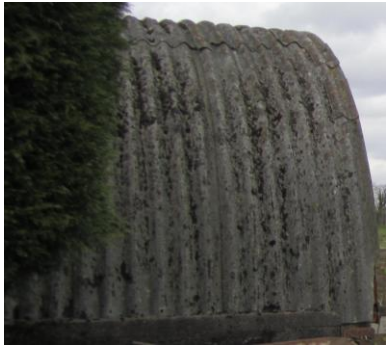
BAT ACCESS POINTS IN ROOF

The roof is curved corrugated fibre cement sheet.

The sheet laps were generally tight with no crevices or gaps.

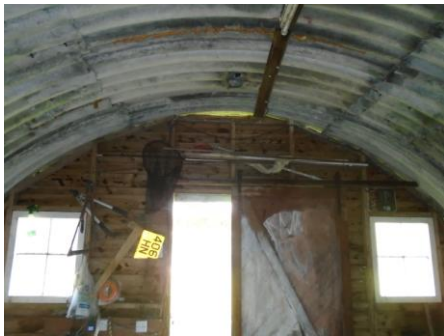
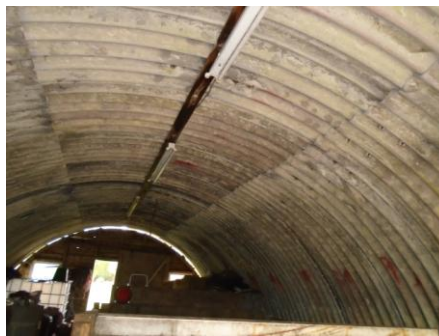
ROOF SPACE

There is no enclosed roof void or any lining to the underside of the sheets. It does not provide any suitable habitat for bats.

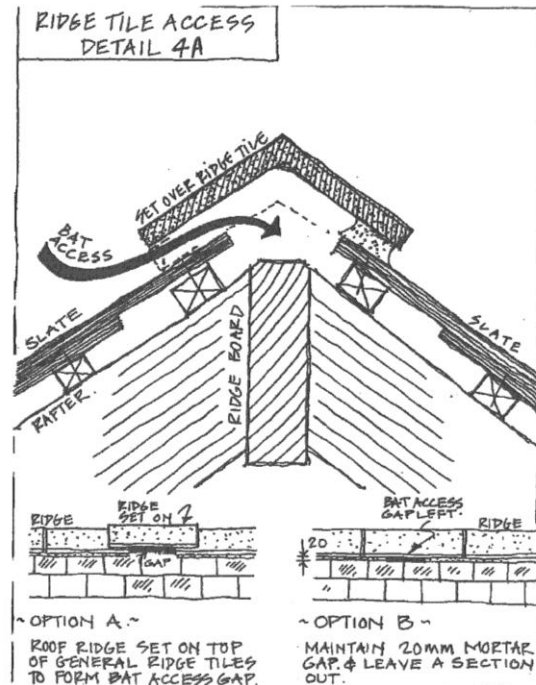
Ridge access tile Detail 4A (below)

RECOMMENDED BY NATURAL ENGLAND: either raised ridge tiles providing 15 – 20mm gaps or leaving access gaps under tiles to enable bats to enter the space beneath the ridge tiles.

Pipistrelles and long-eared bats will enter roofs via narrow gaps under the ridge tile; additional benefits are provided when small gaps are provided through the roofing felt & sarking membrane thus enabling bats to enter any retained roof voids.

PROVIDE 2 No. RIDGE ACCESS TILES ALONG THE ROOF RIDGE.

SPACE RIDGE ACCESS SLATES EVENLY ALONG LENGTH OF ROOF.
