**BAT SURVEY AT -
INGLEDENE
RIMINGTON**

DATE AND TIME OF VISIT
26 th March 2018 5.45pm

REFERENCE. Mr C Taylor

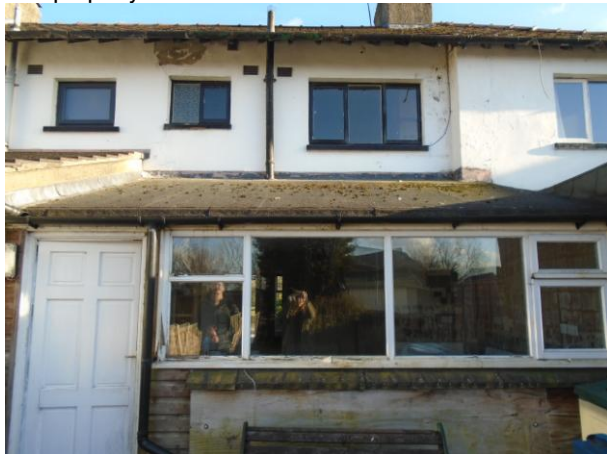
Rear elevation

The property is a mid terraced house in a row of four. Possibly dating from 1940's

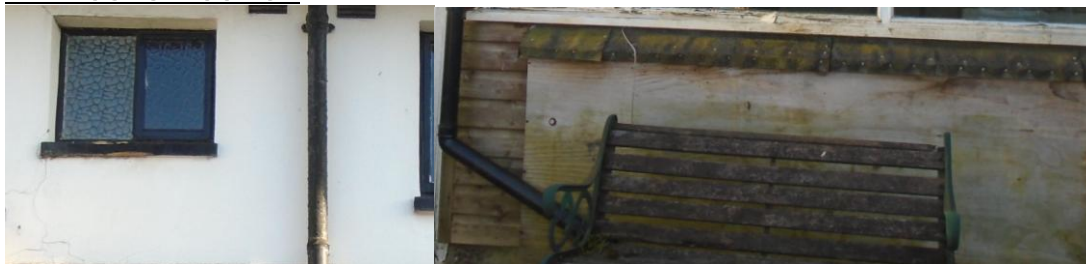
WALL CONSTRUCTION

The rear wall of the main building is white painted render, the extension is a timber frame structure faced with timber horizontal boarding.

The render walls are in good condition with no access points, cracks or crevices.

The timber boarded rear base wall (side walls are party walls) is in reasonable condition with no gaps or any accessible voids behind.

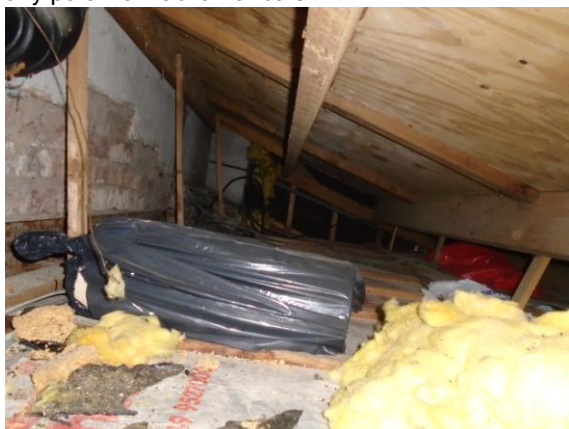
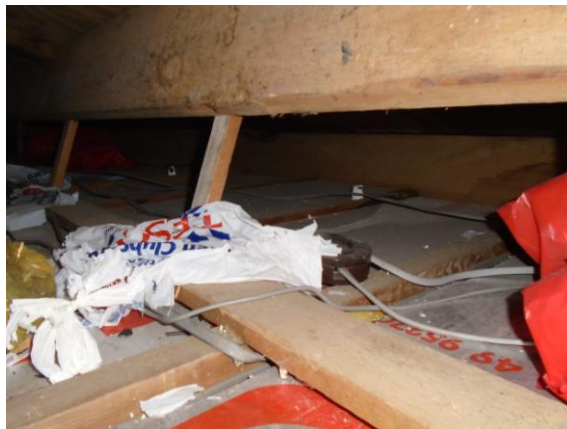
ROOF SPACE

There is a small roof void over the extension. Timber purlins with ply fixed over, insulation boards between the ceiling joists. The space clean and free from any dropping or insect remain evidence. The timbers do not provide any potential habitat for bats.
