BAT SURVEY

AT
DOWER HOUSE
PARK ROAD
GISBURN

REFERENCE NO. 4966

**BAT EMERGENCE SURVEY AT
DOWER HOUSE
PARK ROAD
GISBURN**

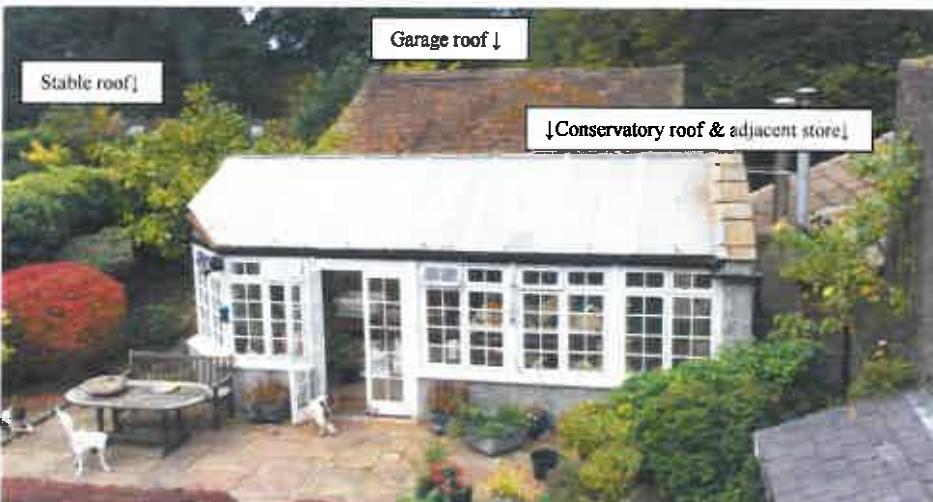
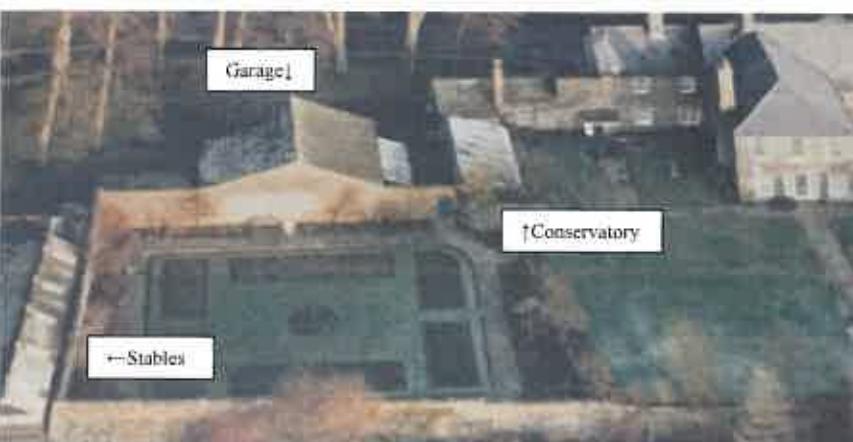
The proposals involve the refurbishment of the existing conservatory by constructing a new glazed roof and connecting it into the adjacent store with a glazed link.

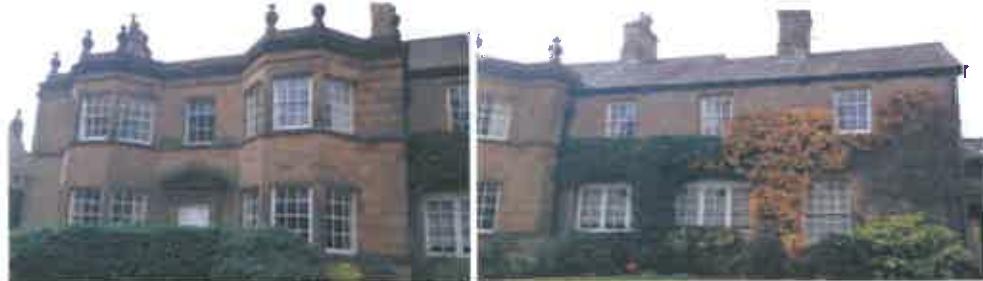
Front (west) elevation of main house

A substantial detached period house with an attached conservatory (a later addition and not original to the house). In the grounds to the N.W of the house is detached stable block and garage. The house has recently been vacated.

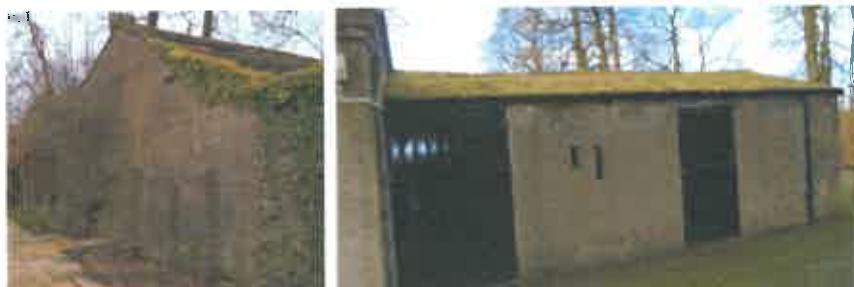
Garage/ store

The garage walls are rough cast render over brick.

The garage Walls are in reasonable condition, the render does not have any significant gaps or crevices suitable for bats. There is an opening at high level which provides access to the void over the store section of the garage.

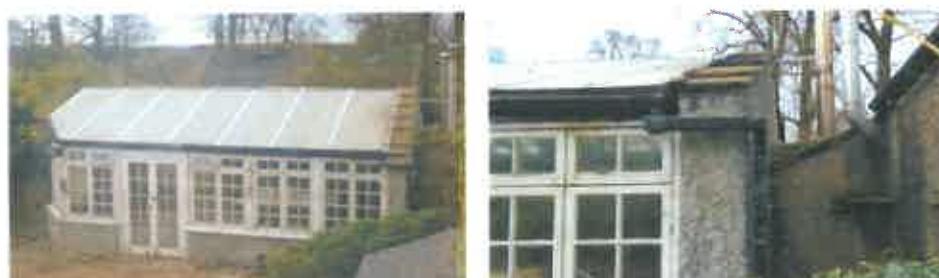
Conservatory front elevations

The conservatory walls half glazed to the front and side elevations with a rough cast render brick base wall. Side and rear walls are brick rough cast render.

The conservatory base and rear walls are in reasonable condition with no gaps or crevices suitable for bats. Some of the windows are slightly open which could provide potential access to the interior.

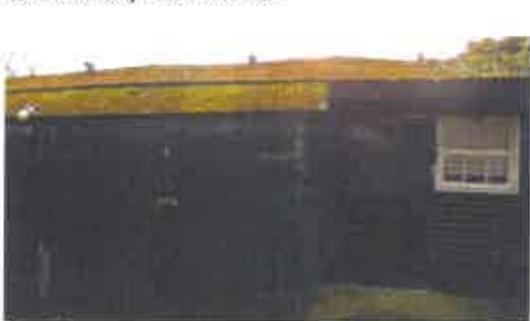
Stables

The stables are a combination of brick and timber boarding fixed over a timber frame. The rear wall is the stone garden wall.

The stables Are in need of refurbishment, there are some sections of rotten wood mainly at low level. See below. The stables have numerous access possibilities.

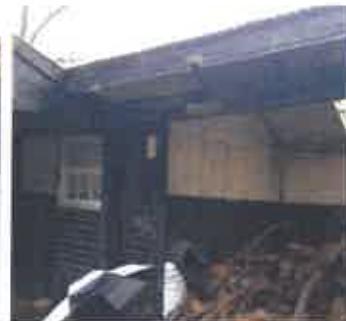
The stable roof has a corrugated Asbestos sheet covering with some clear plastic roof lights, there is extensive moss coverage. The roof is in poor condition and has gaps in the sheets and circular openings at the ridge (probably for vent cowls) allowing potential access for bats and water ingress.

The Stables Do not have an enclosed roof void some of the stables have timber boarding to the underside of the asbestos sheets the timbers are in poor condition the space is generally very draughty and damp. And does not provide good hibernation or roost potential.

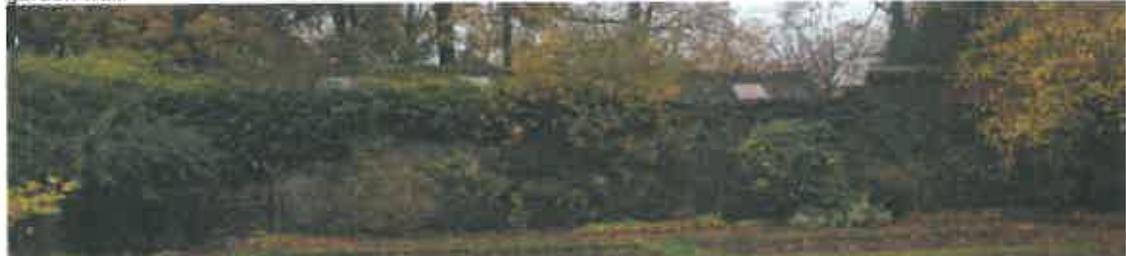
The stables rear wall.

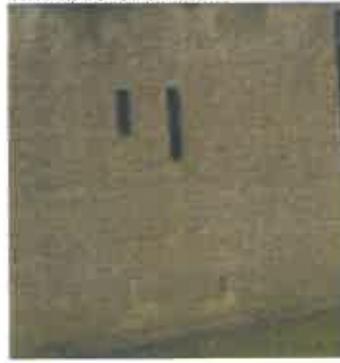
The garage walls are rough cast render.

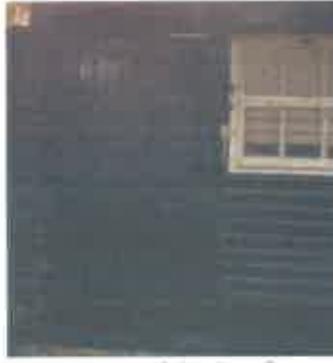
The stables are timber boarding.

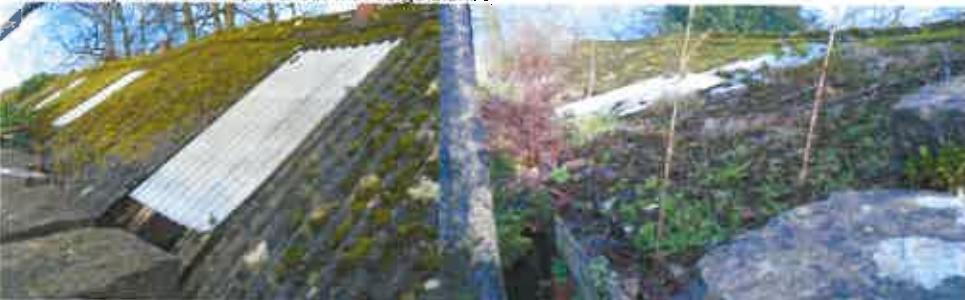
Conservatory roof - Clear upvc sheet with verge stones

The conservatory roof covering had no access points. It was possible to examine the eaves ,crevices and any gaps closely. No signs were found indicating bat use.

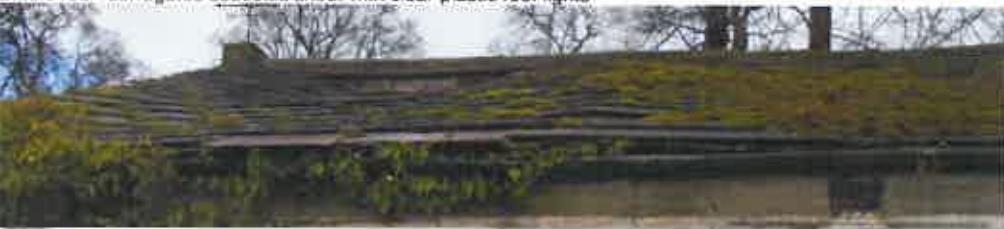
Stable roof- corrugated asbestos sheet with clear plastic roof lights

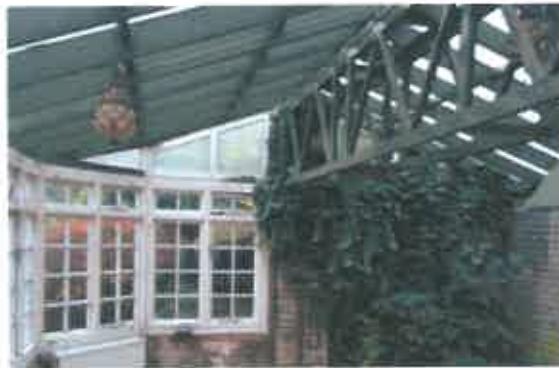
The conservatory does not have a roof void. The roof clear sheets are supported on timber trusses and purlins. The structure is not original to the house and the timbers appear quite recent and in good condition with no cracks or crevices suitable for bats.

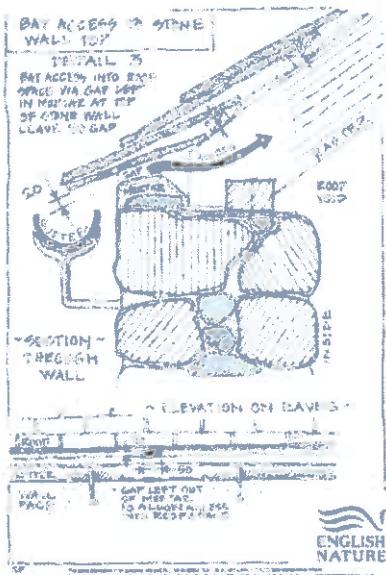
Eaves access

The conversion of the garage provides an opportunity to enhance the potential roosting habitat and the following should be incorporated.

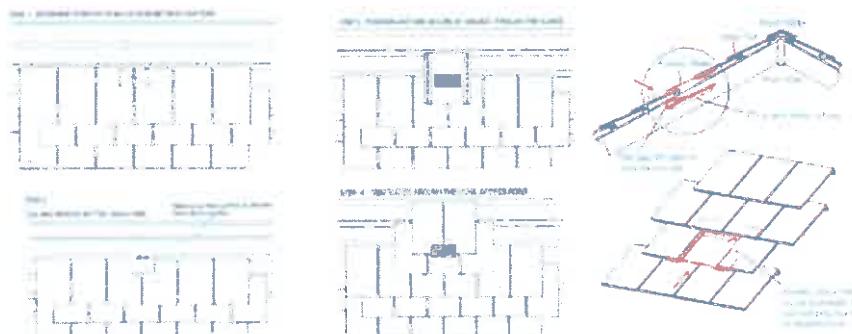
Bat slates

3No in the South pitch of roof

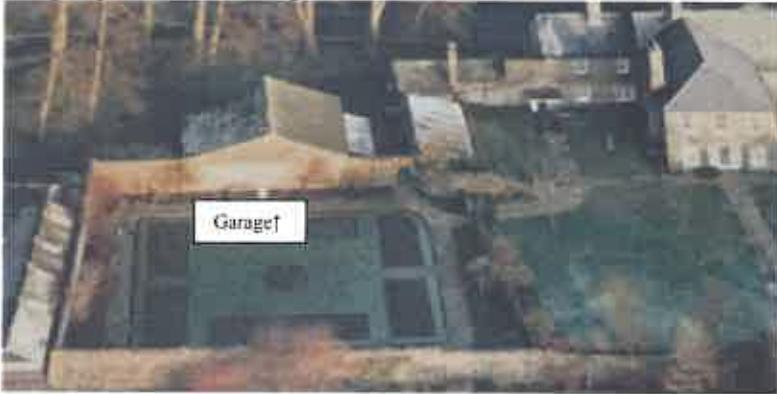
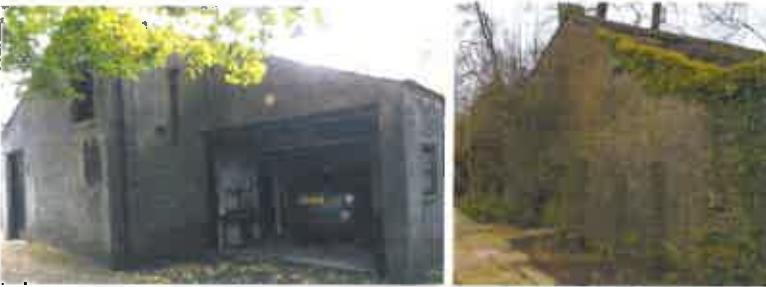
Elevations

The existing garage roof is in poor condition with a recently collapsed section, the owner wishes to repair and re-roof the building using materials to match existing.

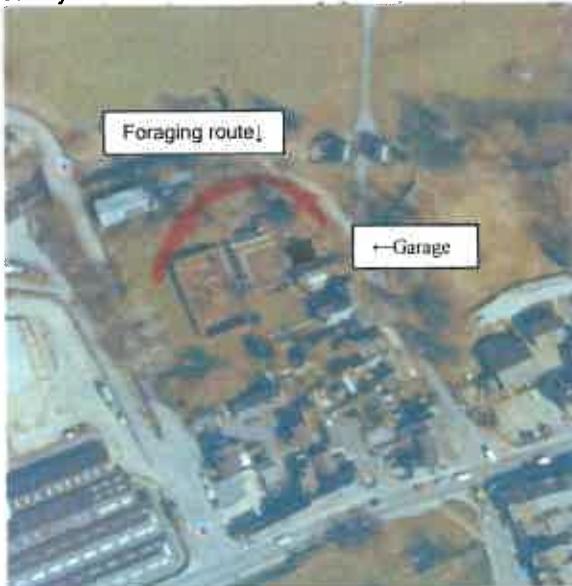
The detector picked up medium level foraging activity at 9.00pm. This activity was not concentrated around the garage it was in the mature tree line on the North west boundary, the red line below indicates the foraging activity. When observing the garage the echolocation signal was weak and no activity in the immediate locality was witnessed, no bats emerged or entered the garage. The foraging activity along the North west boundary involved approx 10no bats appearing and returning from a south west direction, this activity continued until the survey finished when it became too dark to see.
