**BAT SURVEY AT -
BURNSLACK FARM
CHIPPING
PRESTON**

**DATE AND TIME OF VISIT
23rd Feb 2018 10.00am**

REFERENCE NO. 5566

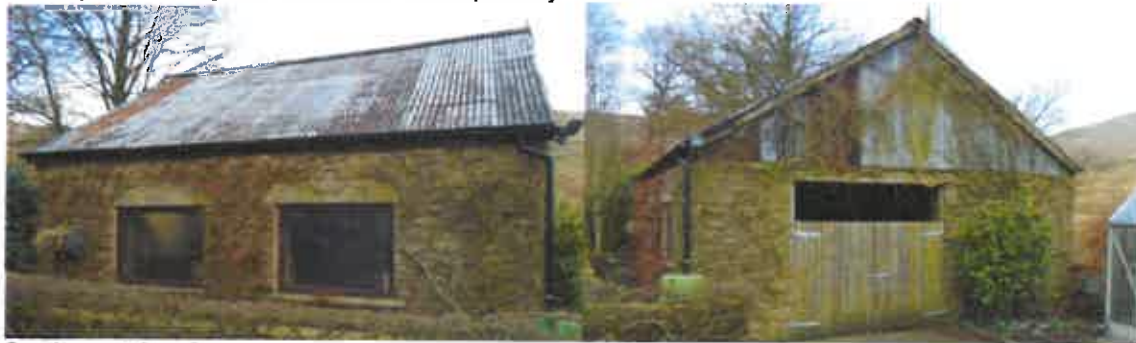
The garage a detached building located in the garden of Burnslack farm. The garage is a more contemporary building than the adjacent farmhouse which possibly dates from the 18th C.

South west elevation

South east elevation

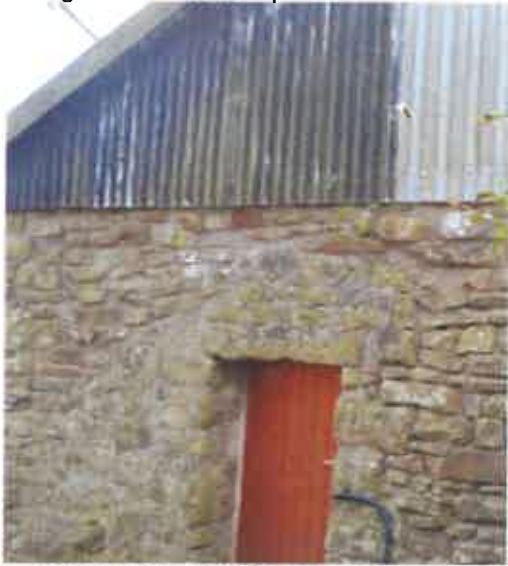
The walls up to the eaves level are pointed solid random stone. The gable is a timber frame faced with corrugated steel or clear plastic sheet.

The walls are in good condition and well pointed there are no access points or cracks / crevices which would provide habitat for bats. The front opening provides free access to the interior at all times.

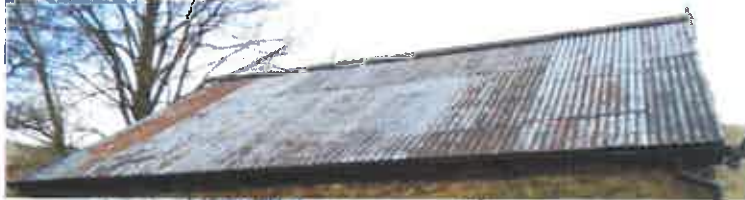
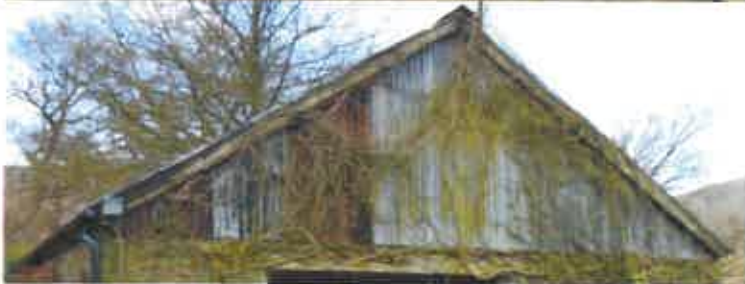
The roof is pitched with a steel corrugated steel sheet finish with timber fascias fixed to the wall. Timber barge boards to the gables.

The roof sheets are tight fitting. The ridge trim has gaps at the abutment with the corrugations. The fascias did not provide gaps suitable for bat use.

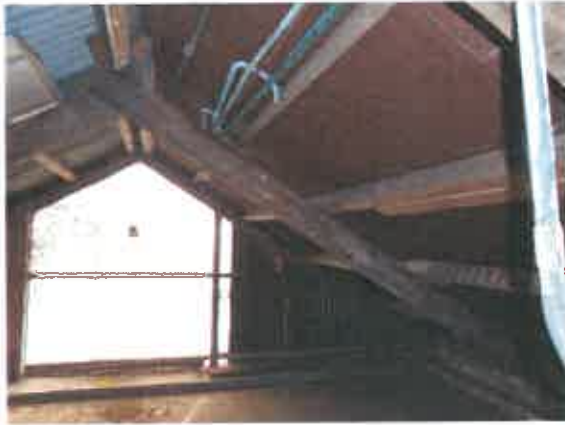
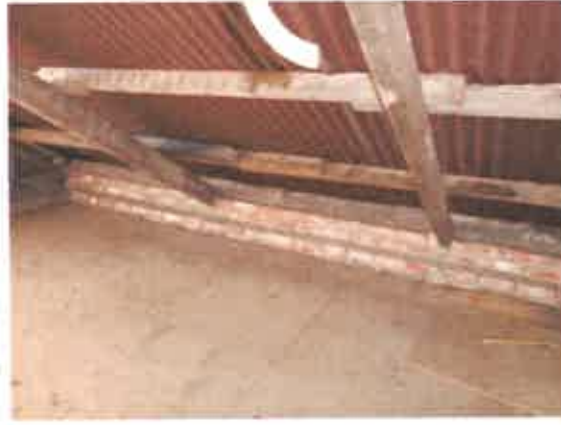
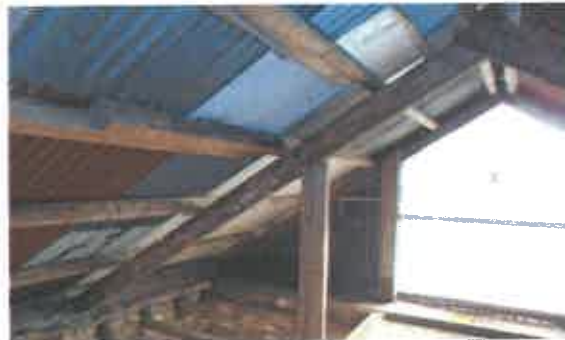
Roof space

There is a floor at the eaves level but there is a large opening for access from the ground floor allowing free access for bats and birds. The roof structure which was timber rafters and purlins with the steel sheet fixed over was easily examined closely. The timbers were in reasonable condition with no signs of rot, cracks or crevices. The space was cold and draughty and did not provide any potential for bat roosting whilst it is possible that bats may enter to forage there were no signs of droppings.
