**BAT SURVEY AT -
51 KNOWSLEY ROAD
WILPSHIRE**

DATE AND TIME OF VISIT
5th April 2018 3.00pm

REFERENCE NO. 5464

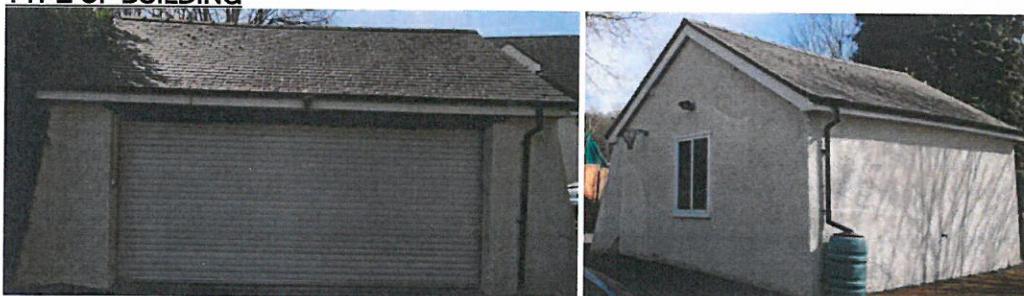
The building is a detached garage located in the garden of a detached house. The garage probably dates from the 1950's. The garage is in regular use.

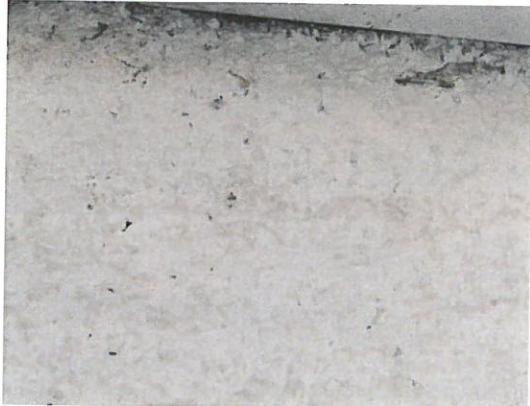
WALL CONSTRUCTION

The walls are brick construction with a rough cast (sharp aggregate) render finish externally with a white paint finish

The walls are in very good condition and provide no access points, cracks or crevices.

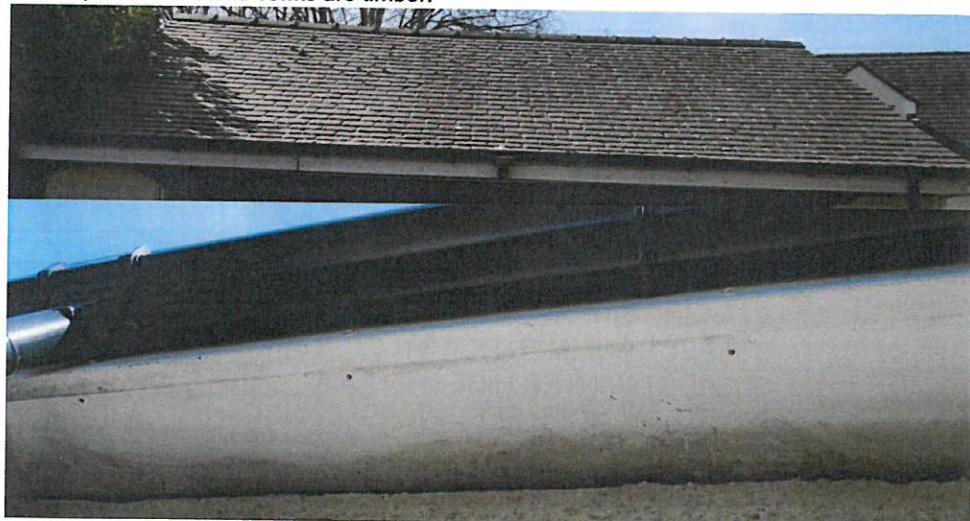
ROOF CONSTRUCTION

The roof is a pitched construction with an overhang at the eaves and barge boards to the gables. The roof finish is slate, the fascias and soffits are timber.

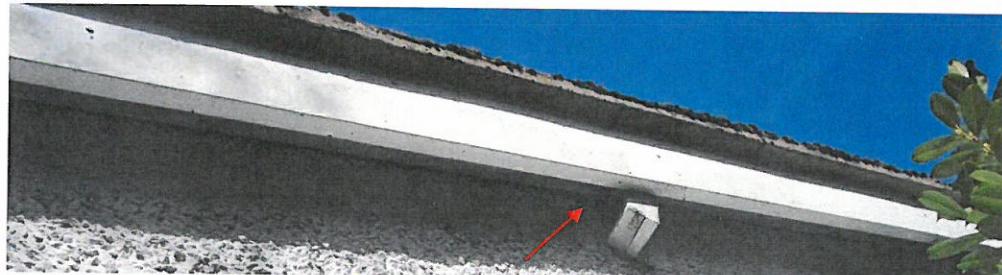
BAT ACCESS POINTS IN ROOF

The slates and ridge tiles are in perfect condition very tight fitting with no possible access points or crevices.

The eaves at the rear of the garage has a slight gap at the abutment of the soffit board with the wall, however the sharpness of the aggregate in the render would deter any bats from entering and the dirt line adjacent to the gap confirms that nothing has entered.

There is a small gap adjacent to the purlin in the south gable which has the potential to be accessed by bats.

All gaps identified were inspected with an endoscope the result was negative no signs of past or current use were found.

Currently the demolition of this building will not impact adversely on any local bat population nor is it likely that any bats will be uncovered or disturbed during the slate removal. It is however recommended that the gap adjacent to the purlin be blocked up before the end of April to prevent the possibility of bats entering prior to the demolition of the garage.

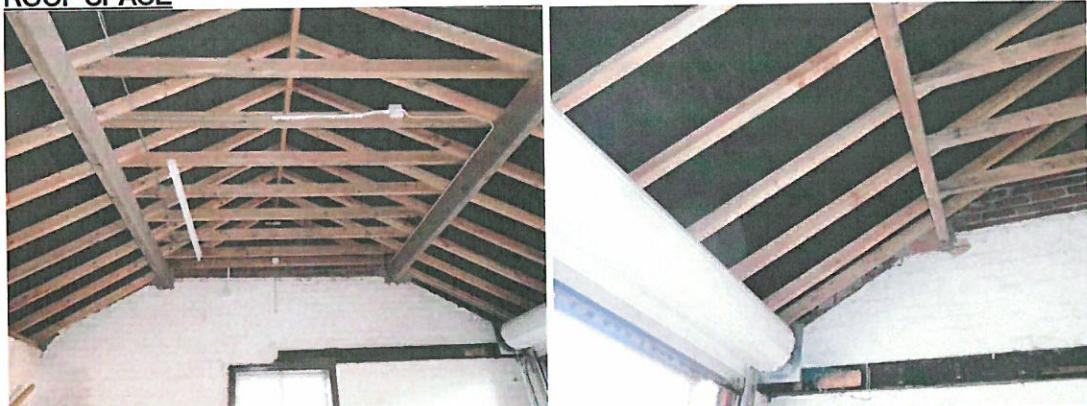
ROOF SPACE

There was no enclosed roof space the timber truss roof structure was easily examined. The felt was in good condition as were the timbers the roof structure did not provide any potential roost habitat.

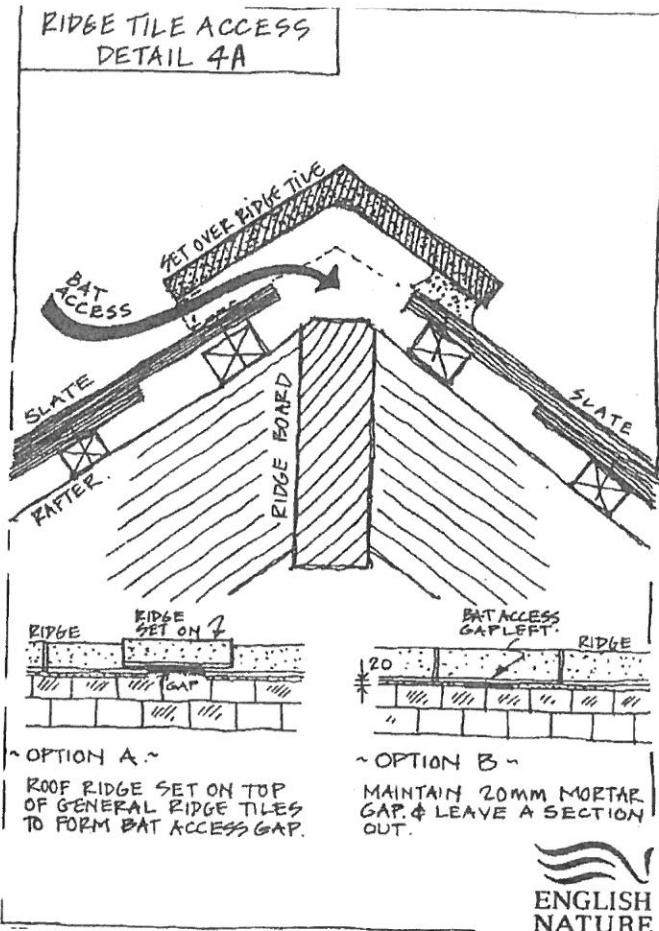
METHOD 2:	
PROVIDE 2 NO RIDGE ACCESS TILES ALONG THE ROOF RIDGE.	RECOMMENDED BY NATURAL ENGLAND: either raised ridge tiles providing 15 – 20mm gaps or leaving access gaps under tiles to enable bats to enter the space beneath the ridge tiles.
SPACE RIDGE ACCESS SLATES EVENLY ALONG LENGTH OF ROOF.	Pipistrelles and long-eared bats will enter roofs via narrow gaps under the ridge tiles; additional benefits are provided when small gaps are provided through the roofing felt or sarking membrane thus enabling bats to enter any retained roof voids.
Ridge access tile Detail 4A (below)
