Appendix 1: Photographic archive

Figure 2: Site location plan showing Victoria Mill and evaluation trenches

Figure 16: Phased block plan of Victoria Mill

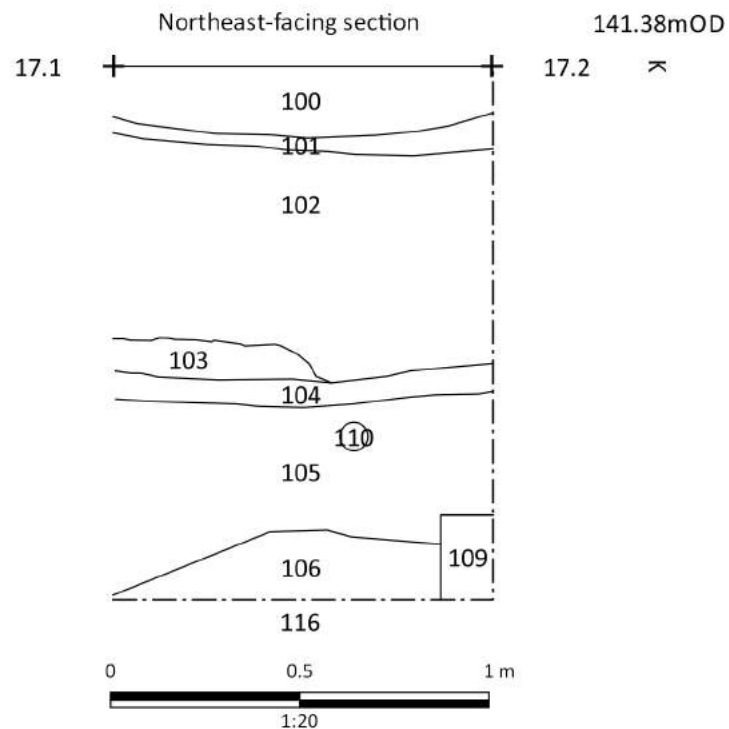
Figure 17: Plan and section of Trench 1
