Project Ref: 17140/GR/02 Victoria Mill,

Sabden

Project Details: Victoria Mills, Sabden

Executive Summary

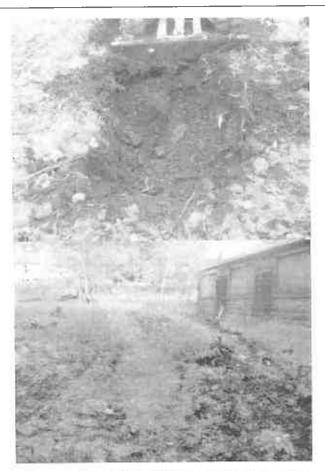
Suspected Asbestos Containing Materials (Chysotile cement roofing/tiles) were noted on the ground surface within the north-western area of the site and Asbestos Containing Materials (comprising asbestos cement tiles) were encountered within TP03 between 0.2 and 1.4m bgl.

Plate 4: TP03 – Showing asbestos tiles within Made Ground and on ground surface

It is recommended that the buried asbestos tiles (ACM's associated with TPO3) and any ACM's fragments on the ground surface are removed for off-site disposal at a suitably licenced facility. Any works undertaken which are likely to disturb or remove the asbestos within the Made Ground onsite should be undertaken in accordance with the CAR 2012 regulations (Ref:13) and associated CL:AIRE 2016 Industry Guidance on managing and working with Asbestos in soil, construction and demolition materials (Ref.14). Utilisation of the JIWG Decision Support Tool for Asbestos is Soil and Construction and Demolition materials indicates that the work to remove the buried Chrysotile asbestos tiles is likely to be classified Nonlicensed work, although PPE will be required. A copy of the JIWG -DST is provided in Appendix H.

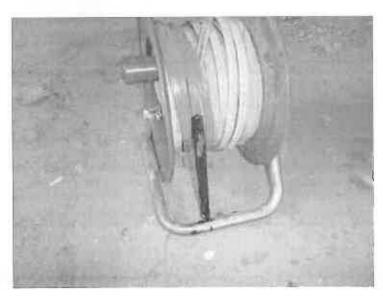
A hydrocarbon or creosote odour was also noted during the excavation of WS02 (underlying the Mill building). In addition Non Aqueous Phase Liquids (NAPL) comprising 'creosote/oil' type of contamination were also encountered during the groundwater monitoring of historic boreholes (primarily in WS05 and to a lesser extent in WS04) within the central area of the Mill building.

Plate 10: NAPL (Oil Creosote) type contamination on dipper associated with monitoring of historic WS05
