**OTTER, WATER VOLE AND WHITE-CLAWED
CRAYFISH SURVEY & REPORT**
at
**Land at Watt Street/Whalley Road
Clitheroe
BB7 9ED**

JCA Ref:
13611f/g/DB

Version:
Planning Application

Date of Report:
12/04/2018

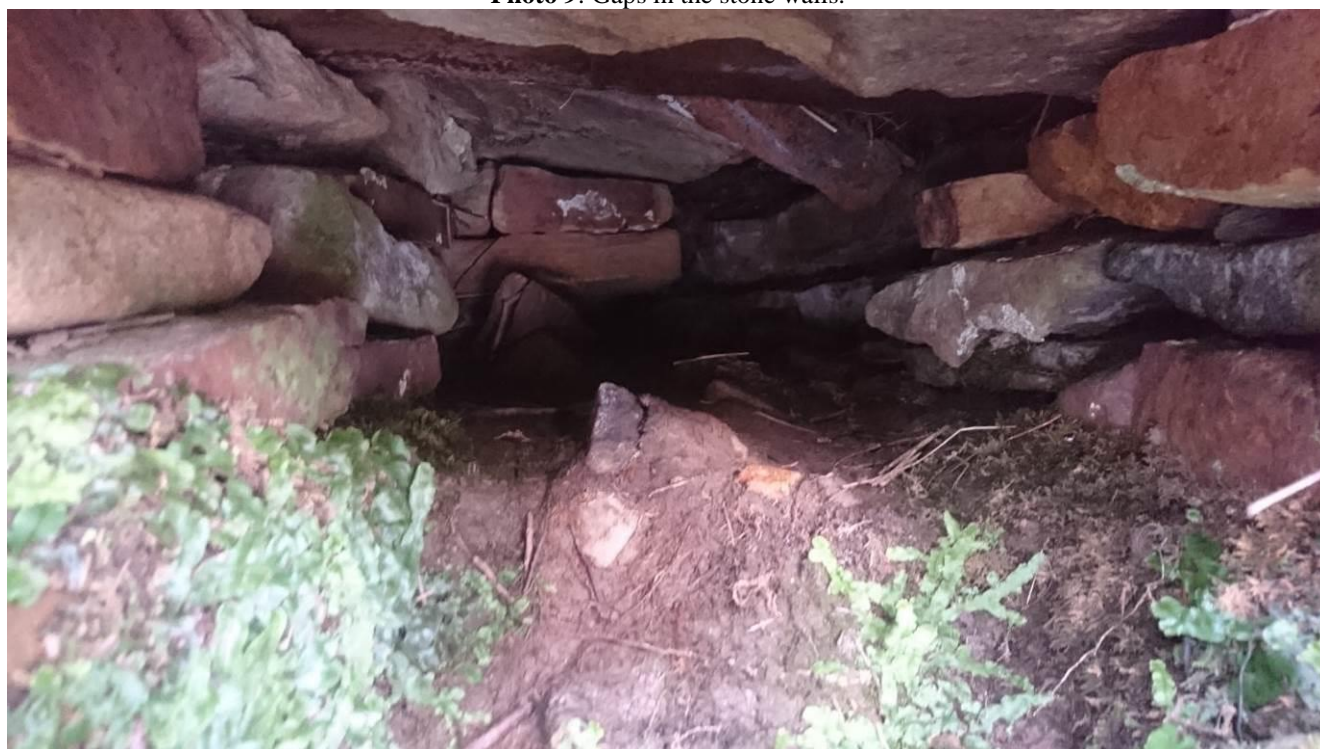
Photo 9: Gaps in the stone walls.

4.2.1 No records of water vole were found within 2km of the site. Although the site does contain habitats suitable for water vole, including gaps in stone walls along the brook edge, no evidence of water were found on the 27/10/2017. Suspect droppings were found on the 12/12/2017 which are awaiting analysis.

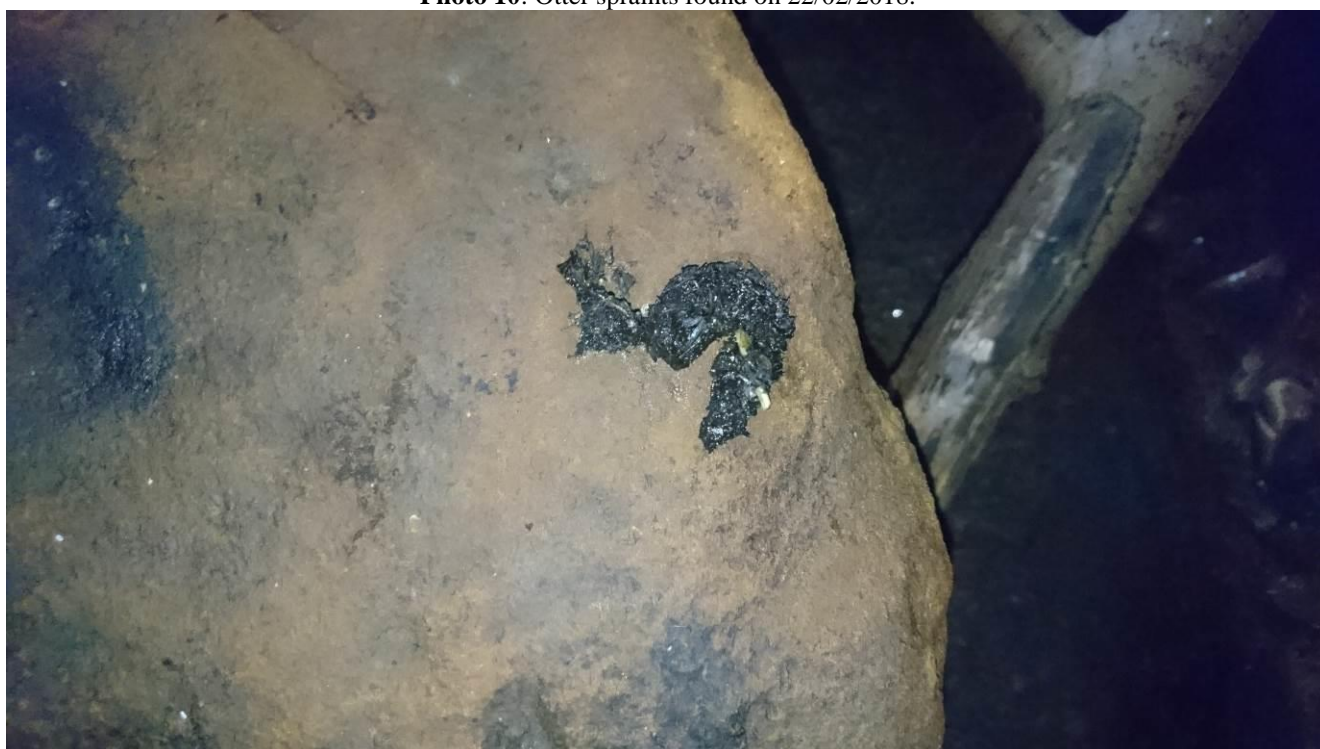
Photo 10: Otter spraints found on 22/02/2018.

pond on both the 27/10/2017 and 12/12/2017. However, on return to the site on 22/02/2018, otter spraints were discovered in two locations under the tunnel at Sabden Brook, directly below the former mill (**Appendix 2, Photos 10 and 11**). The stretch of the brook and the mill pond were once again search, but no other evidence of otter could be found.

Although Victoria Mill may be on the extremities of an otter territory, as suggested by the evidence discovered, otters do certainly utilise the tunnel below Victoria Mill. Avoidance, mitigation and compensation will be required under the proposed development plan to preserve the favourable conservation status of this protected species, as otters may be disturbed during and post-construction. Therefore a Natural England Mitigation Licence for Otters will have to be applied for pending planning approval. The following is an outline of strategies that will be required at Victoria Mill to reduce disturbance and will be included in the Mitigation Method Statement:

- Otter fencing: As the site is situated next to the Sabden Brook and an active otter territory, otters may enter the site during construction works. To prevent this happening exclusion fencing can be installed. 1.8m galvanised welded square mesh fencing should be erected around the entire site during the construction period to ensure otters don't enter the site when works are taking place. This mesh fencing is buried partially in the ground with an overlap to prevent digging. Mesh is held in place with wooden posts. An overlap at the top of the fence can also be created if required. Fencing can be removed once construction works have been completed.
