RE: Proposed development at Holden Clough Nursery, Holden, Bolton-by-Bowland, Clitheroe BB7 4PF

Bat roost and bird nest evidence from survey – Holden Clough Nursery

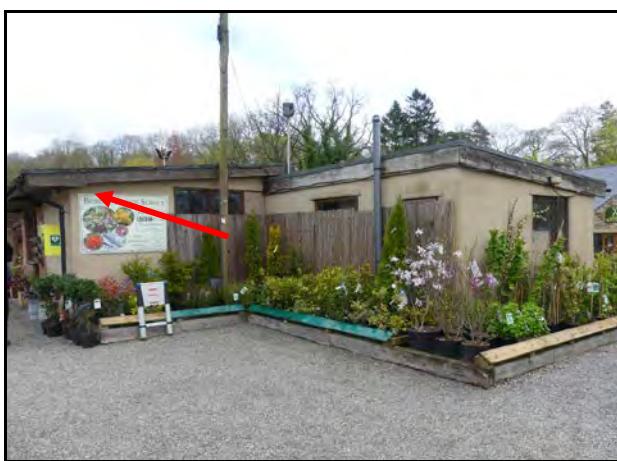
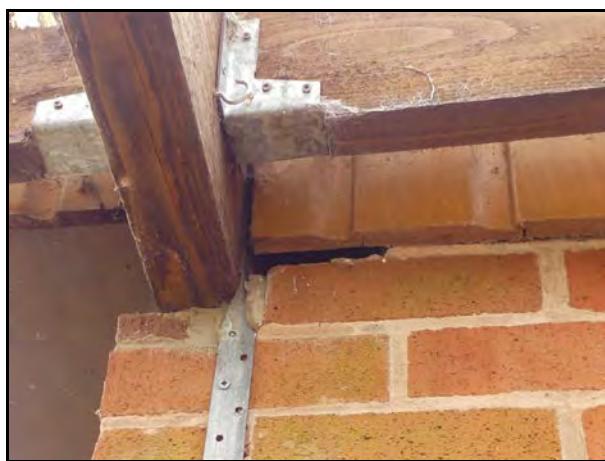
There are gaps at the top of external walls, giving access to small enclosed voids; these features are suitable for use by roosting bats throughout the year. There are no potential roost features associated with the internal parts of the building.

An unoccupied bird nest was present underneath a roof overhang at the south west corner of the Potting Shed building. Gaps at wall tops and sheltered areas beneath roof overhangs have high potential for use by nesting birds at this building.

Potting Shed: View of south and west elevations with bird nesting site marked with red arrow (lhs) and likely bat roost feature at wall top (rhs)

It is advised that for these buildings, with these features, this condition and landscape setting, a minimum of three emergence survey/re-entry surveys should be carried out per roosting feature during the bat active season, between May and August. It is also advisable at this stage to undertake surveys using remote detectors over a minimum continuous 2 weeks period during the bat active season; these surveys could run alongside the bat emergence/re-entry surveys.

It is recommended that nesting sites, particularly for blue tit, robin and wren, are included in any new/refurbished building to offset the loss of nesting opportunities offered within the existing buildings.

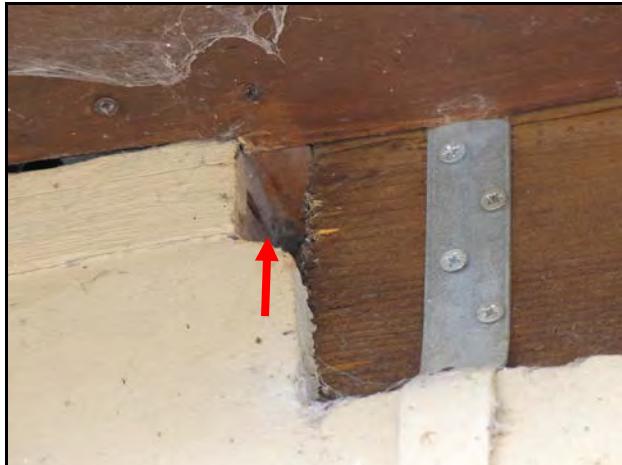
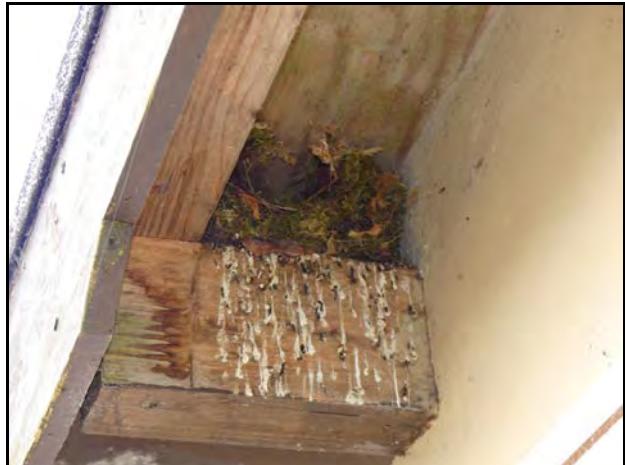
Potting Shed: Likely bat roost feature marked with red arrow (lhs) and disused bird nest (rhs).

It is advised that at least one bird species (probably a robin or a wren) has nested at the Potting Shed and there is high potential for nesting birds to be present during the nesting season (February to September). Nesting birds may therefore pose a legal constraint to the proposed development. Therefore, it is advised that works are either undertaken outside the nesting bird season or if works cannot be avoided during this period a pre-commencement check is carried out by an ecologist.

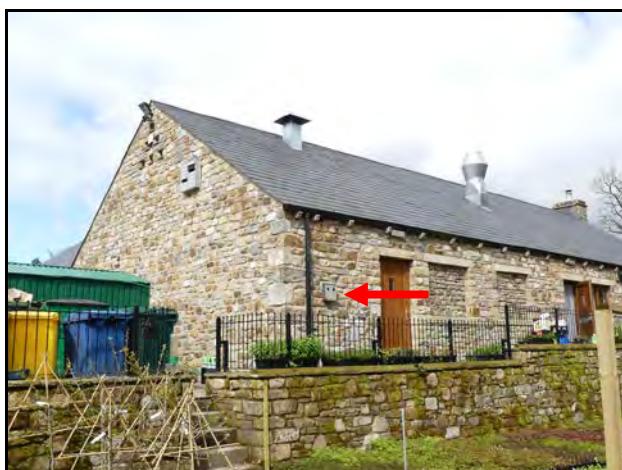
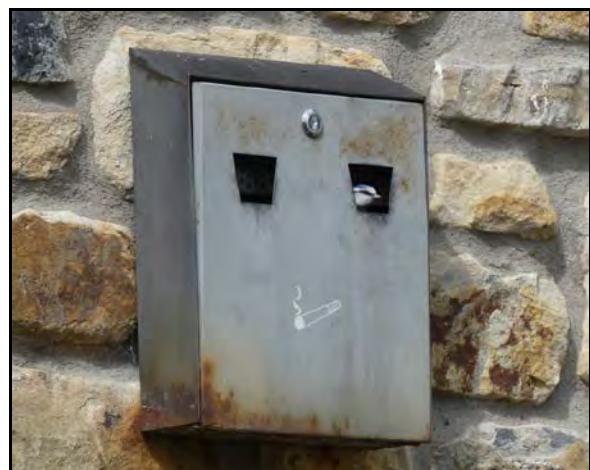
A blue tit was nesting in a wall-mounted cigarette bin on the east elevation of the Tearoom building. No other likely nesting features were found associated with this building.

Tearoom: Location of blue tit nest marked by red arrow (lhs) and closer view (rhs)

It is advised that blue tits have nested at the Tearoom and there is high potential for nesting birds to be present during the nesting season (February to September). Nesting birds may therefore pose a legal constraint to the proposed development. Therefore, it is advised that works are either undertaken outside the nesting bird season or if works cannot be avoided during this period, a pre-commencement check is carried out by a suitably experienced ecologist.

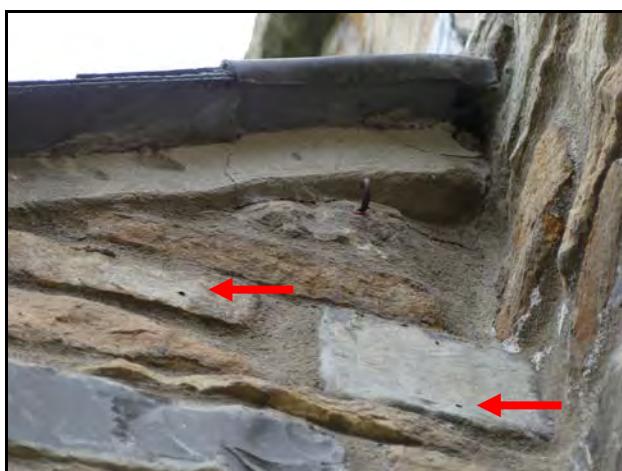
During the survey, bat droppings were found on external walls on either side of chimney on the north elevation, and below a gap at the south west wall junction. The evidence is shown on a diagram attached to this advice letter.

Tearoom: Bat droppings (marked with red arrow) below likely roost site (lhs). Holden Beck: View to south showing potential site for otters and likely nesting birds and bat foraging (rhs)

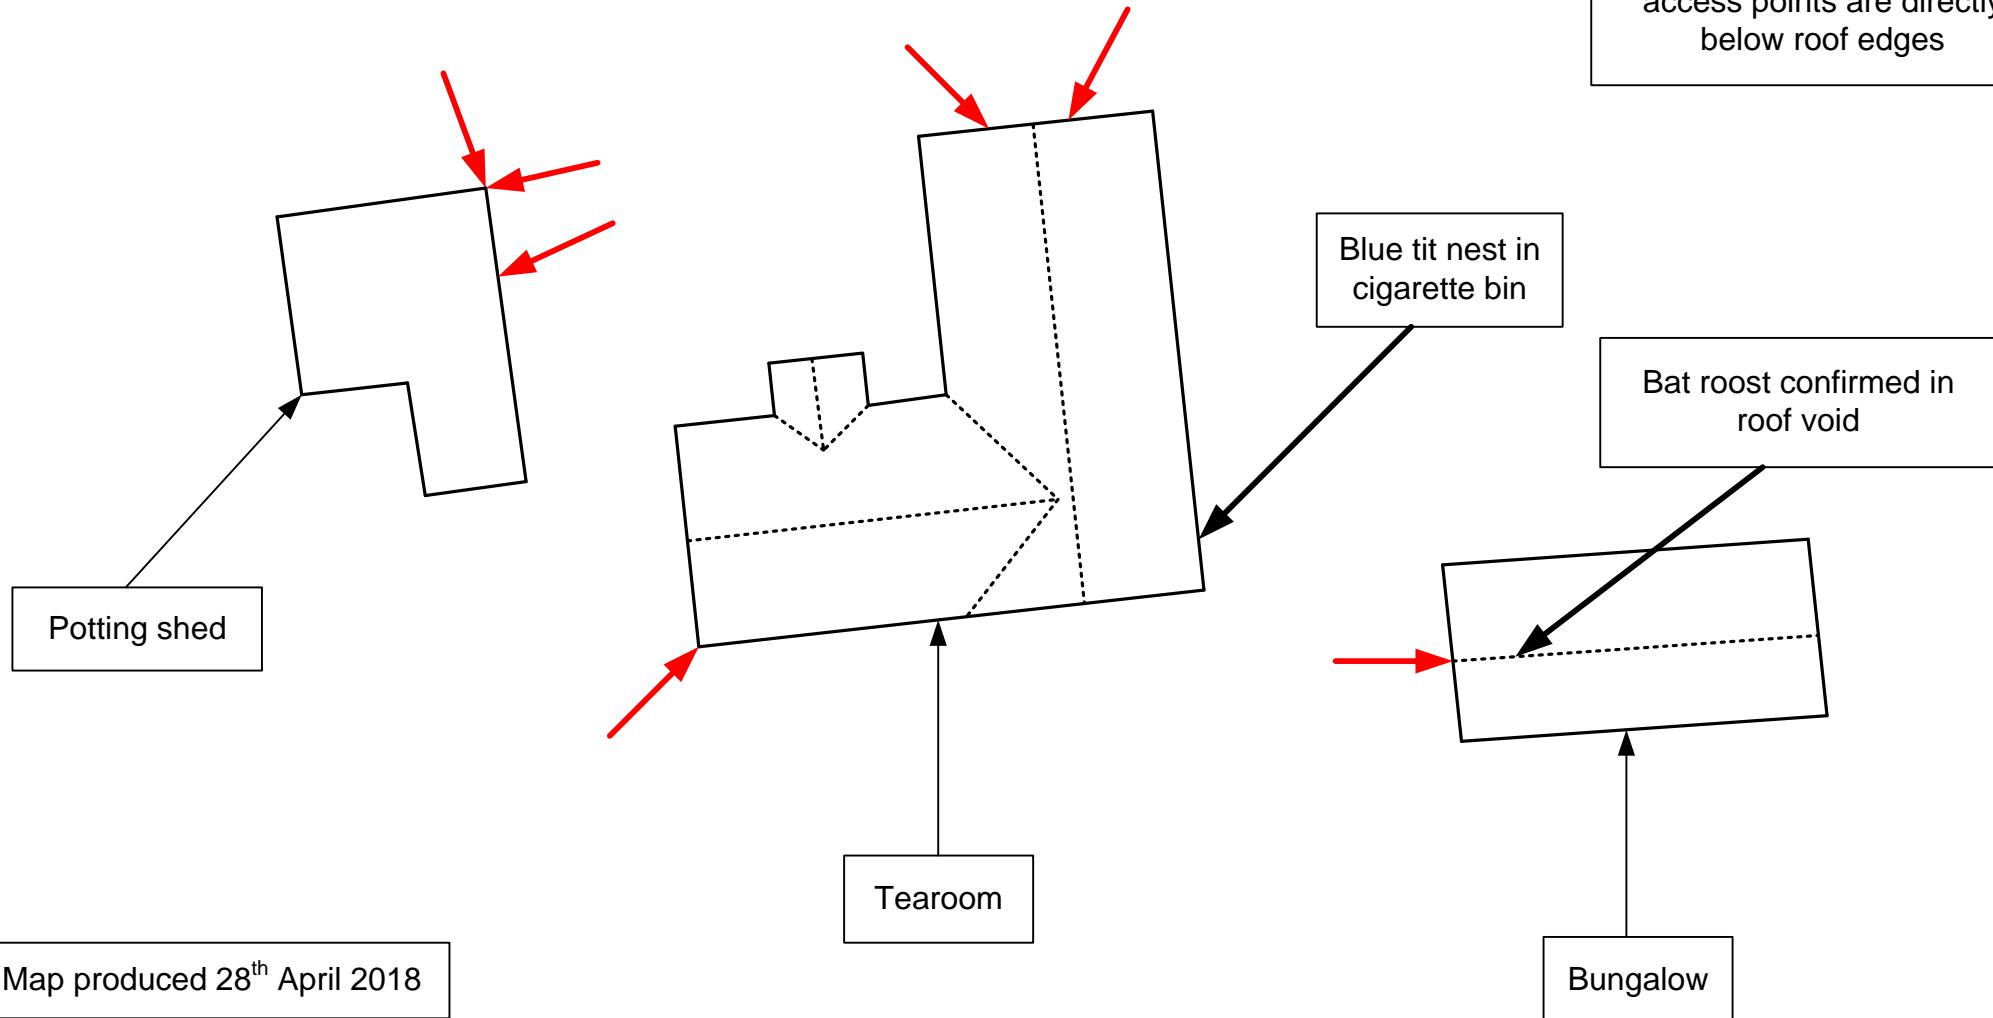
Nursery personnel reported finding two live bats in April 2018 in a water tank immediately adjacent to the north east corner of the potting shed building. During the survey, a small number of bat droppings were found stuck to external walls at the north east corner and north elevation of the building. The evidence is shown on a diagram attached to this advice letter.

Red arrows denote bat signs, likely bat access points and bat roosts. All bat signs and access points are directly below roof edges
