## BAT SURVEY AT

Holden Clough Nursery, Bolton-by-Bowland

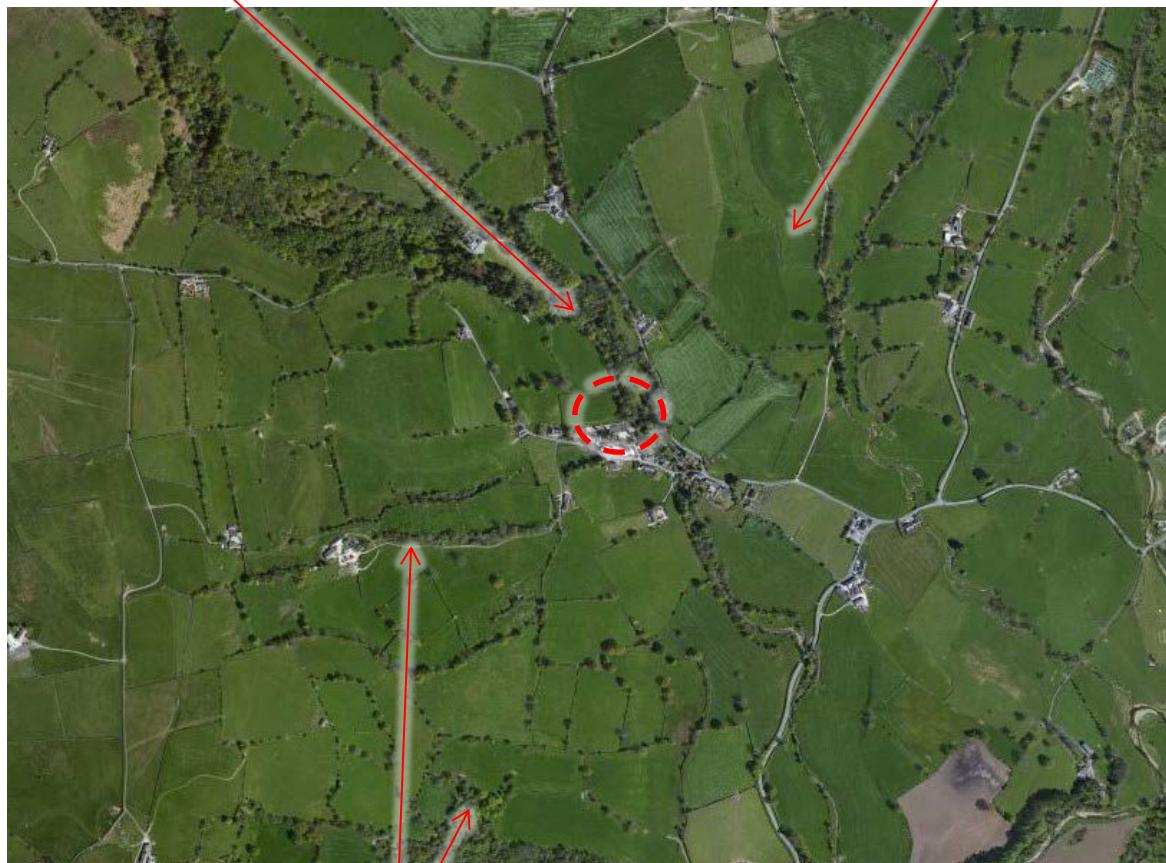
Holden Beck and associated woodland likely to offer high quality foraging and commuting potential

Open and exposed pasture likely to offer low quality foraging opportunities

Hedgerows and fragmented woodland likely to offer moderate foraging and commuting potential

The habitat on and adjacent to the site identified from satellite images was ground truthed. Details of the habitats found on and adjacent to the site are detailed in Figure 5.

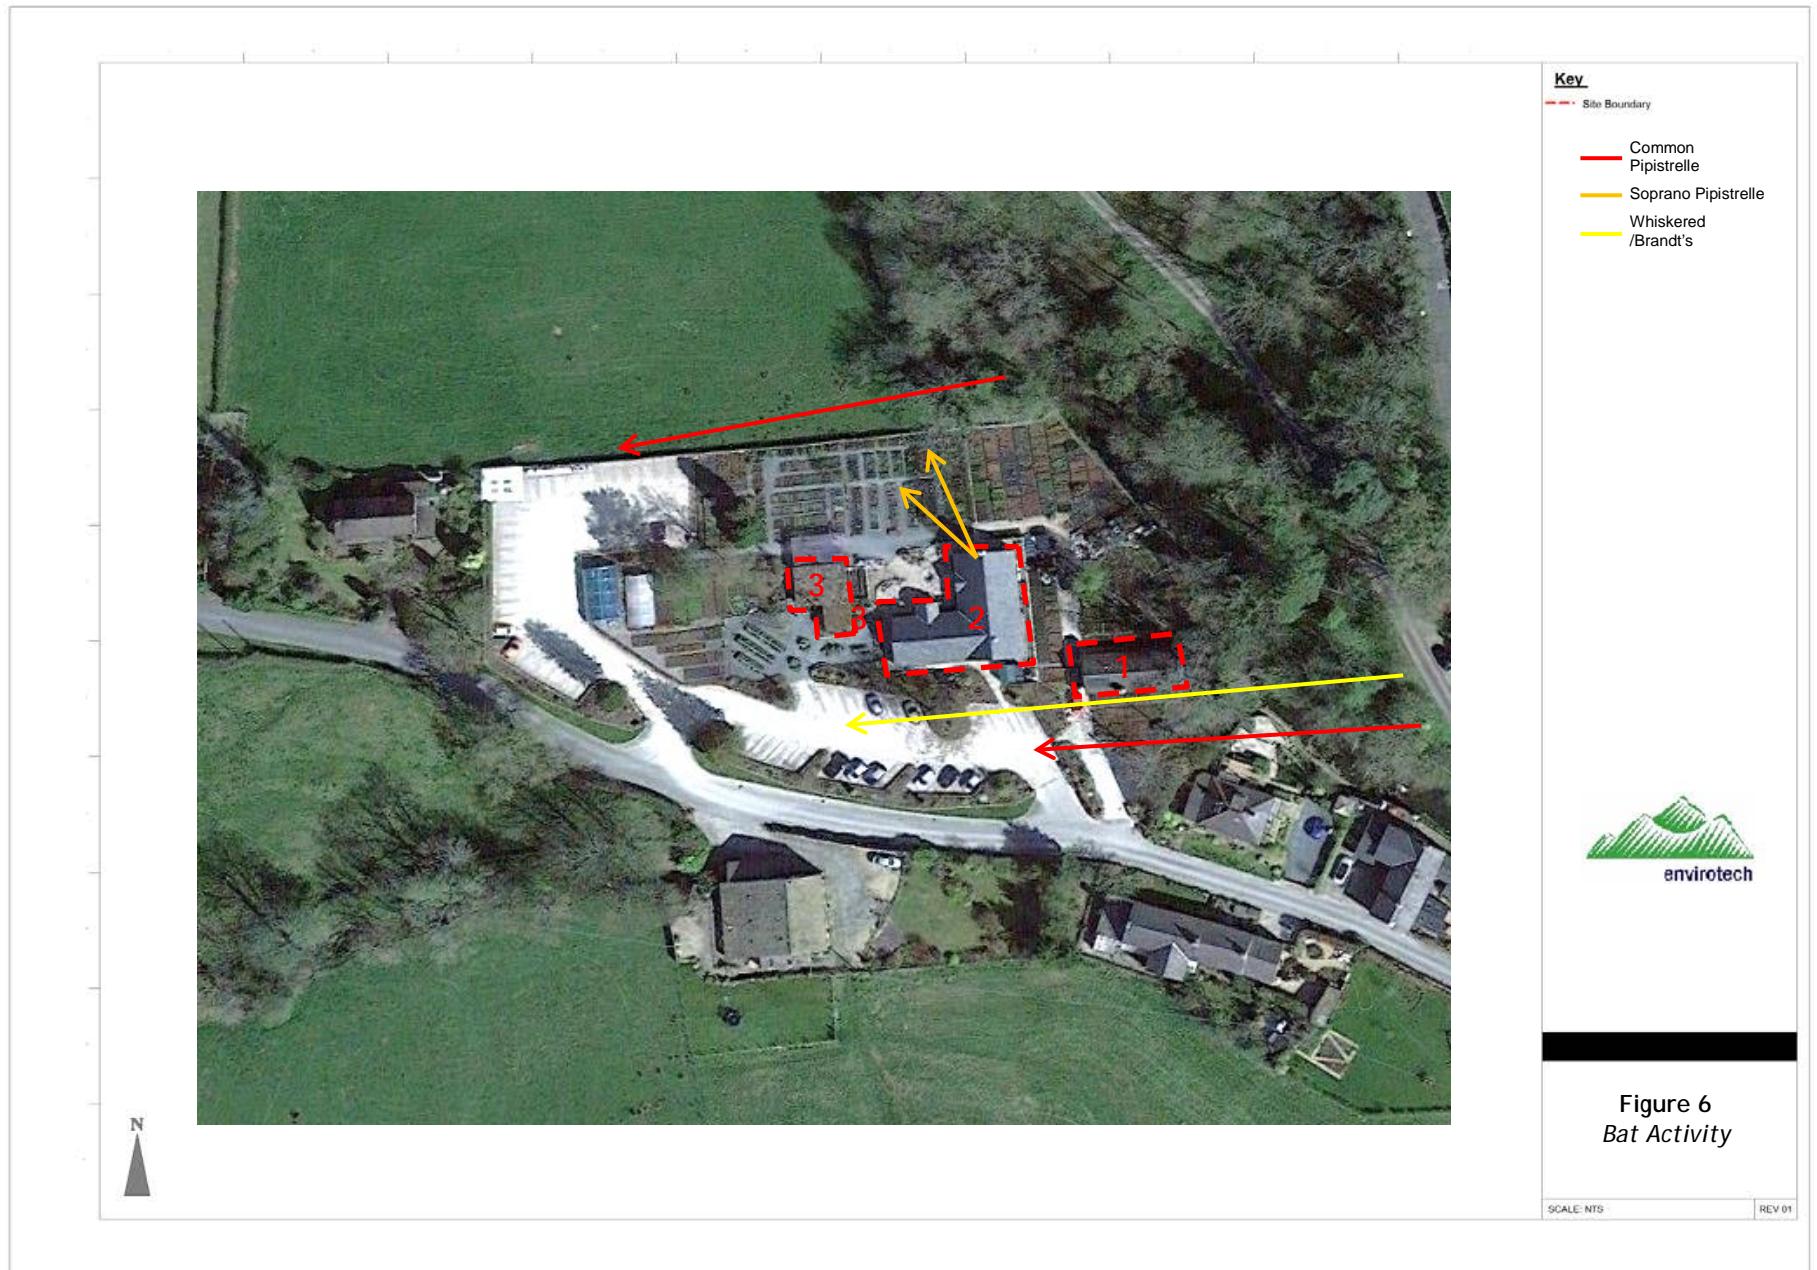
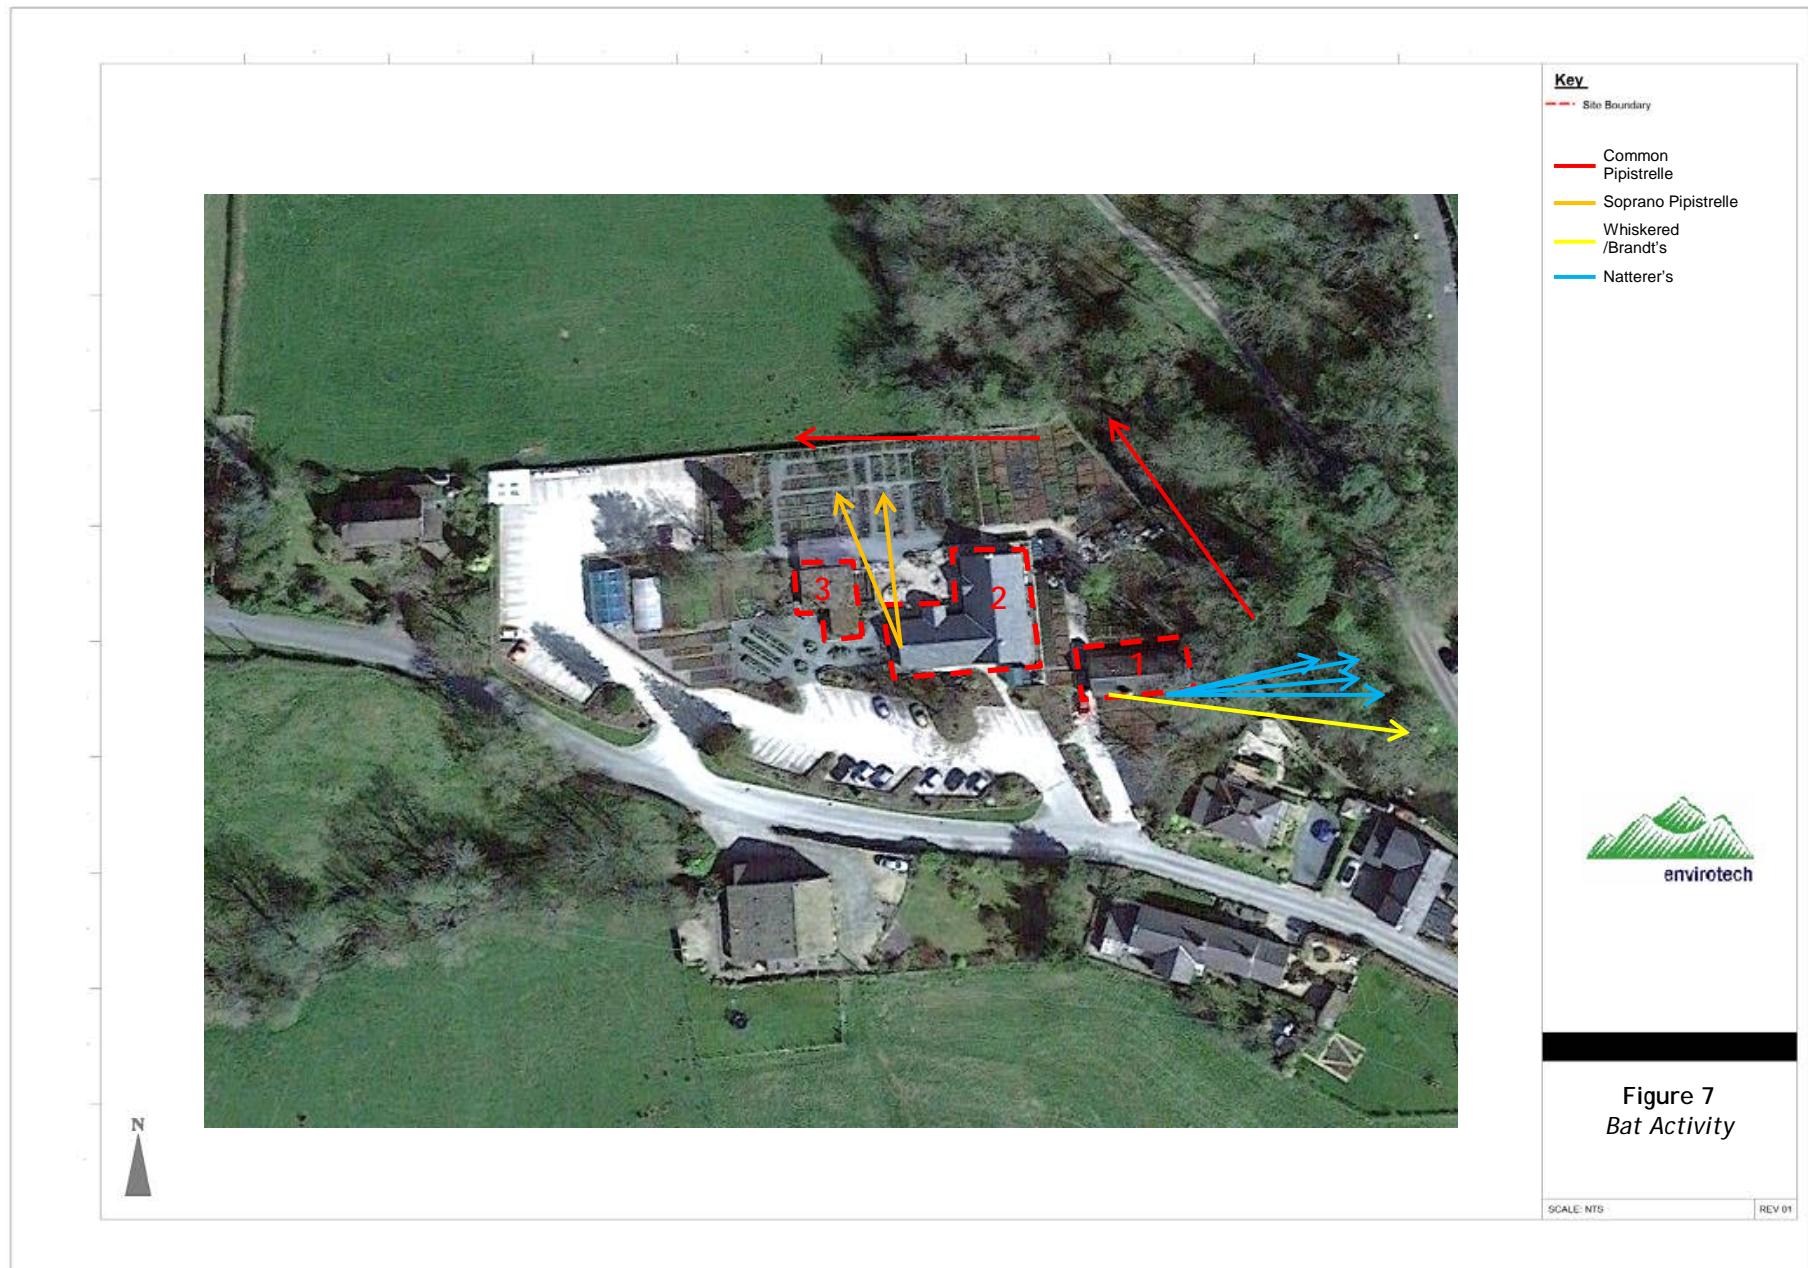
Bat activity is plotted on Figure 7.

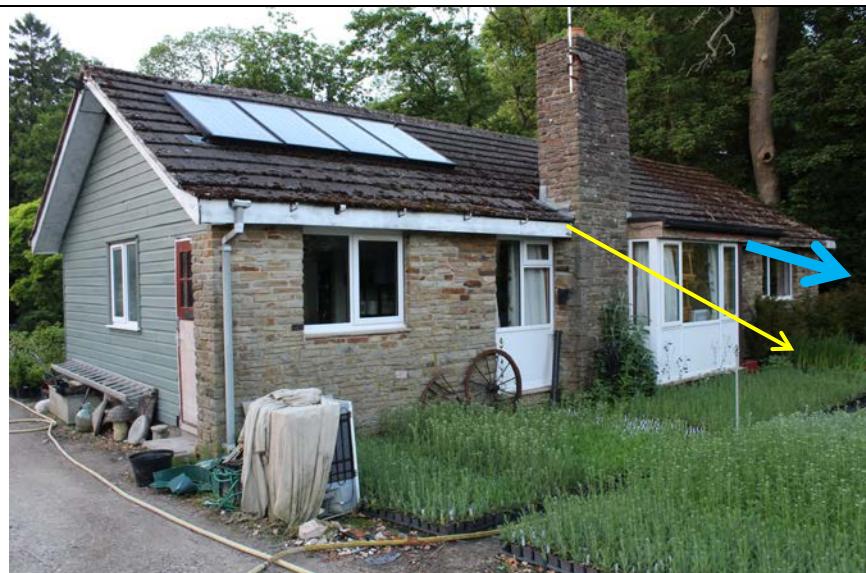
Building 1 is a bungalow that is not included in the current proposals but may be developed in future. A Whiskerd/Brandt's bat (yellow arrow) and four Natterer's bats (blue arrow) were recorded emerging from the building.

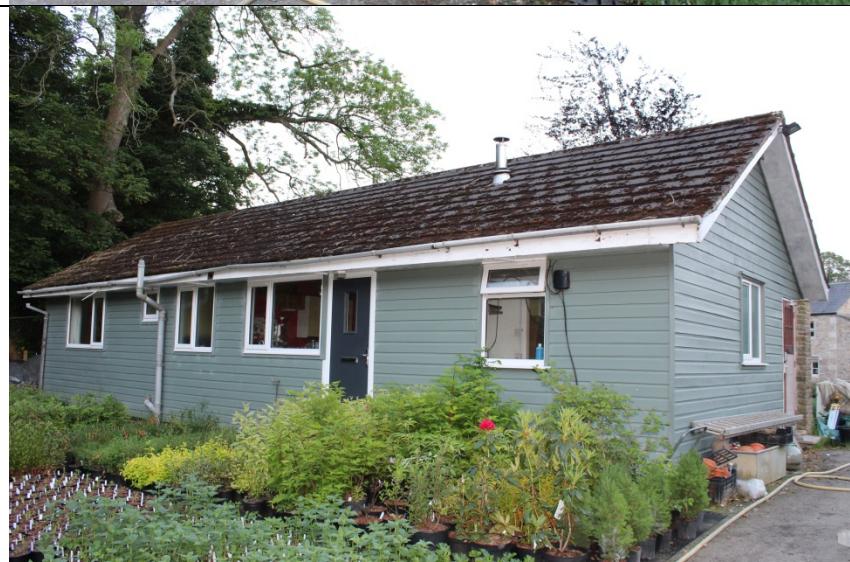
**Building 1**  
Part of the bungalow is clad with timber. The roof is well sealed.

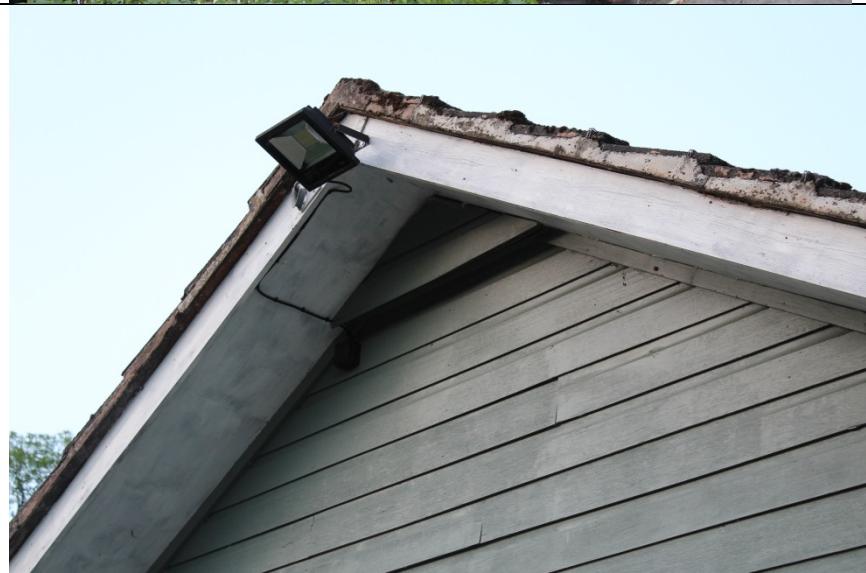
**Building 1**  
There is a large vent in the timber cladding that would allow bats free access but shows no signs of use.

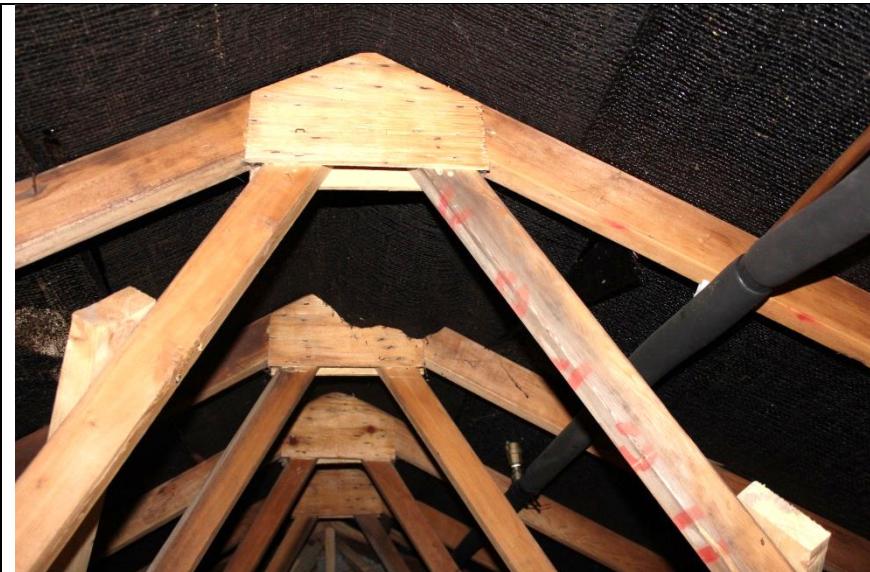
### Building 1

There are droppings leaking into the roof void from a rip in the roofing felt. These were DNA tested and came back as Natterer's bat droppings.

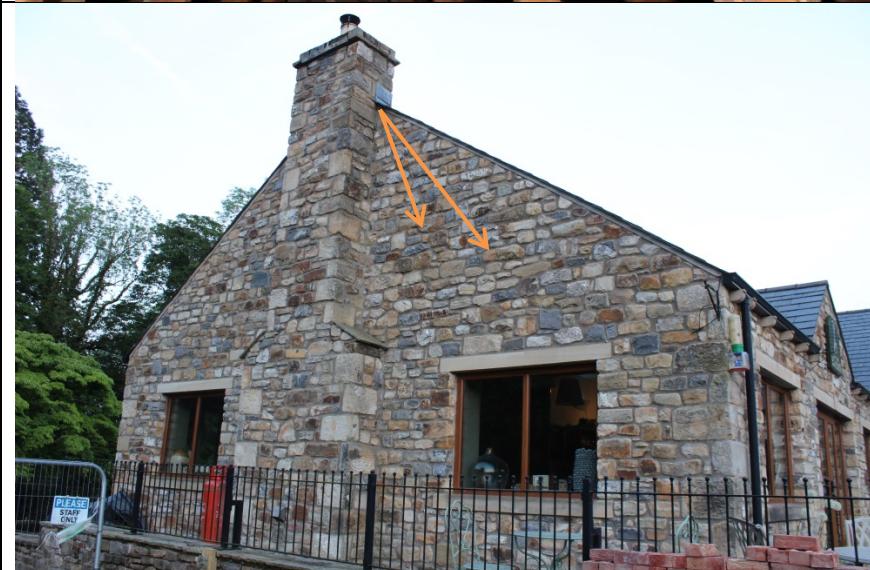
### Building 2

Two soprano pipistrelles were recorded emerging from a flashing gap on during the first survey at the site. Two soprano pipistrelles also emerged from a similar place on a different gable during the second survey.

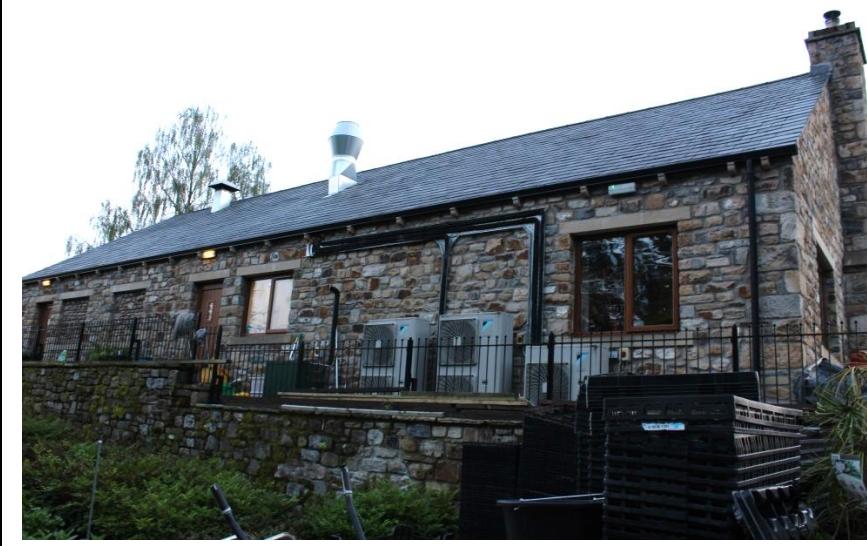
Building 2 is otherwise very well sealed.

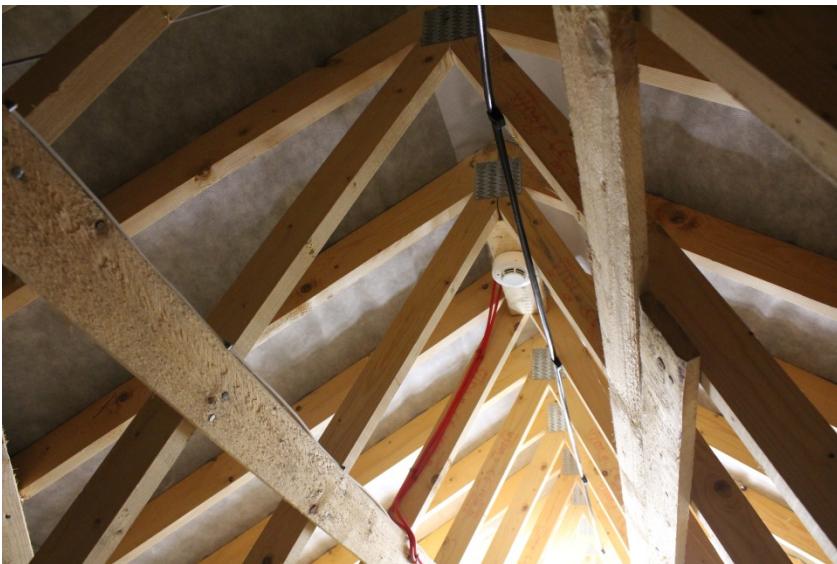
The roof void of building 2 was found to be very clean.

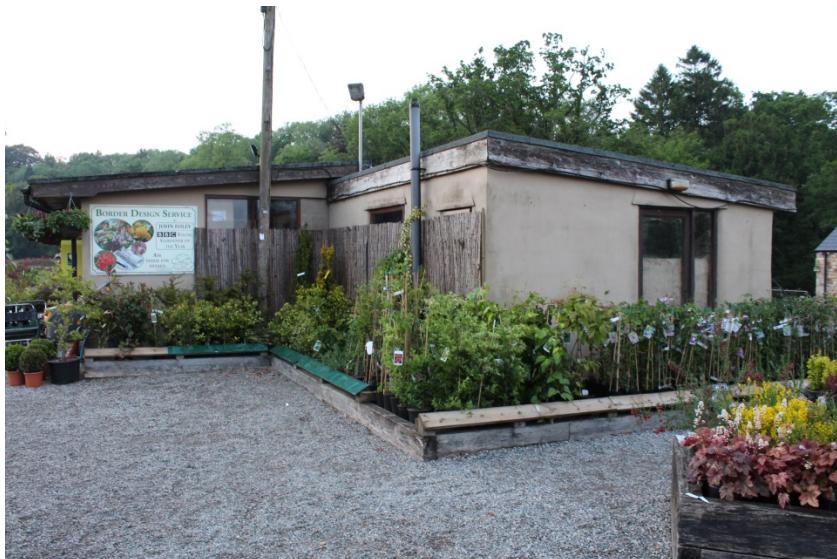
### Building 3

The potting shed was considered to offer negligible potential for use by roosting bats. There were no areas that appear to offer suitable roosting opportunities.
