**BAT SURVEY AT -
20 CLITHEROE ROAD
WHALLEY**

DATE AND TIME OF VISIT
16th May 2018 5.45 pm

REFERENCE. Mr and Mrs Dent

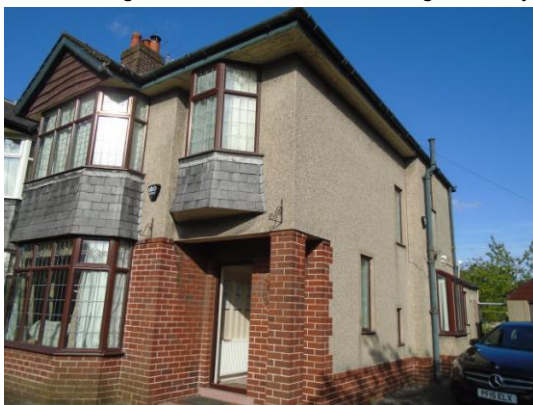
Front and side elevation

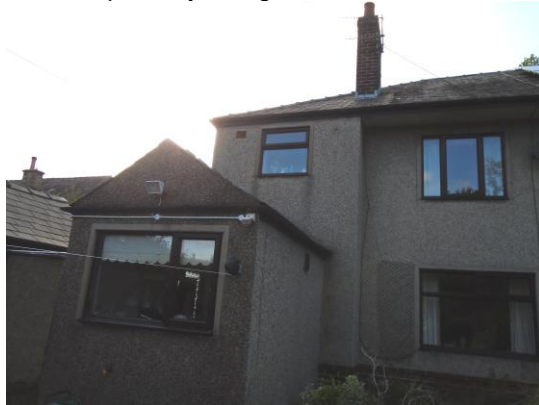
Rear elevation showing outrigger to be demolished

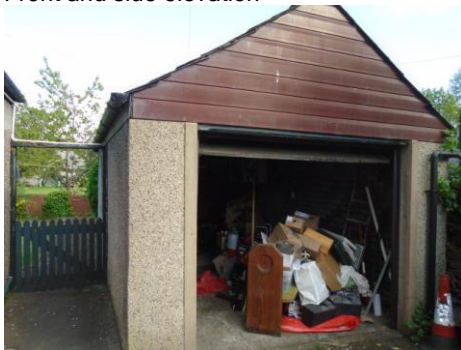
Detached garage

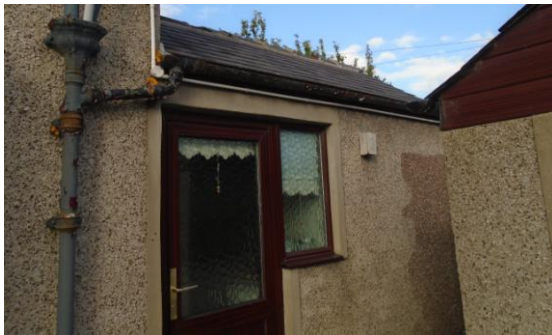
The walls are mainly rough cast render over brick both to the garage and house, the front bay has slate hung sections and the gable is timber boarded. The gable of the garage is clad with upvc boarding.

Outrigger and part garage wall

The render is in good condition no cracks or crevices for bat ingress. The hung slates are tight fitting as is both the timber and upvc boarding, there are no voids behind which could be used by bats.

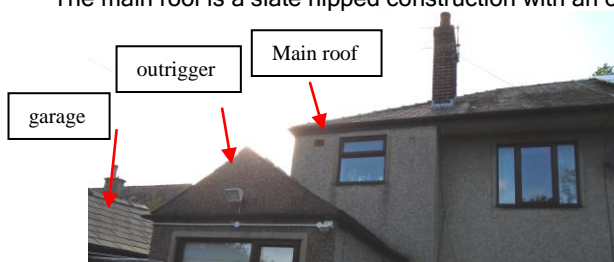
The main roof is a slate hipped construction with an overhang at the eaves to the front and rear.

The garage roof is a slate pitch with no overhang and flush fascias at the eaves, the outrigger is pitched with flush fascias and a pointed verge.

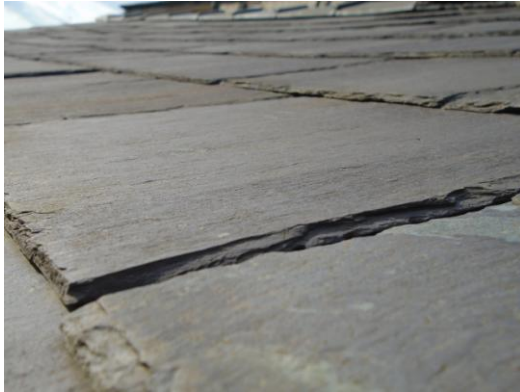
The slates on all of the roofs are in good condition and tight fitting as are the ridge tiles, lead flashings are in good condition with no gaps. The eaves to the garage and outrigger were closely inspected, the fascias are very tight with no gaps behind. The main roof to the side elevation has flush fascias and are also very tight fitting. No access points in the roof were found.

Garage roof

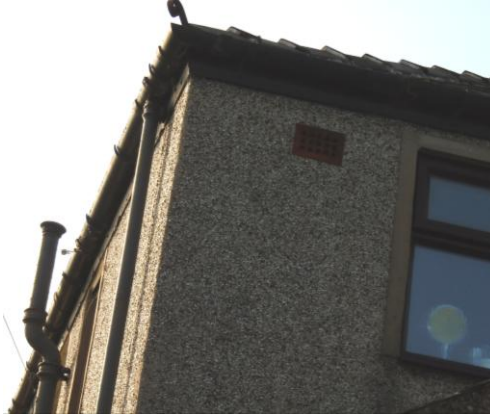
Main roof

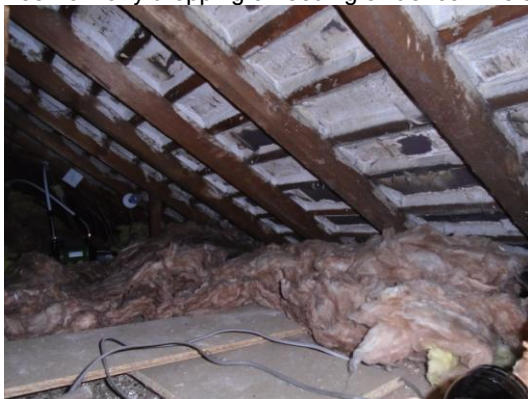
The main roof space was thoroughly examined for all the above listed signs. The slates are pointed onto the rafters and battens the quilt and boarding was inspected for dropping or feeding evidence both were clean and free from any dropping or feeding evidence. The space is not accessible to bats.

main roof

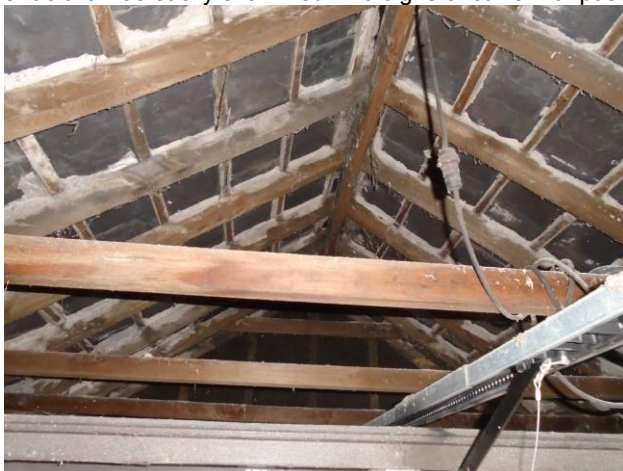
There is no enclosed roof void in the garage, slates pointed on timber battens and rafters as before. All the structure was easily examined. No signs of current or past use it does not provide any roost potential for bats.

garage roof
