BAT SURVEY AT

WOODSIDE HOUSE,
HOTHERSALL

Author	Chris Arthur	Date	27/09/2017
Checked by	Andrew Gardner	Date	27/09/2017
Report Version	1		
Field data entered	<input checked="" type="checkbox"/>		
Report Reference	4183

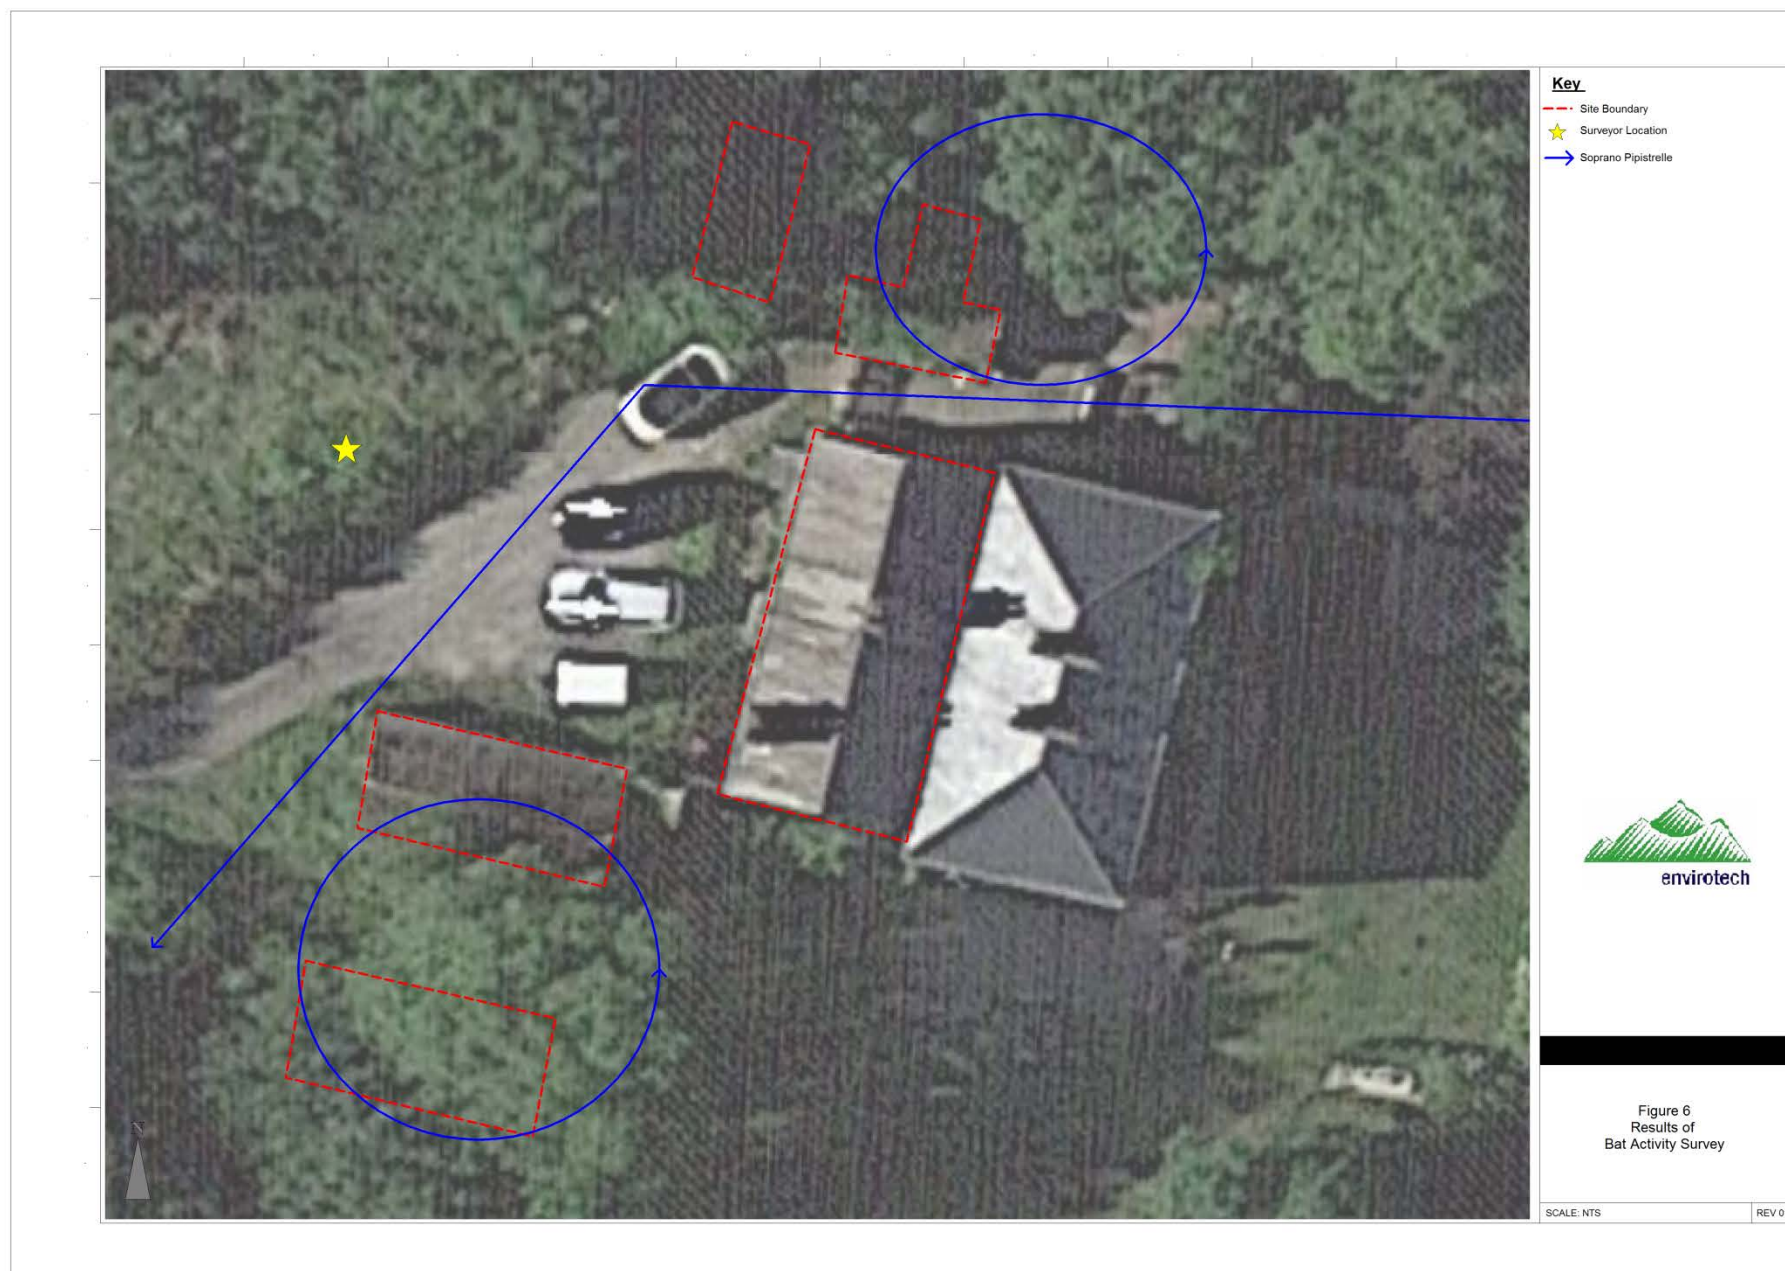
The survey was terminated when light levels reached 0.2 Lux and seeing bats became difficult.

Bat activity is plotted on Figure 6.

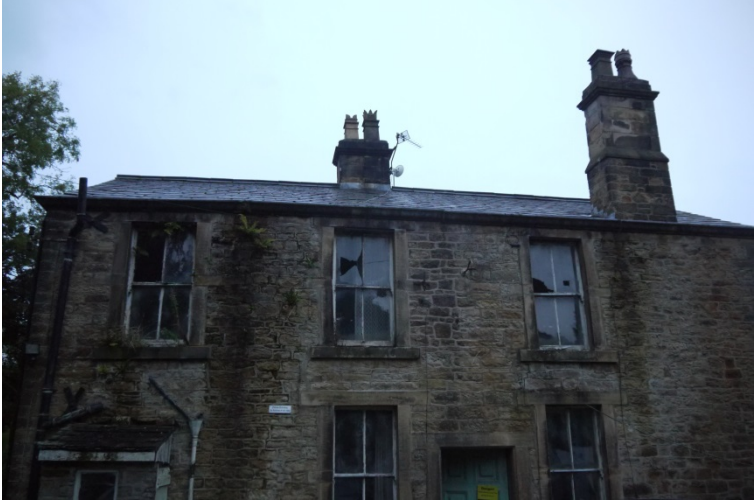
<p>The main building on site is a derelict semi-detached stone built dwelling. The stone walls are well sealed, and the wall tops are inaccessible to bats.</p>

The walls of the building are made from natural stone and are in good condition. There are no gaps or cracks and the pointing between the dressed stone is in excellent condition.

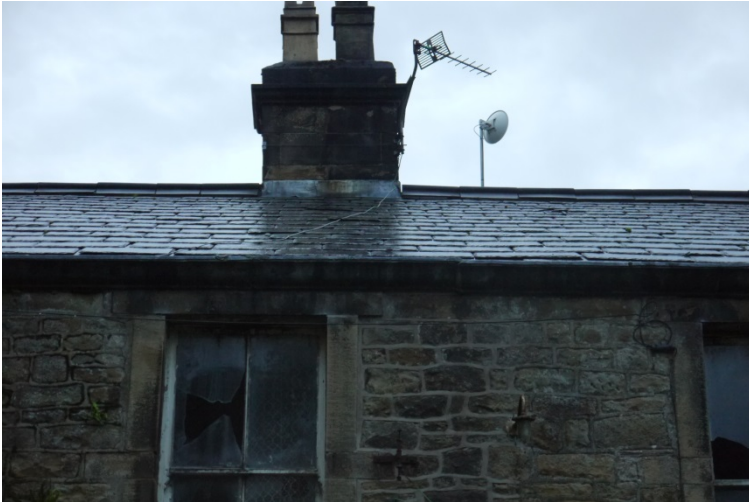
The roof is in surprisingly good condition. There are only occasional gaps on the ridgeline which are shallow and exposed, with no indications of use by bats.

The roof of the building is pitched and made from slate, with an approximately North-South orientated ridgeline. The coverings are in surprisingly good condition, with the slates mostly fitted tightly. Inevitably there were occasional raised slates on both roof pitches, as well as ridgeline gaps where the mortar was missing. The full extent of the gaps could be seen from the ground with close focus binoculars and a 1,000,000 candle power torch. No indications of use by bats could be found.

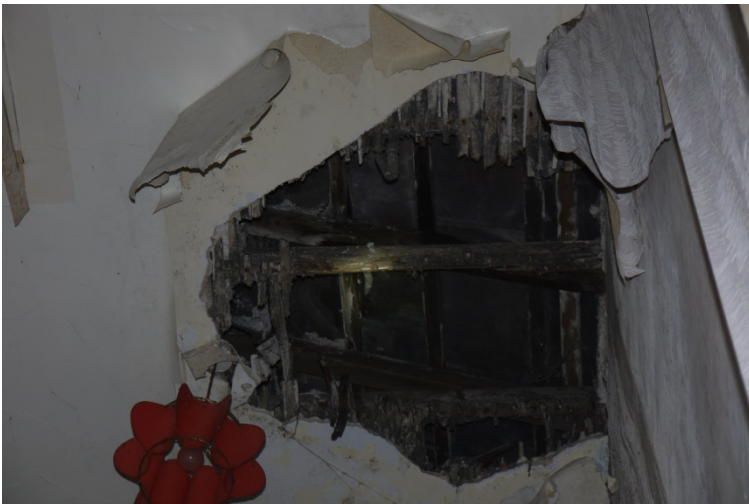
The stairs have collapsed preventing access to the first floor but the roof void can be seen through holes where the ceilings have failed.

The interior of the building is severely degraded and it was deemed unsafe to enter the first floor, particularly as the stairs had completely collapsed. The roof void could be seen from the ground floor through holes where the ceiling has failed, which it was noted was unlined.

The roof void of the dwelling could not be inspected for safety reasons. This is not considered to be a significant constraint as the dusk emergence survey would identify any use of this area.

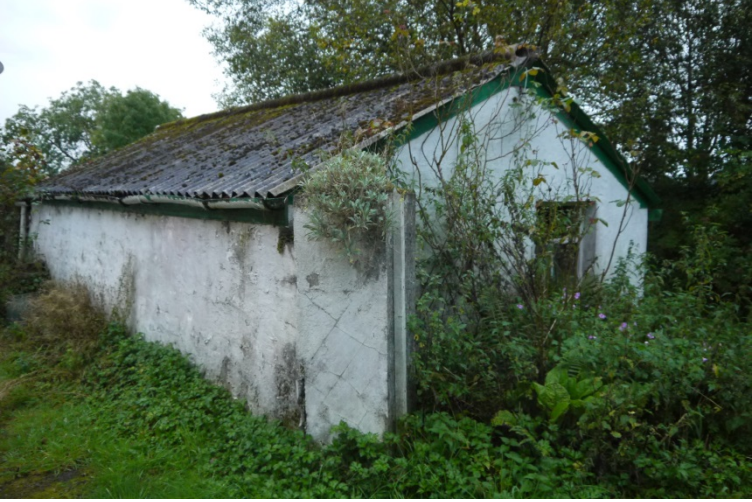
<p>Two outbuildings to the South are made from concrete block and have cement fibre and metal corrugate roofs.</p>

The buildings to the South also suffer from encroaching vegetation, but to a lesser extent. These are constructed of concrete block with cement fibre and metal corrugate roofs. Doorways and windows are open to create very cold and light conditions internally.

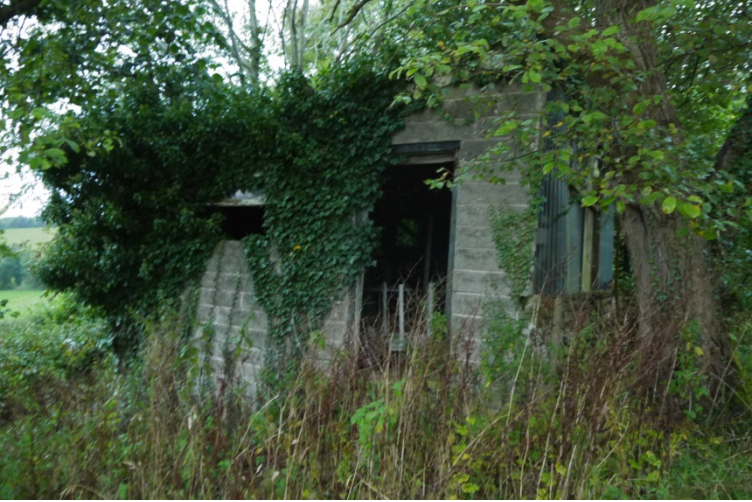
<p>The buildings are open making the interiors cold, light and draughty.</p> <p>They have negligible potential for roosting bats and contain no evidence of use.</p>

These buildings are all assessed as being of negligible potential for roosting bats, and no evidence of such use could be found.

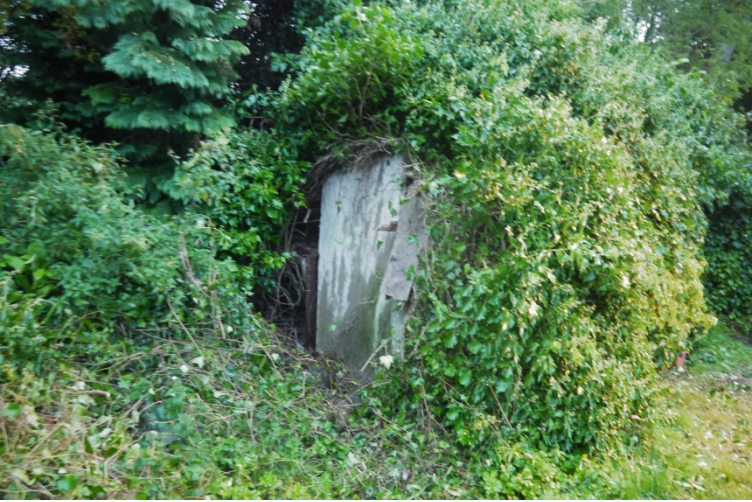
<p>Two very small outbuildings to the North are enshrouded by vegetation making them completely unsuitable for use by bats.</p>
