## Heritage Assessment

## Great Mitton Hall, Clitheroe, Lancashire

On behalf of Mr and Mrs Kay

May 2018

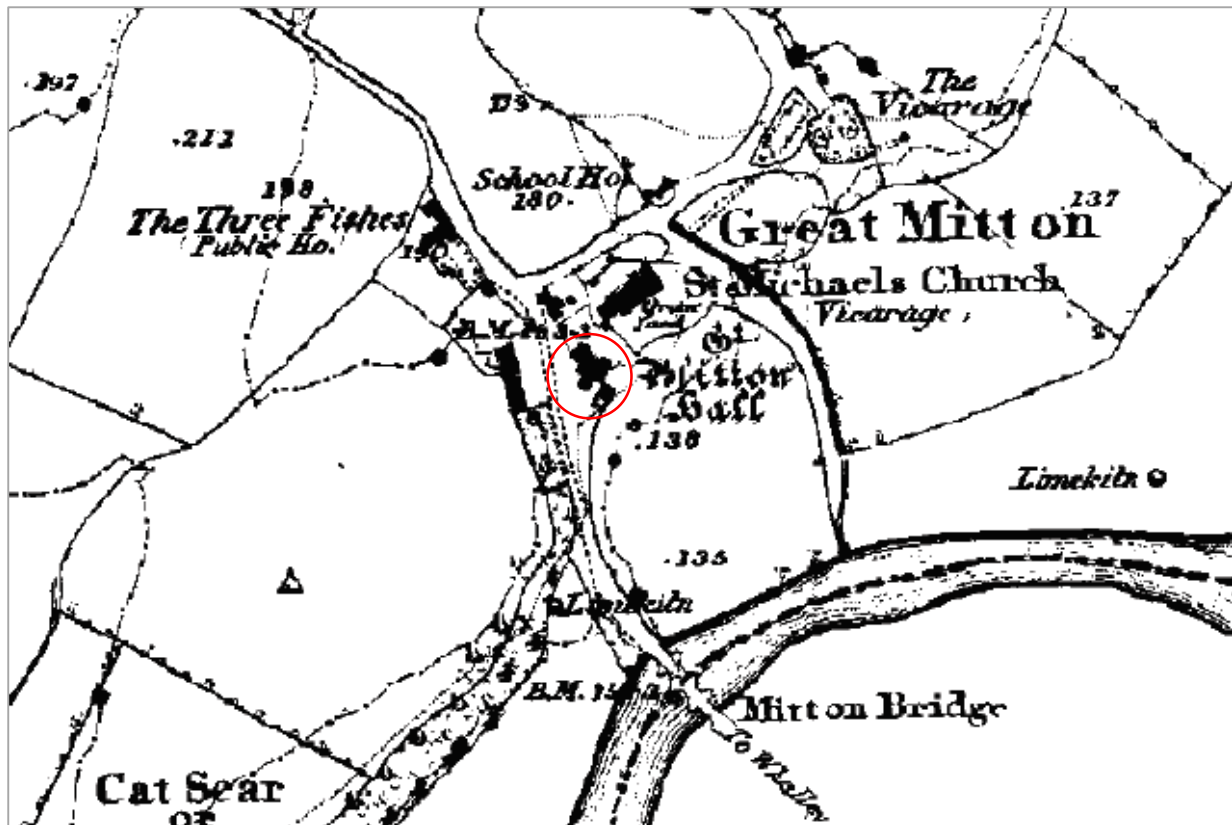
Figure 1 – Extract from the O.S. map of 1848 showing Mitton Hall, circled.

- 3.2 The Hall appears to have been occupied by the Sherburne (Shireburne) family in the 17<sup>th</sup> century, who aspired to the social status of the minor gentry, but by the time of the 1851 census it was occupied by John Holden, a farmer of 100 acres. Holden appears to have been in partnership with three other male relatives, probably his younger brothers. Members of the Holden family lived at the Hall until at least 1881, but by 1891 it was in occupied by a different farmer, James Hird, and his family – at which time it was called Mitton Old Hall. The disposition of the buildings as they were shown on the O.S. map of 1848 can be seen in Appendix 1.

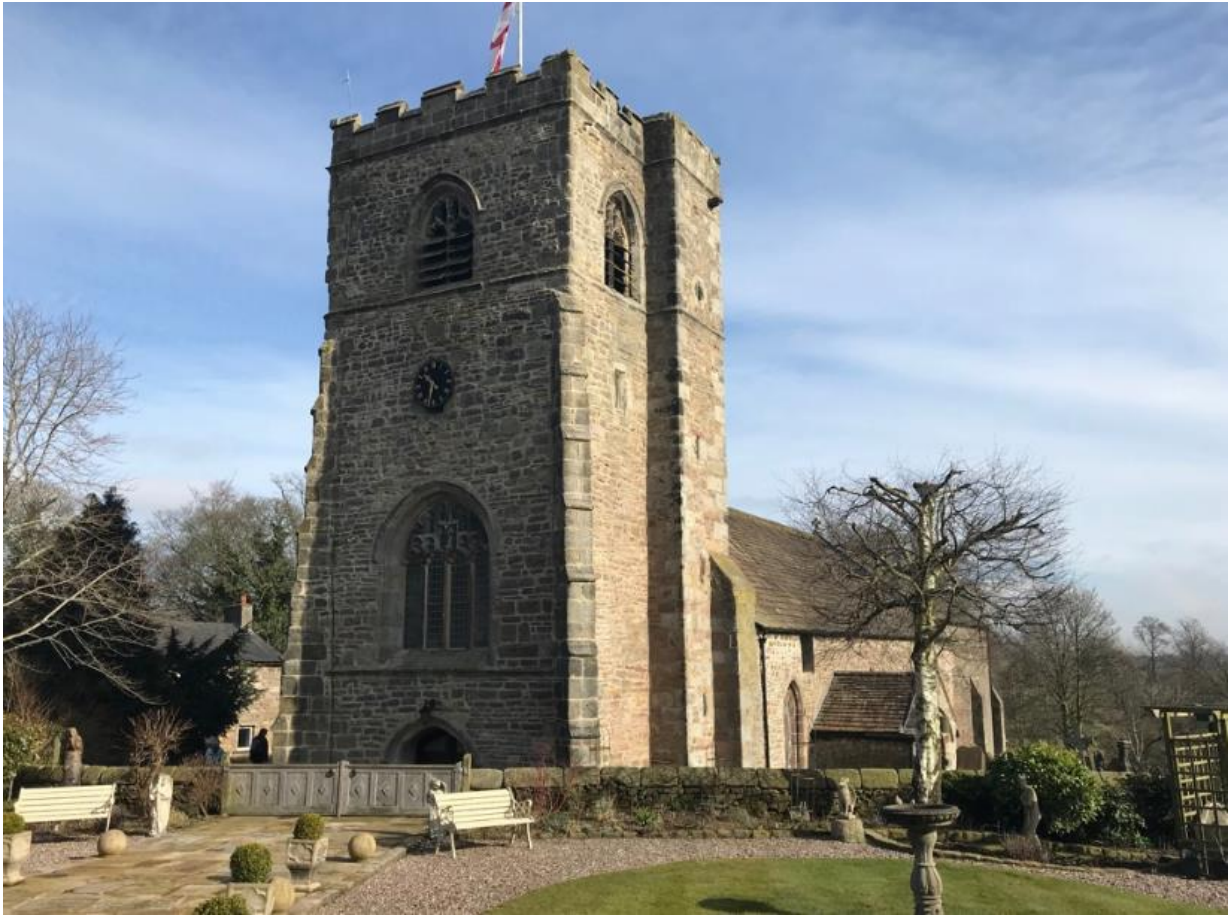
Figure 4 – The Church of All Hallows

### 3.7 Dating from the 13<sup>th</sup> century, the Church of All Hallows has a 15<sup>th</sup> century west tower and a late 16<sup>th</sup> century north chapel (Figure 4). It is a particularly well preserved building which contains important monuments, roof

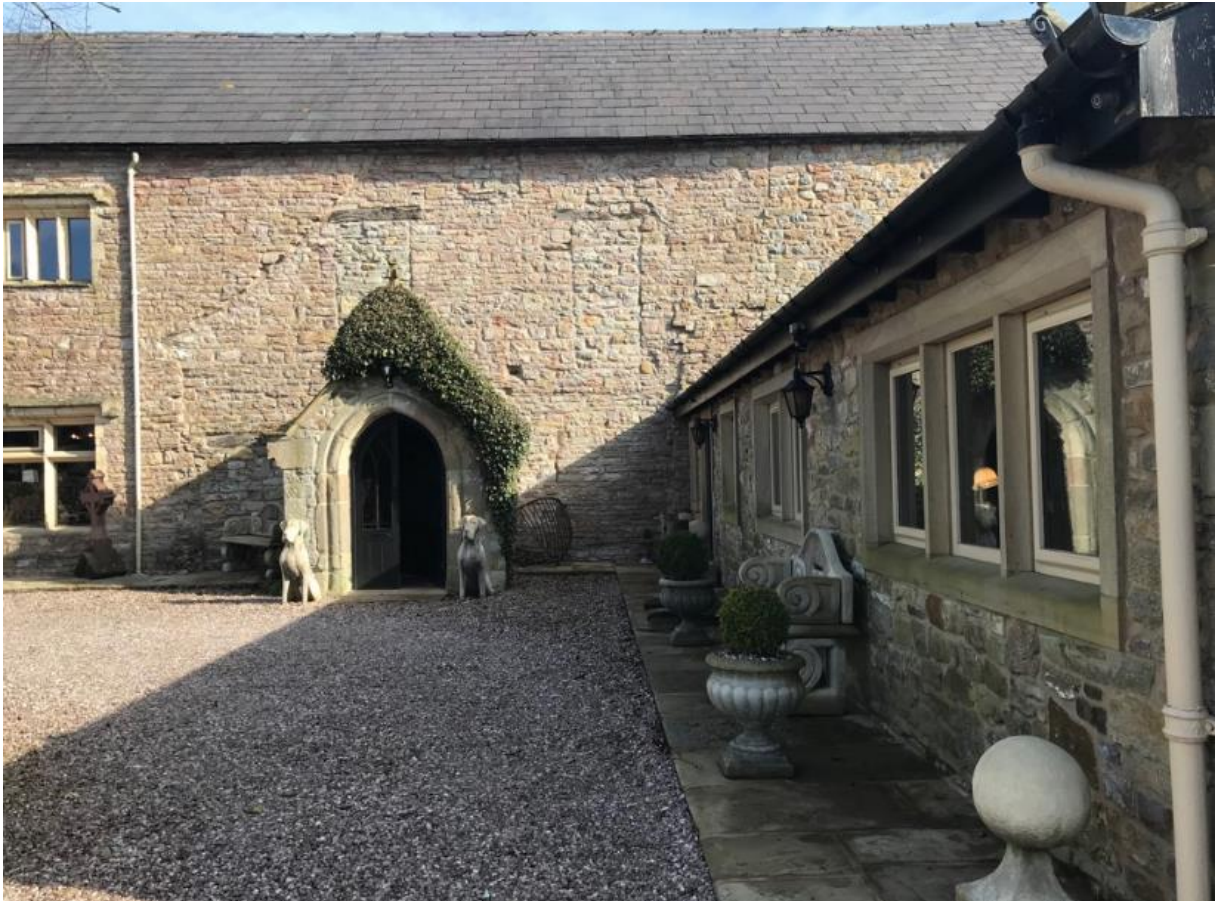
Figure 5 – Great Mitton Hall (front, south-west elevation) with the single storey modern range to the right.

- 3.4 The single-storey extension attached to the south-western corner of Great Mitton Hall is a modern structure that is not of historic interest or significance, and which postdates the list description (Figures 5, 6 and 7).

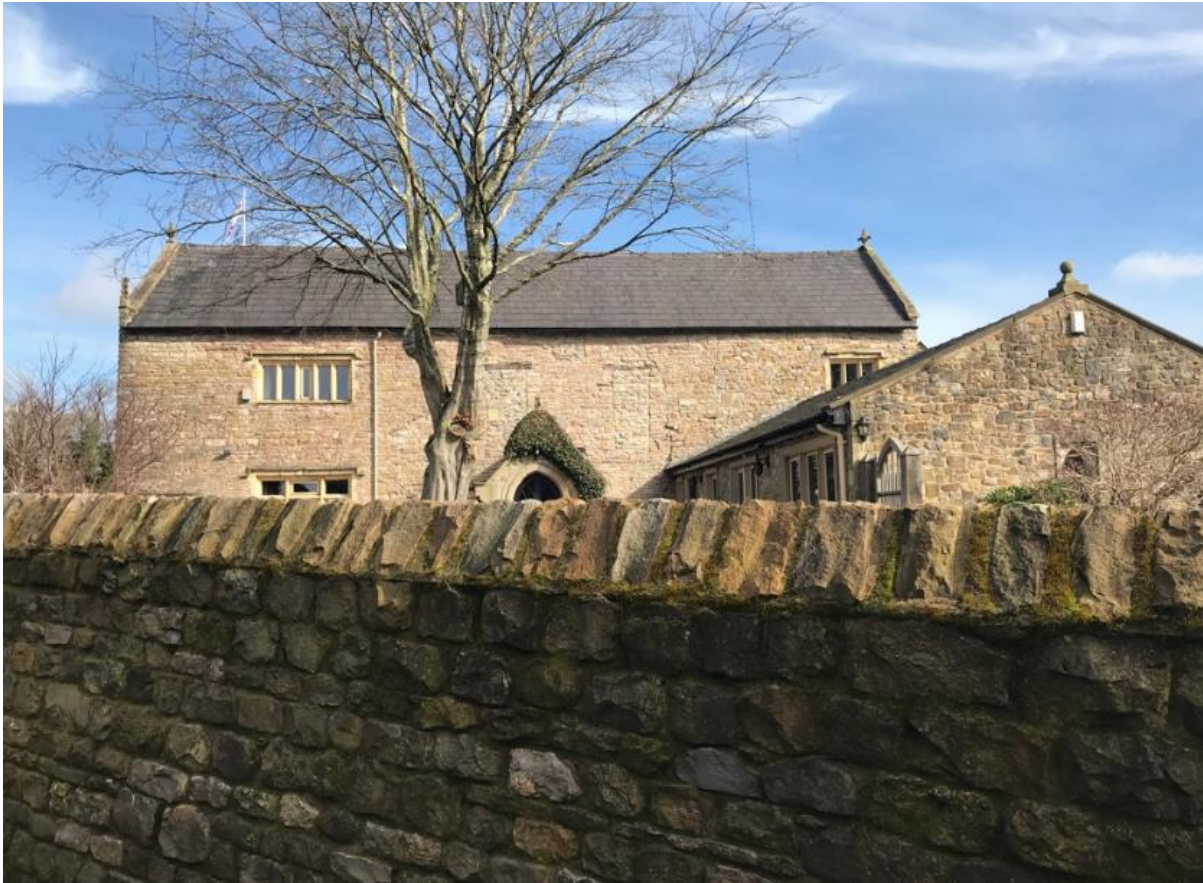
Figure 6: Great Mitton Hall seen from the road, with the modern range to the right (compare Figure 5).

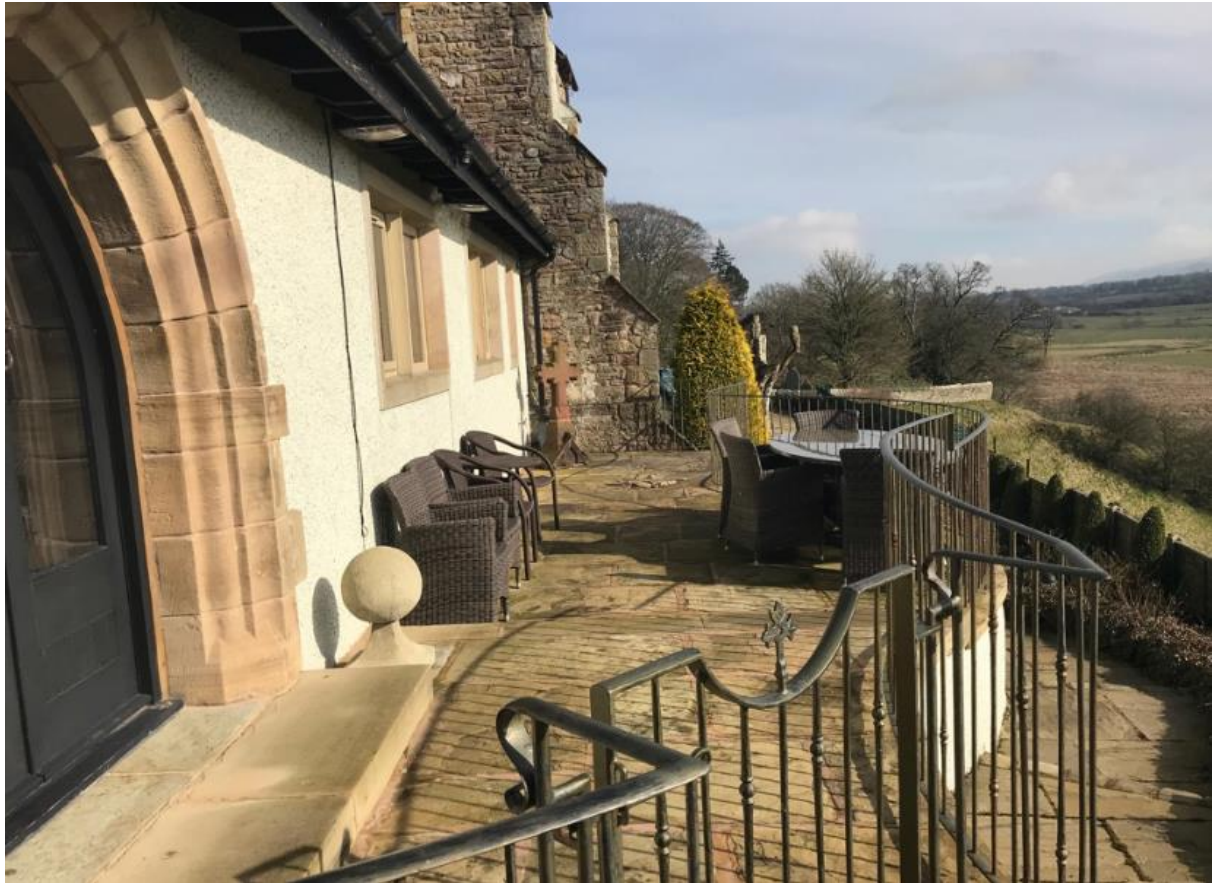
Figure 7: The modern range, pointed opening and modern patio overlooking the Ribble valley.

4.4 The removal of the pointed arched opening from the south wall of the modern range (Figure 7), and its replacement with a new window to match others on the same elevation, will improve the overall character of the listed building in the following ways:

4.5 Reconfiguration of the patio and railings (Figure 7) will simplify this feature, without affecting any historic fabric, so that it becomes a less evidently modern feature beside the older part of the Hall.

- 5.2 A small extension is proposed on a modern range attached to the Hall, together with improvements to make the patio (Figure 7) less obvious, to tone down the colour scheme of the southern gable of the Hall so that it harmonises with the Church, and to remove an pointed arched doorway in the modern extension that is not authentic to the listed building. These works will not affect any historic fabric. The extension will be visually unobtrusive, and the other works will improve the character of the Hall, including the removal of a coniferous tree.

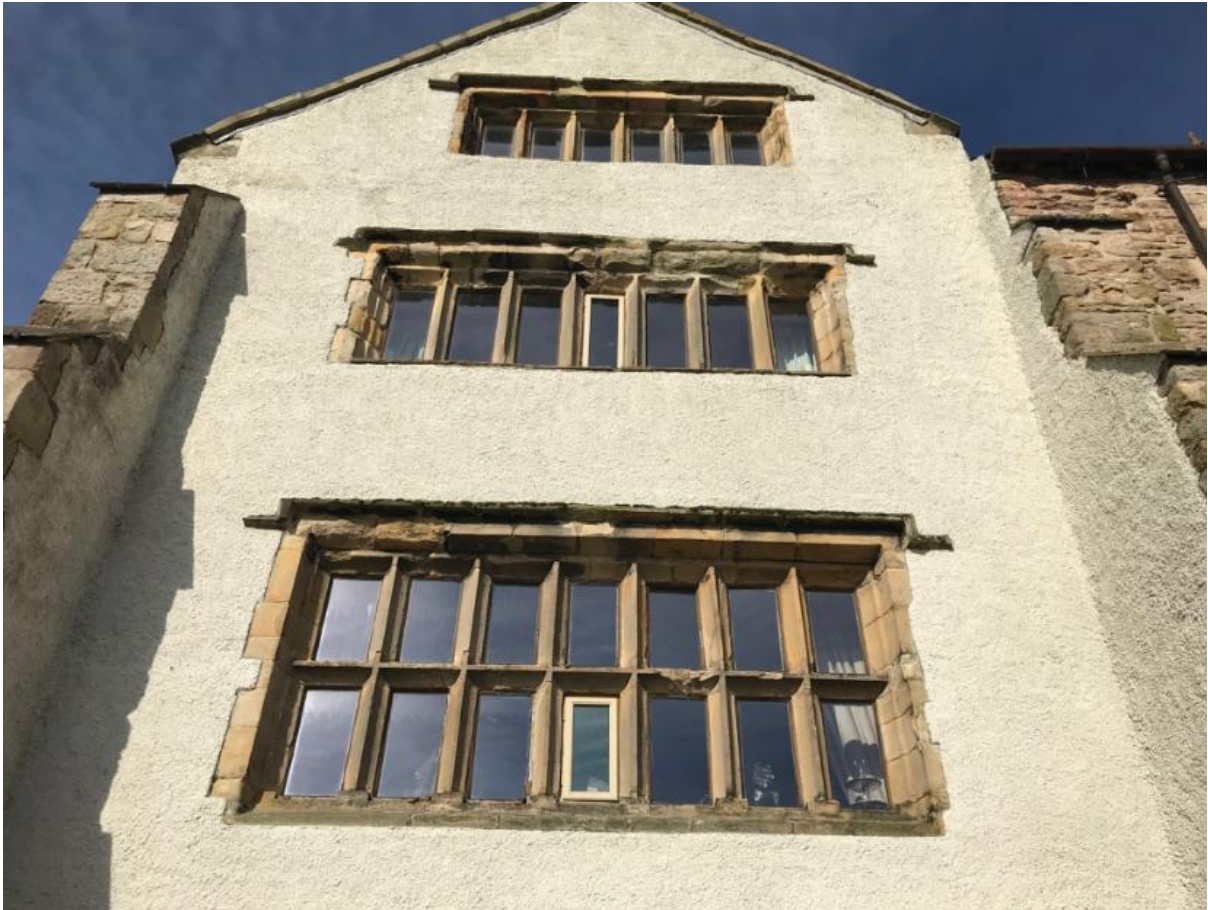
Figure 8: The painted and rendered south gable of the Hall, with windows overlooking the Ribble valley.

- 3.3 Site observation (9 March 2018) suggests that parts of the fabric predate c.1600 and that the roof may originally have been of pre-Tudor construction. The external stone shell of the building, and in particular the gabled elevation overlooking the valley of the River Ribble, has a noticeably Tudor appearance as was noted by Pollard in 1882. The lines of mullioned windows on three storeys are of particular note (Figure 8).

Architectural interest: The Hall is a good example of the vernacular architecture of what was originally the West Riding of Yorkshire, using local materials in a style that aspired to the Tudor fashion of the late medieval period. It is an early example of a building that has a conscious relationship with its surrounding natural landscape in the form of lines of windows placed in the gable to as to enjoy the view over the valley of the River Ribble (Figures 8 and 9).

4.6 The gable wall of the Hall has already been rendered and painted, so repainting will not affect any historic fabric. By toning down the stark white gable to a stone colour, the Hall will be tonally balanced with the adjacent Church (Figure 8).
