Buildings at Lyme House Farm
Chipping Road, Thornley-with-Wheatley, Lancashire:
Historic Buildings Record

Buildings at Lyme House Farm Chipping Road, Thornley-with-Wheatley, Lancashire: Historic Buildings Record

HISTORIC BUILDINGS RECORD

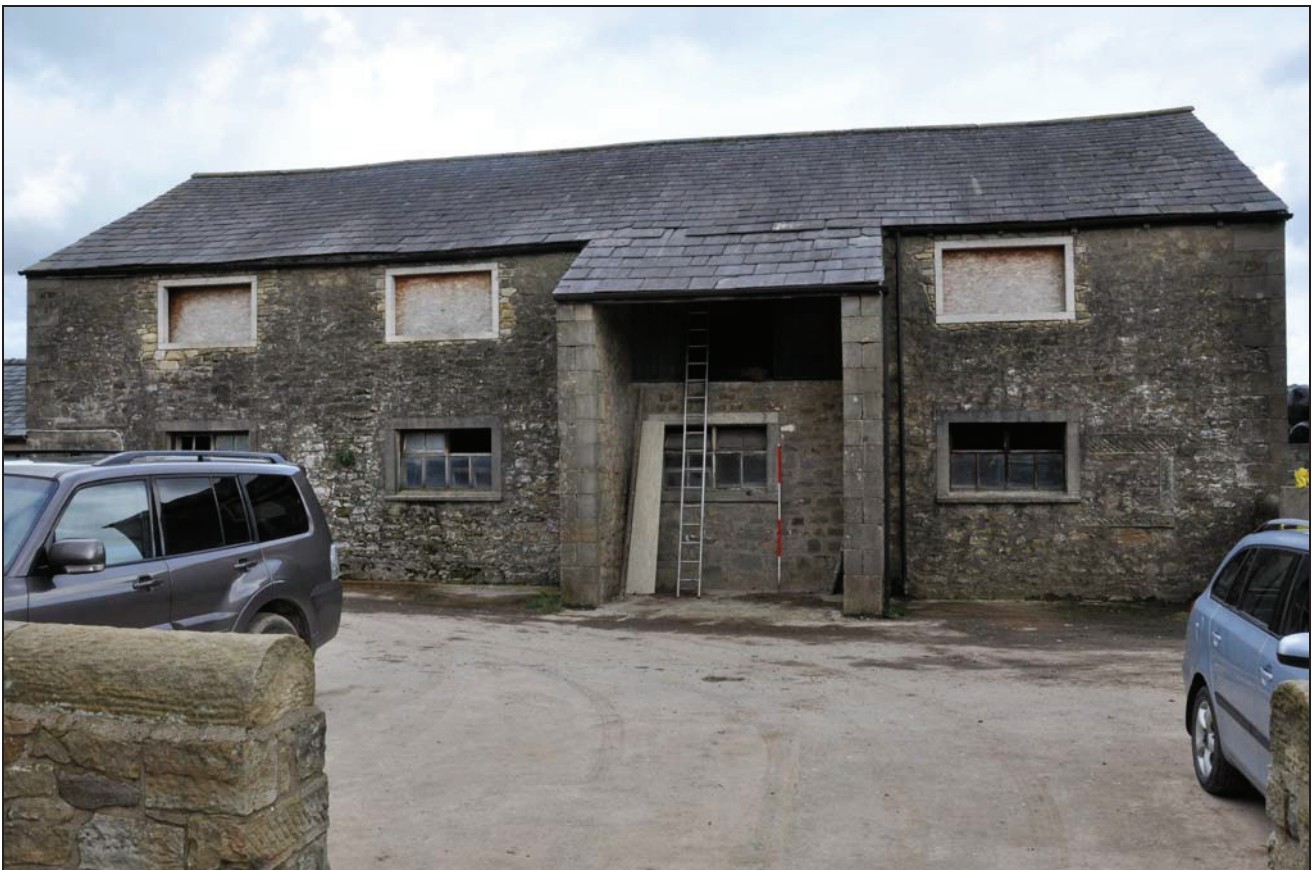
Photo 2: Barn (building 1): south-west elevation

- 8.1 The barn which forms the core of the group of four buildings appears to be early 19th century and is a relatively large, four-bay structure with front porch to the former cart entry in the front, south-west elevation (**2**). Its walls are chiefly of local sandstone rubble with neatly squared ashlar quoins, though other historic dressings vary in their finish, some being plain while others have bold diagonal tooling commonly found in this area of Lancashire, and this variation suggests there have been historic interventions, as well as the creation of more obvious 20th century openings. Many of the latter have concrete surrounds and relate to the post-war conversion of the ground floor to a large shippon. The blue slate roof is also believed to be 20th century, and probably replaced original stone slates.

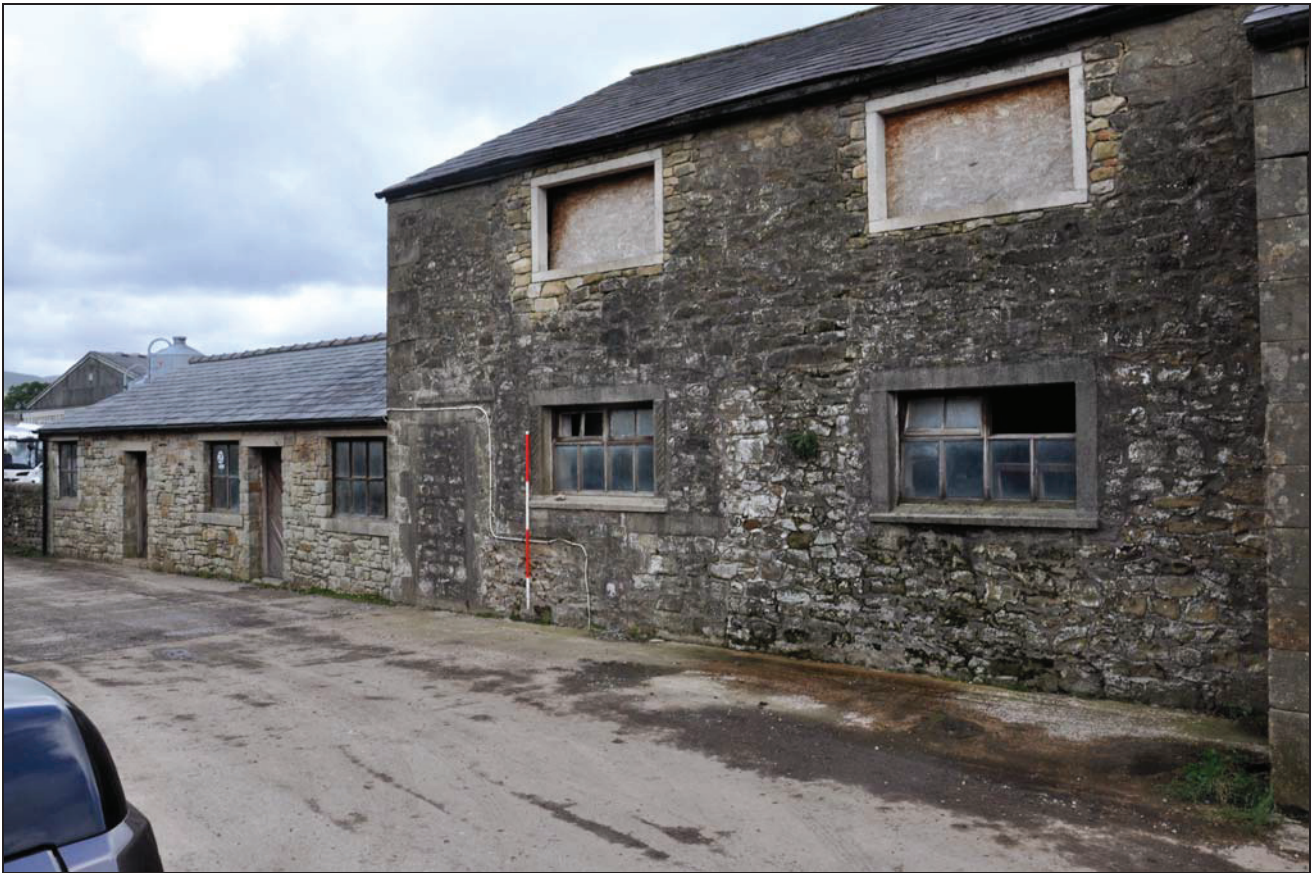
Photo 3: Barn (building 1) and former cart shed (building 3): south-west elevations

also now largely blocked, which can be seen on the interior at first floor level, but this did not have a matching porch. To either side of the front porch, the six large window openings are all 20th or 21st century creations, but two earlier openings can be identified, a doorway at the left end and a window at the right (3).

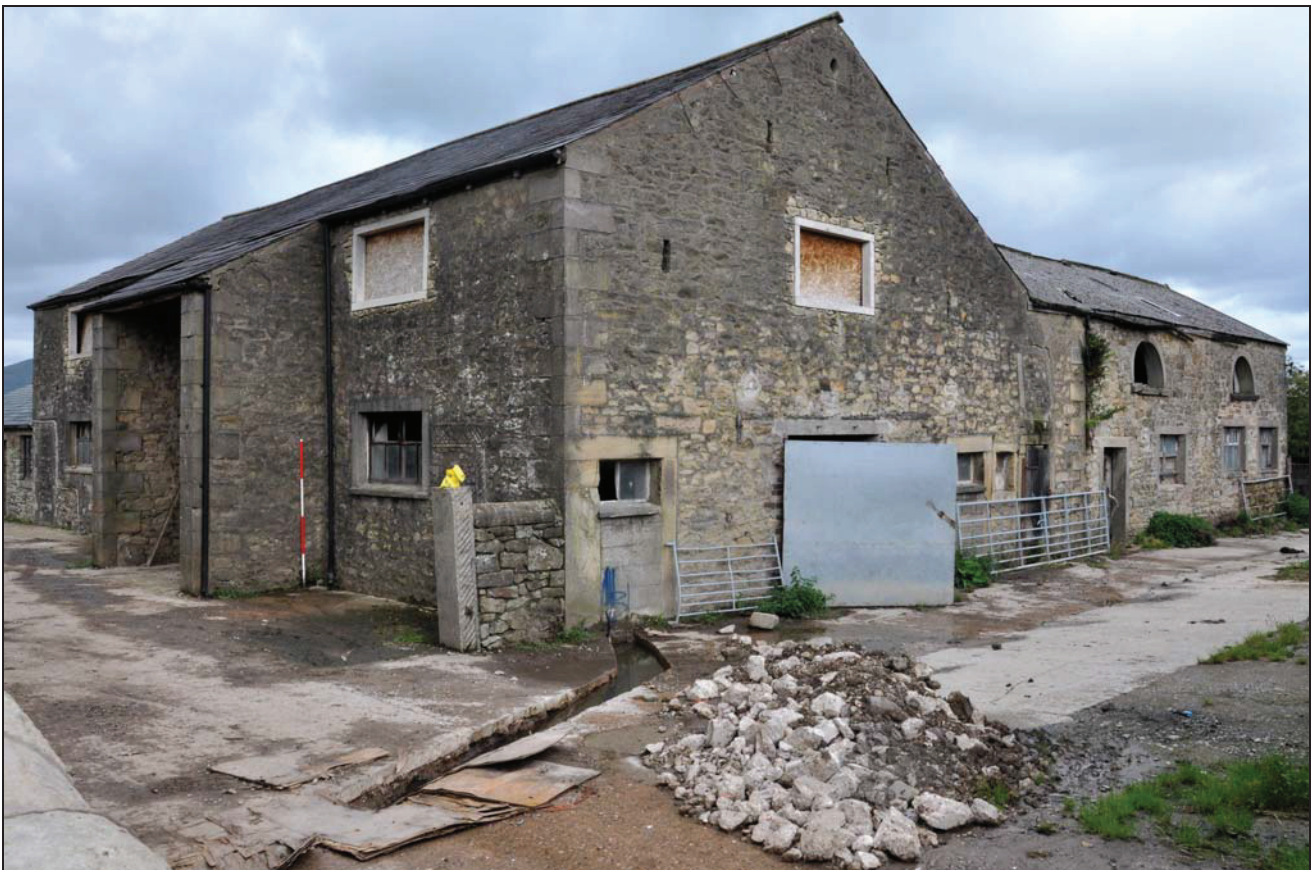
Photo 4: Barn (building 1) and former stables (building 2): south-east elevations

- 8.3 The south-east gable has its historic character more fully intact (4). At ground floor level are two former doorways with a larger one between, the latter probably enlarged from an original one, in order to allow tractor access. Another large, recent opening occupies the middle of the gable at first floor level, but there are also four original breathers, together with a circular owl-hole at the apex (5). At the right hand end, the gable continues beyond the main rear line of the building by about 3m, to create a narrow outshut with its own entrances on two levels, and this may have served as a loose box with loft over originally (6); its peculiar concave north corner seems to have been an adaptation to allow access into the later building 2 (7). The north-west gable of building 1 is partly hidden by building 3, and the doorway and window in this end of the building both appear to be secondary. There is a similar owl-hole at the gable apex (8,9).

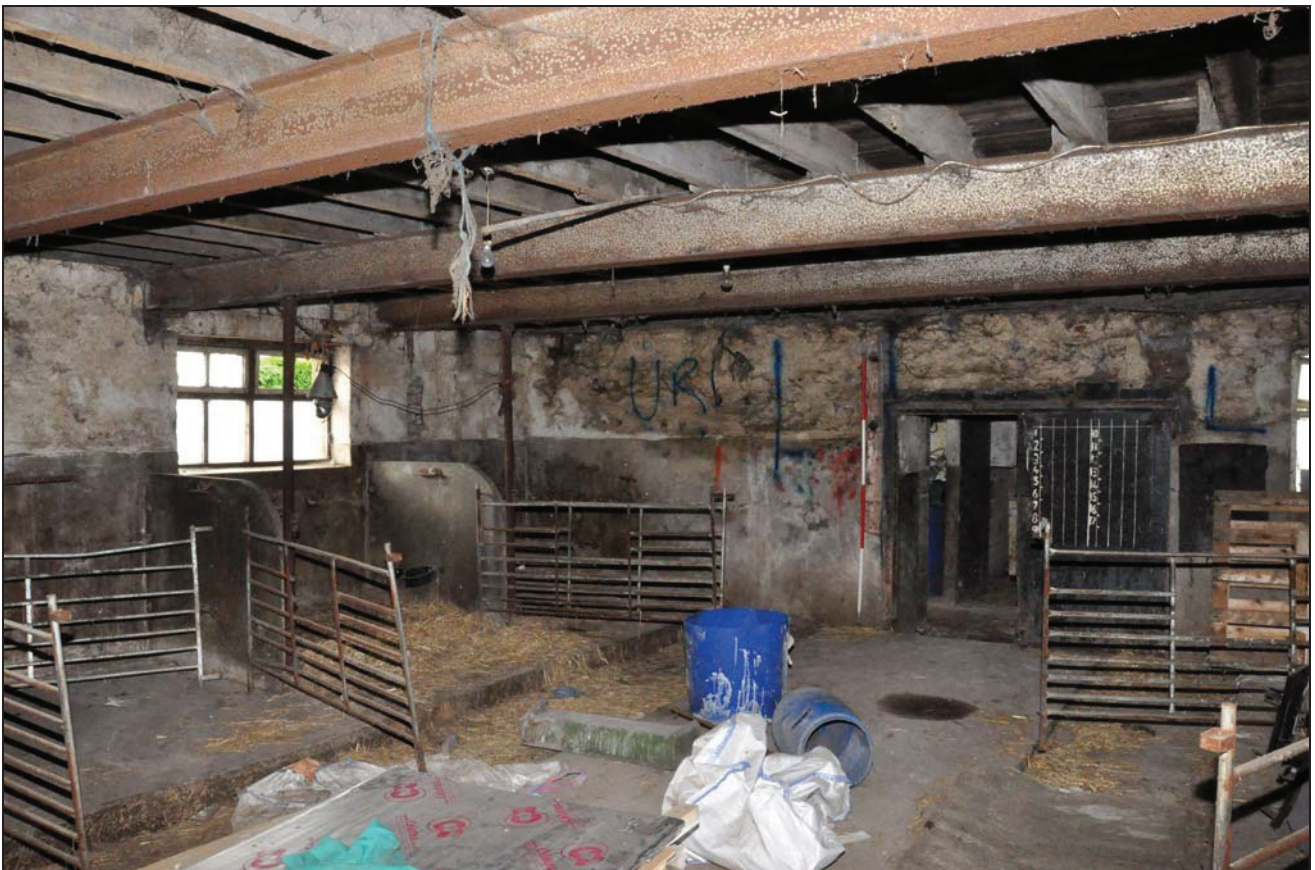
Photo 10: Barn (building 1): ground floor, looking west

- 8.5 The barn's ground floor now forms a single large shippon with modern hay loft above its full length, supported by steel beams and columns, and there are no historic features of interest (10,11). Similarly, at loft level, it is only the two surviving original trusses which are of interest (one has been replaced with a steel truss) (12,13). These are of imported softwood, with a bolted king post design, entirely characteristic of the 19th century. Carpenter's numbering to the joints can be seen on the upper faces (14).

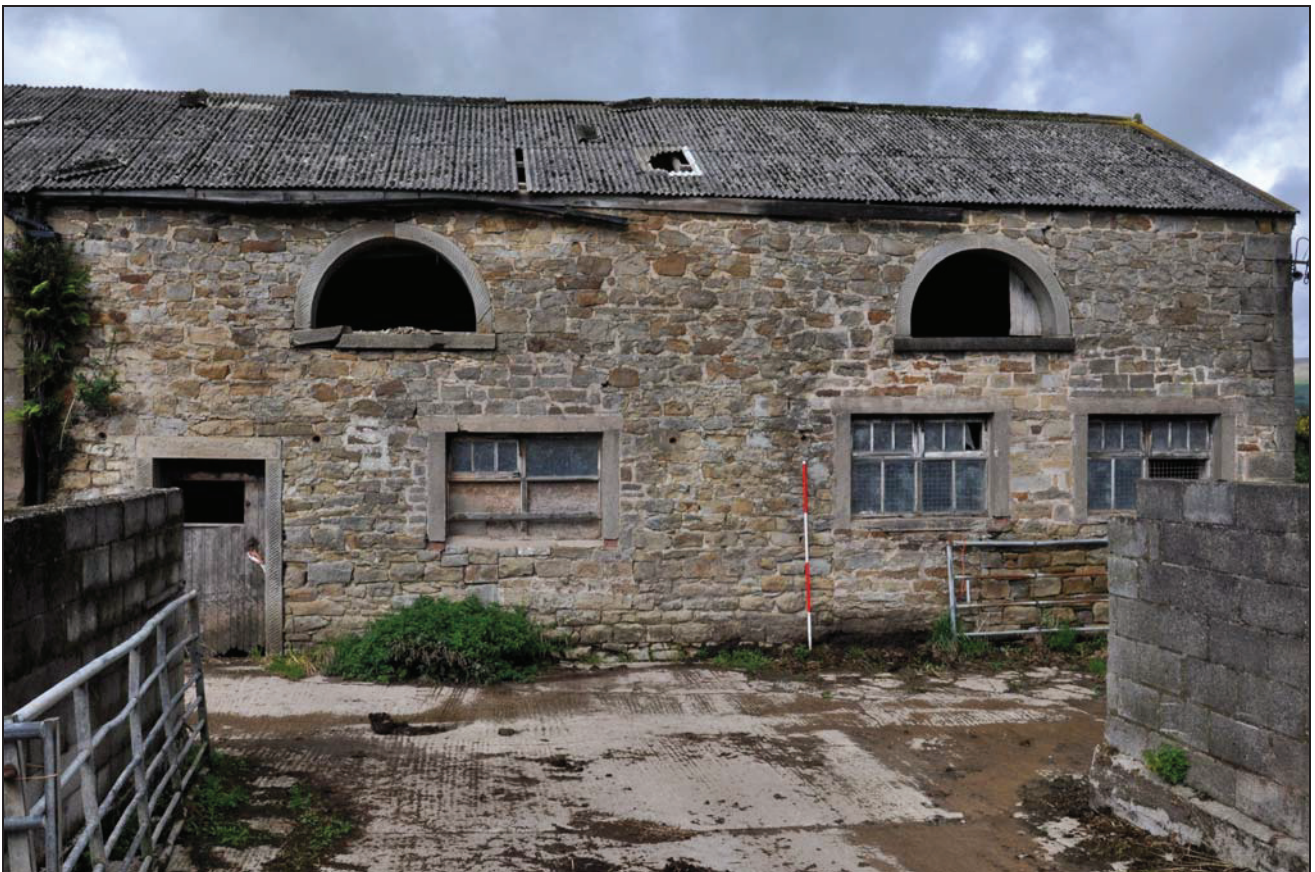
Photo 16: Former stables (building 2): south-east elevation

- 8.7 The extension of the barn to the north-east was carried out between the 1840s and the 1890s, and comprised a two-storey, three-bay building facing south-east (**16-19**), although in common with building 1, its interior was radically altered in the mid 20th century. Despite this, two historic timber beams supporting the first floor at the north-east end of the building survive to suggest that it contained a three-stall stable, with hay loft over.

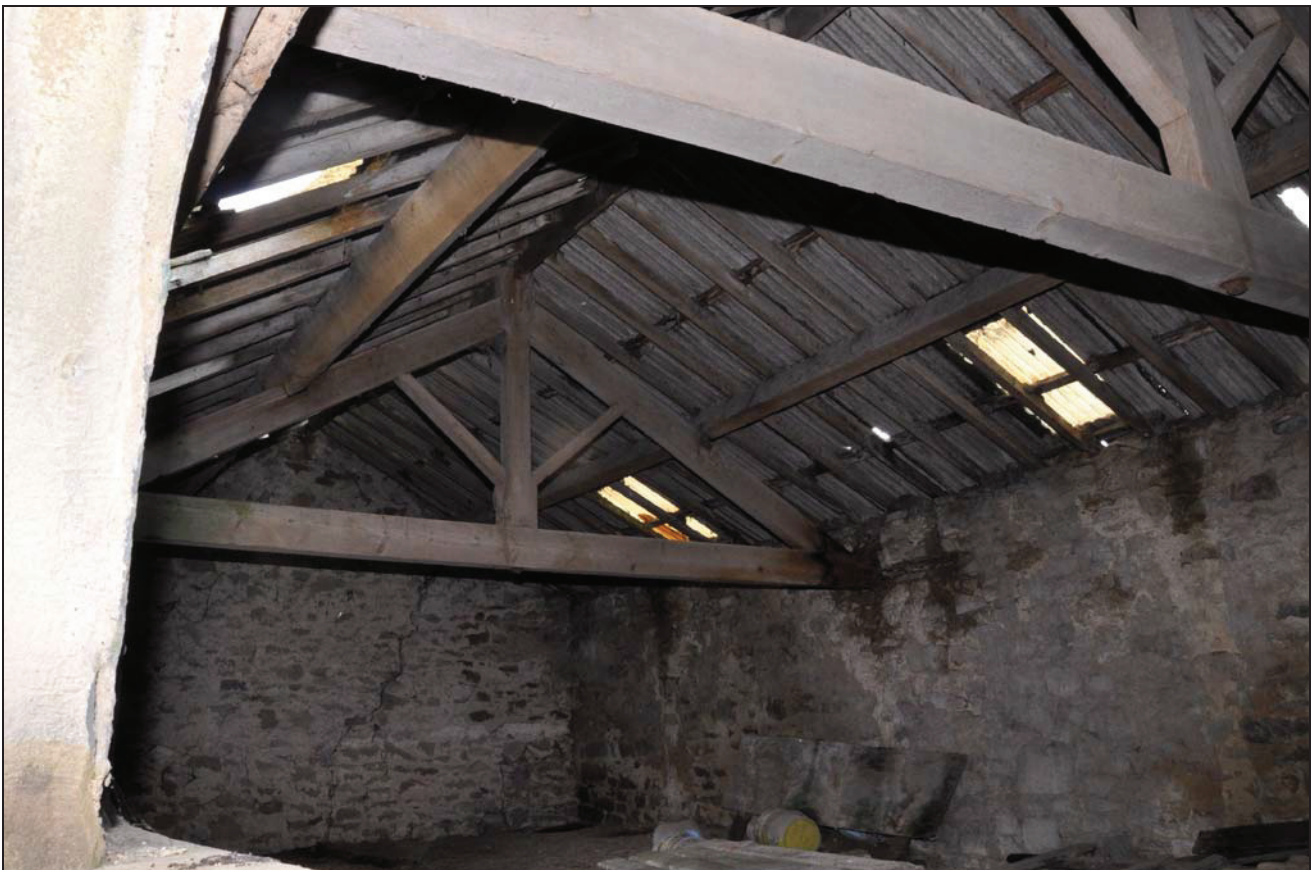
Photo 24: Former stables (building 2): first floor, looking west

- 8.10 The modern shippon on the ground floor of building 2 has a concrete floor and pre-cast concrete boskins forming a row of stalls for vacuum milking (**22**). Four steel beams at the south-west end support the hay loft, but at the north-east end are two timber beams with mortices in their soffits, which appear to have survived from a stable, and would have held dividers beneath, which separated three stalls (**23**). Whether or not a similar arrangement occupied the rest of the ground floor cannot be deduced however. The hay loft is not safe to enter but was viewed through one of the forking holes in the south-east side: it is undivided and has two king post trusses very similar in design to those in the barn described above (**24,25**).

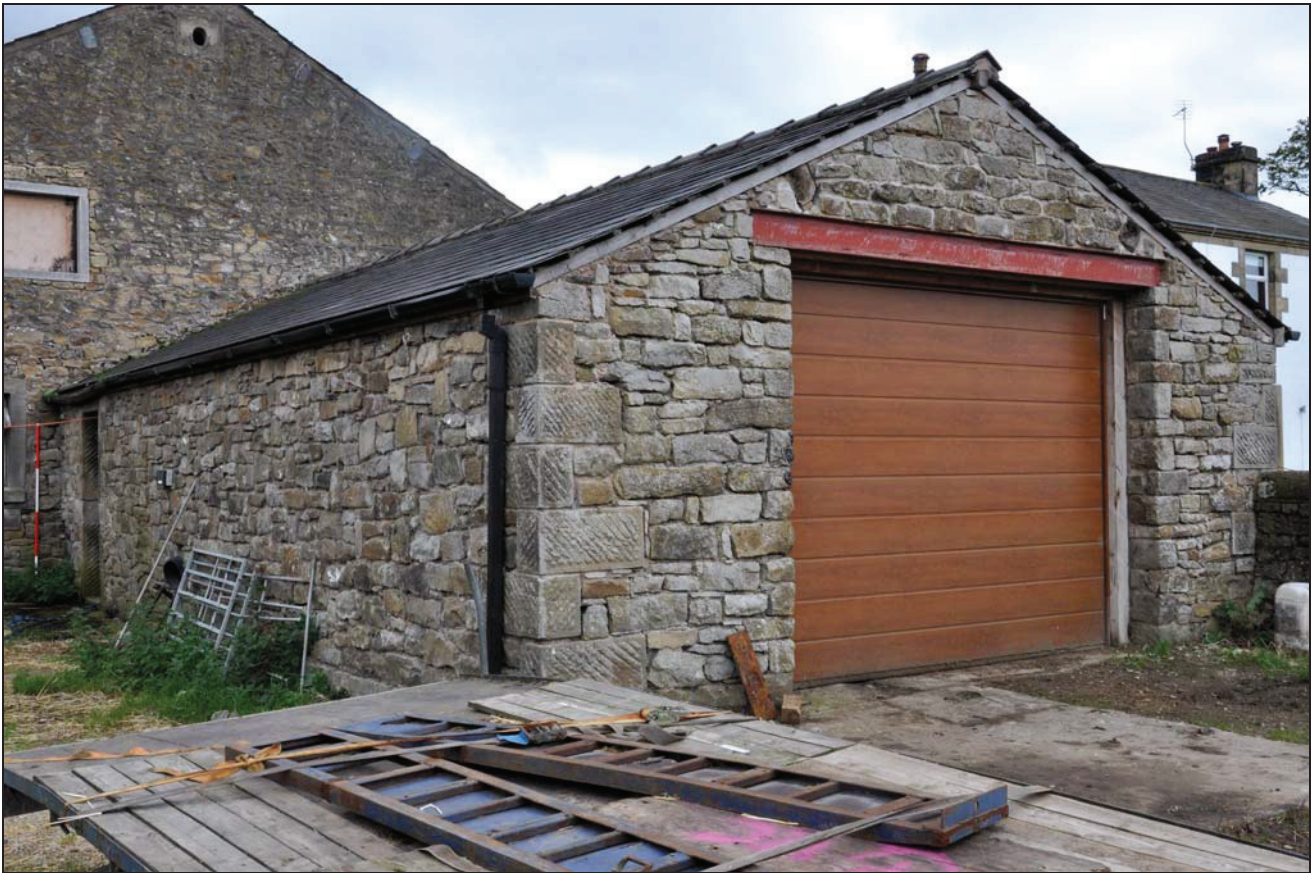
Photo 27: Former cart shed (building 3): general view, looking south

- 8.12 The OS maps of 1912 and 1932 (figures 7 & 8) show the building to have been open-fronted, but later in the 20th century it was built up with the existing stone-faced outer wall, whose inner skin is concrete block, and which incorporates two doorways and three windows. The north-west gable and much of the rear wall have also been rebuilt recently (the former incorporating the new doorway opening under a steel lintel), and the roof has been re-slatted, but the rear doorway does appear original (27).

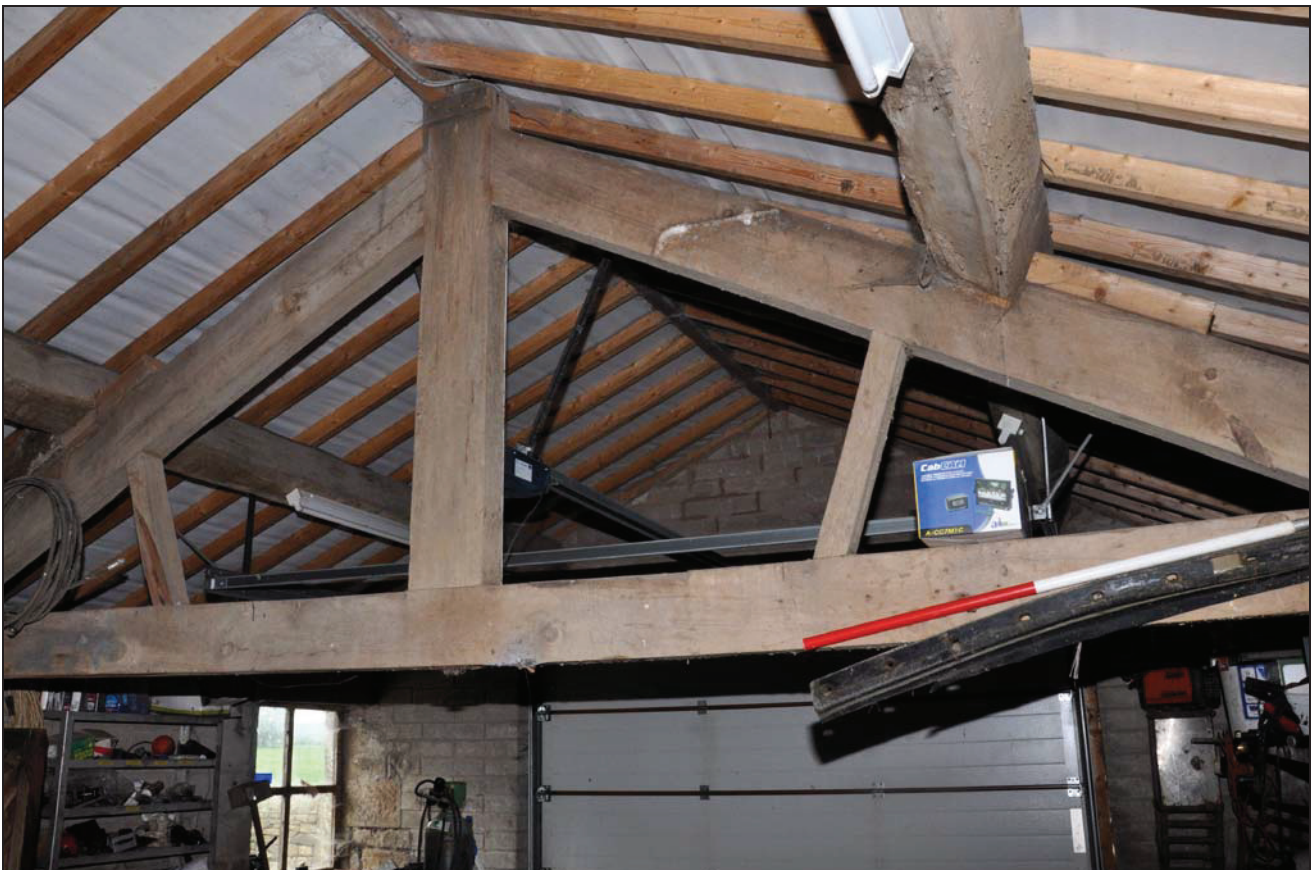
Photo 28: Former cart shed (building 3): roof truss

- 8.13 A brick wall divides bay 2 from bay 3 internally, and may be original, but otherwise the interior is not of interest. Bay 3, next to the barn, appears to have been a dairy in the mid 20th century and may have housed the milking machine. There is an exposed roof truss between bays 1 and 2 which is clearly original, and of similar imported softwood as the other trusses at the site, with a similar king post design (28).
