**BAT SURVEY AT -  
31 DALE VIEW  
BILLINGTON**

**DATE AND TIME OF VISIT  
25<sup>th</sup> June 2018 2.00pm**

**REFERENCE NO. 5596**

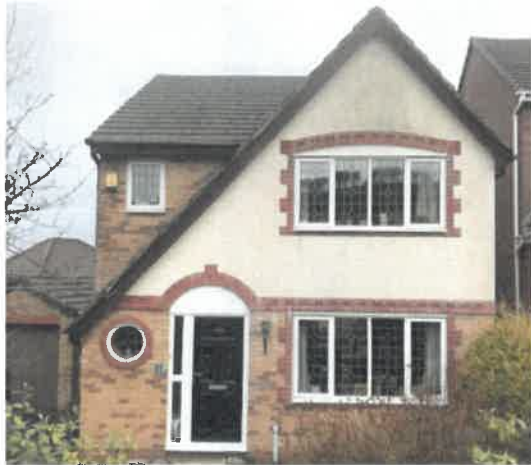
Front elevation

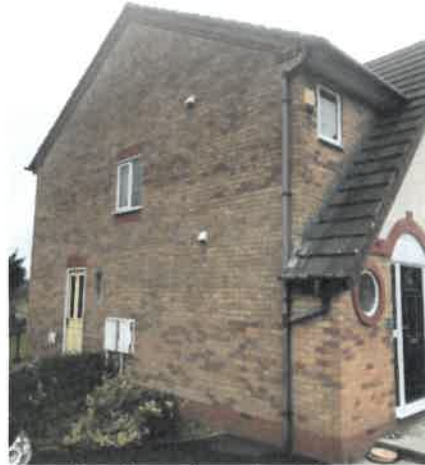
side elevation to be extended

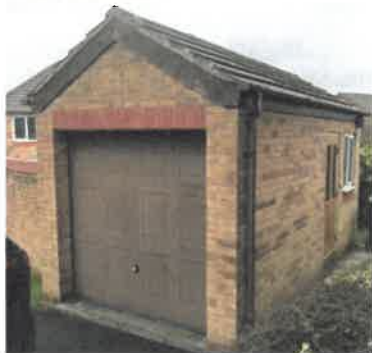
Garage

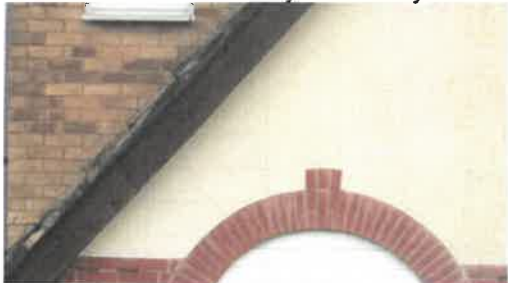
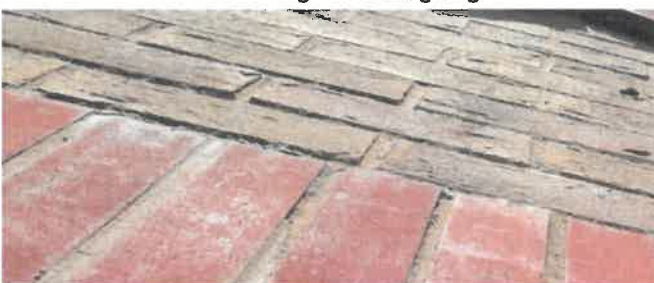
The house walls are mainly brick cavity with a section of render to the front gable. The garage walls are brick.

No access points in the walls all in good condition

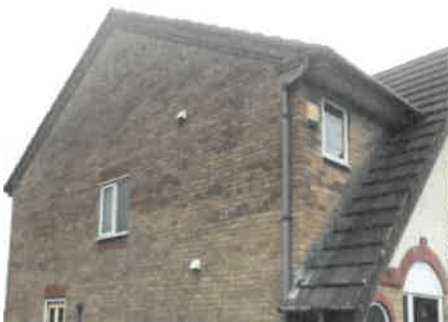
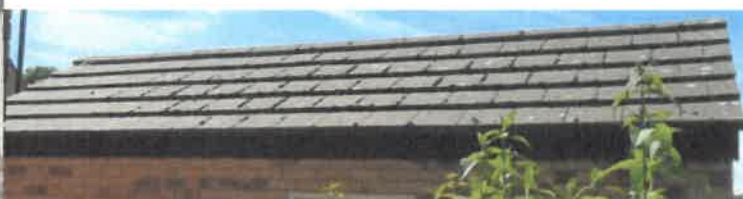
The main roof of the house is pitched with an overhang at the eaves there is a gable to the front elevation with the left hand pitch taken down to ground floor level ( see below). The eaves soffits are boarded.

The garage roof is pitched with flush to wall timber fascias and barge boards. The roof finish to both roofs is tile.

The tiles are all very tight fitting with no gaps or slipped tiles. The soffits on the house are very tight fitting with no possible access points. The fascias and barge boards to the sides and gables of the garage are flush to the wall

with some slight gaps in places due to the timber having warped slightly, however it was possible to check behind for any signs of bat entry or presence the result was negative.

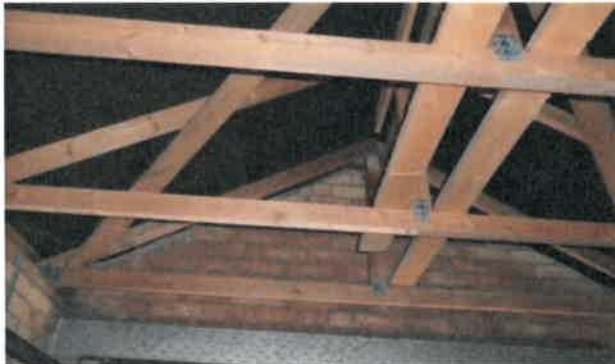
The garage does not have an enclosed roof space all the timber trusses and felt underlay were easily examined, and all found to be in excellent condition. The roof did not provide any high value roost potential for bats.
