**BAT SURVEY AT -**

WARDS FOLD FARM  
ABBOTTS BROW  
MELLOR

DATE AND TIME OF VISIT  
9<sup>th</sup> June 2017 10.00 pm

REFERENCE NO. 5325

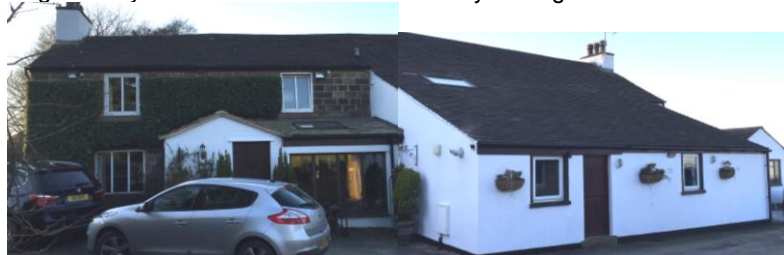
The property is a detached farmhouse and barn which has been converted to form one dwelling with a granny annex, the original conversion took place approx 40 years ago. The annex at the northern end of the building is single storey and was constructed about 15 years ago.

Farmhouse and barn

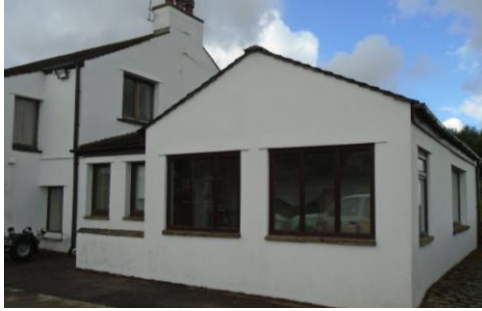
The annex to be demolished is constructed in cavity blockwork with a smooth white painted render finish the gable wall of the adjacent house wall also has a render finish.

The walls provide no access points, cracks or crevices which have the potential to be used by bats.

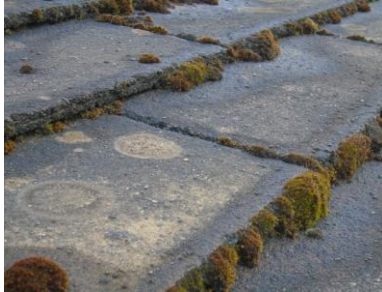
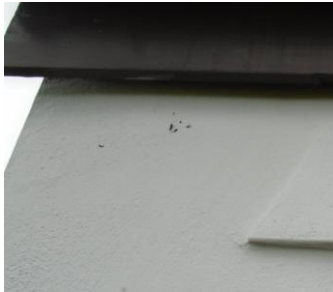
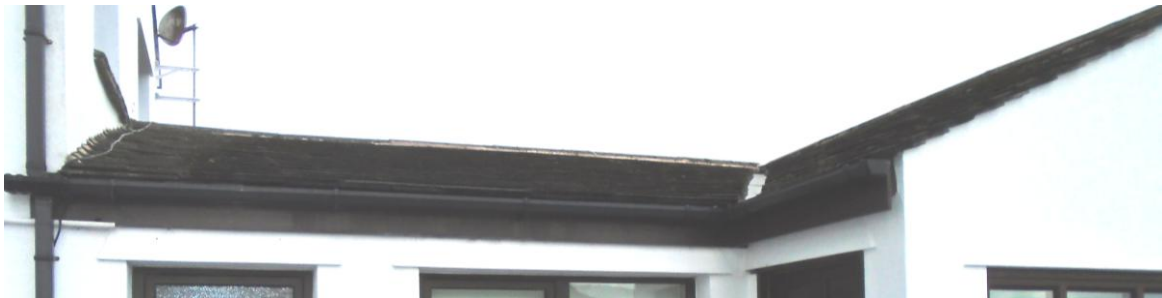
Potential access points ↑

The fascias however do provide a void behind, the void was possible to inspect closely, over the door there are some gaps at the abutment of the wall with the roof providing a crevice which has the potential as a roost opportunity.

Any gaps at the eaves level need to be blocked as soon as possible particularly above the door opening. It is also recommended that bat habitat be included in the scheme see next page.

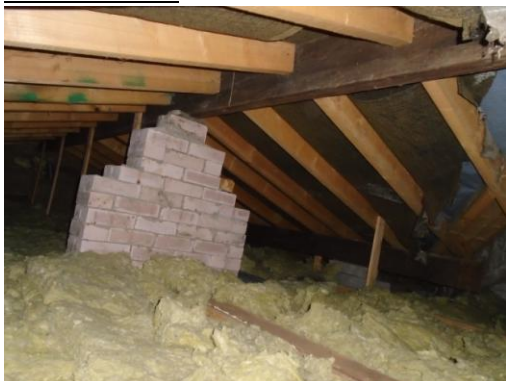
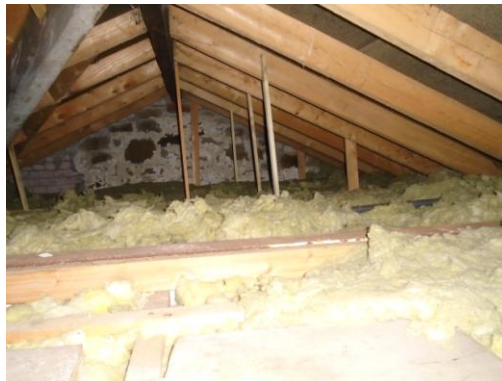
The roof void is accessed via a hatch, the felt and rafters are in good condition with no rot, cracks or crevices. The space is clean and dry with no dropping or insect remain evidence on the quilt insulation between the joists.

The roof space did not have any evidence of current or past bat presence.

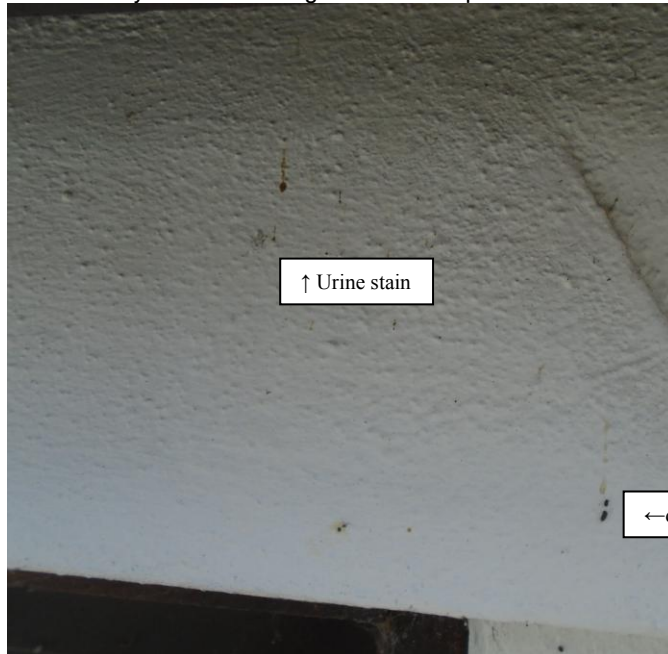
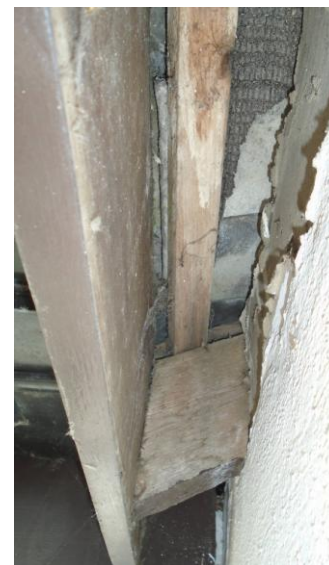
The focus of the survey was on the annex being affected by the application. The exterior was examined closely for dropping, staining or grease marks at potential access points. The fascia void was mainly covered by old cobwebs and there were no signs of grease marks or staining indicating entry by bats, however close examination of the section above the door did reveal a single dropping and urine stain on the wall below. The void behind the fascia was further examined for any indication of entry to the gap between roof covering and the wall. No grease marks or any further dropping evidence( the dropping found was old ) was found indicating frequent or current use. Based on the evidence found it appears that a single bat has used the building in the past but currently there are no signs to indicate presence.

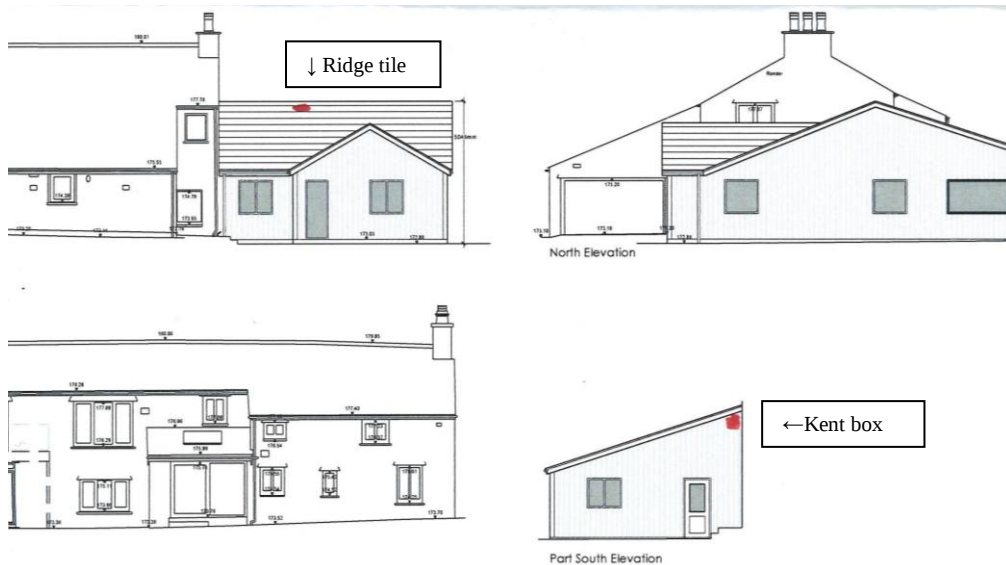
Ridge access tile Detail 4A (below)

RECOMMENDED BY NATURAL ENGLAND: either raised ridge tiles providing 15–20mm gaps or leaving access gaps under tiles to enable bats to enter the space beneath the ridge tiles.

Pipistrelles and long-eared bats will enter roofs via narrow gaps under the ridge tiles; additional benefits are provided when small gaps are provided through the roofing felt or sarking membrane thus enabling bats to enter any retained roof voids.

Ridge tile access formed in position indicated below
