*Heritage & Design Statement*  
*For*  
*Proposed Listed Building Application*  
*For*  
*Internal alterations to:*

*Masons Farmhouse & Barn*  
*Bashall Eaves.*  
*Clitheroe.*

## **Masons Farmhouse & barn adjoining.**

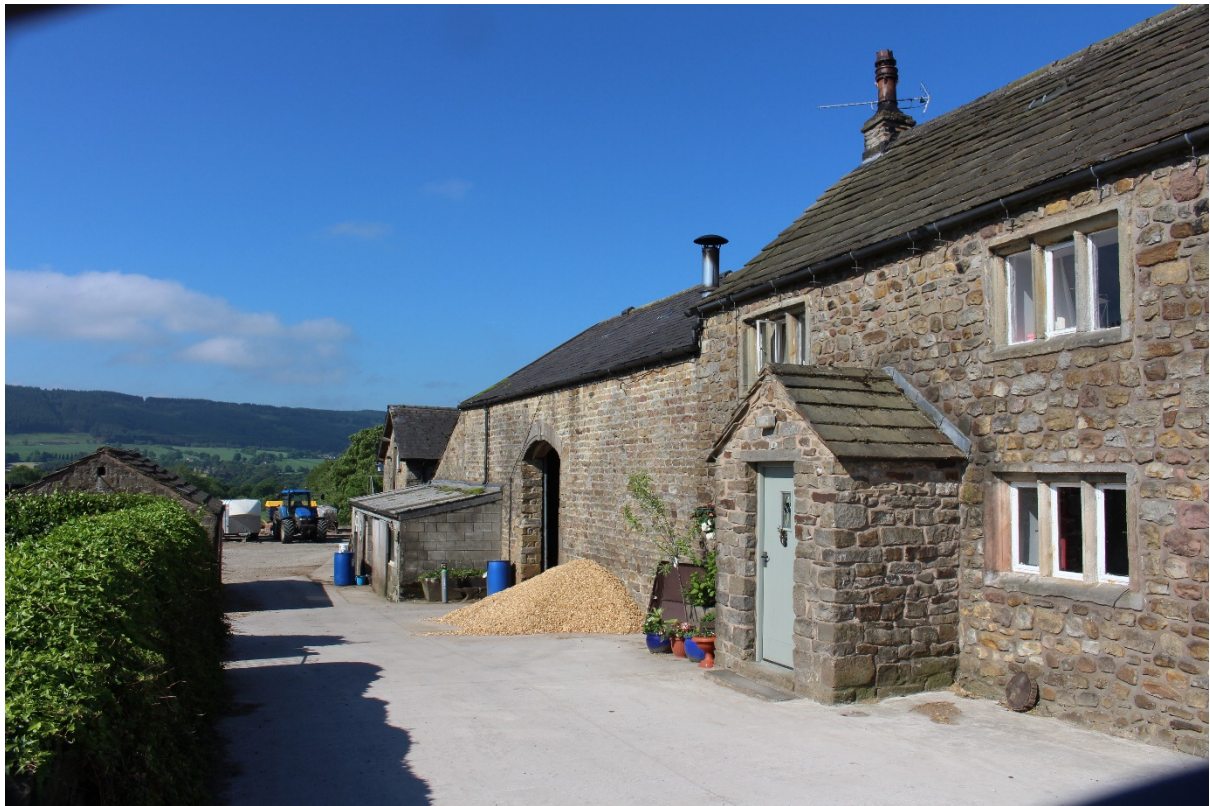
*Photograph N0.1*  
*Masons Farmhouse & Barn. Grade II Listed Building*

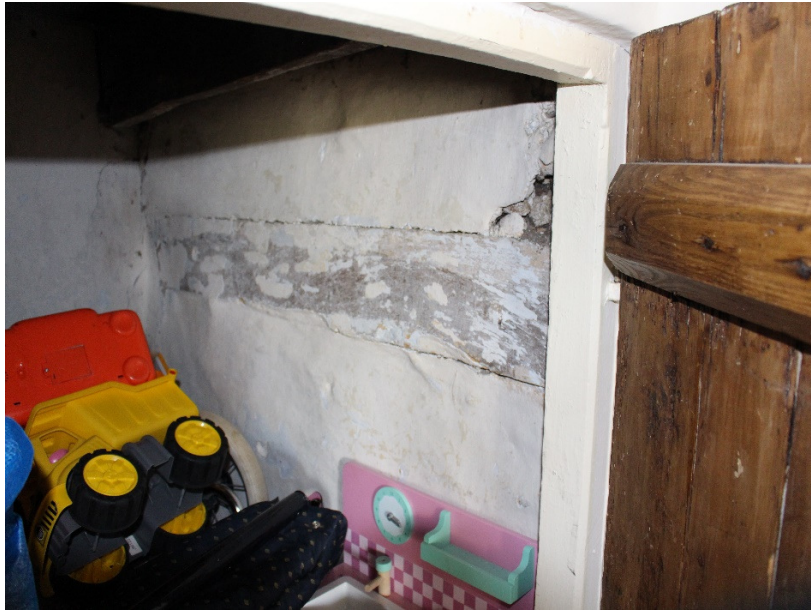
*Photograph N0.2 showing timber in wall below the stair landing.*

*The original heritage asset the subject of this Listed Building Application is the dividing wall between the two ground floor rooms. These rooms form the original layout of the farm building and include the staircase which was at the rear of these rooms. The dividing wall supports the timber floor beams on both sides and is an original feature of the building, indicated in Photo's No13 & 14. The wall may be a stone wall with timber supports within the wall, but this will not be known until some investigation is carried out to assess its construction, there is a horizontal timber within the wall below the stairs which may have supported the landing, this is indicated in Photograph No.2*

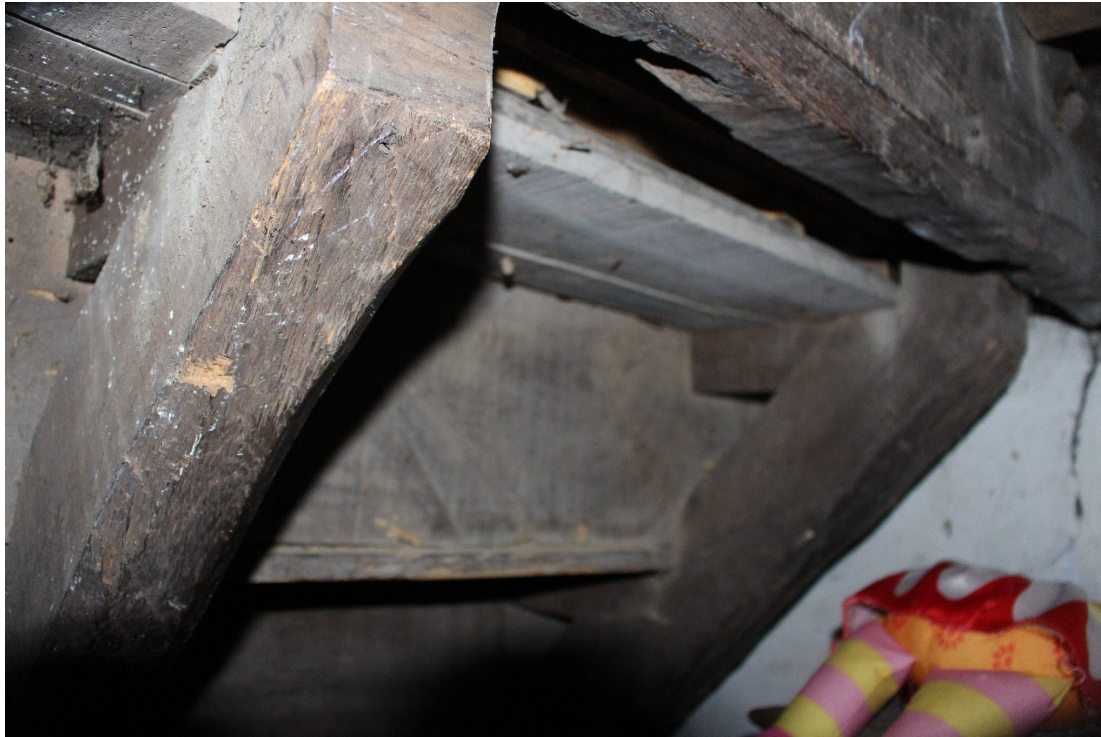
*Photo No.3*

*This photo shows the underside of the present staircase supported on a similar timber.*

*It is also proposed to re-site the lower section of the timber stairs (indicated in Photo's No.3 & No.8) to the opposite side as shown on the drawing. This will involve forming a new well to accept the lower flight and infilling the existing stairwell on the opposite side, where a new store cupboard will be formed. These alterations will use timbers to match exactly the existing floor joists and to sit them into notches which will already exist in the floor beams. Replacement floor boards will be formed from reclaimed timber of a type to match the existing.*

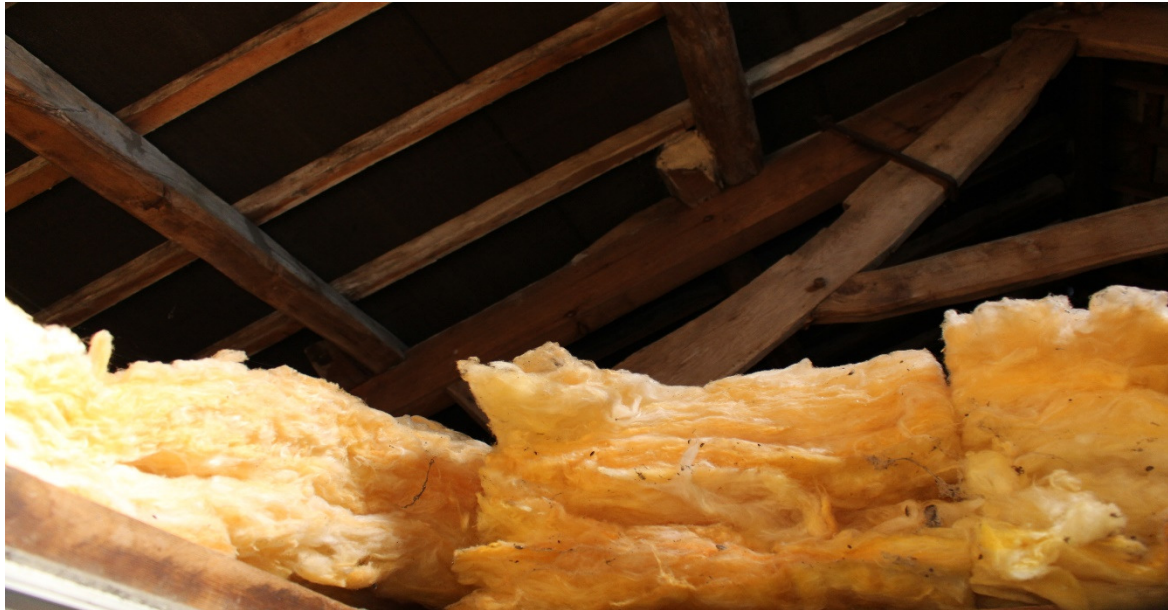
*Photo No.10*

*Photo showing added top chord and purlins*

*The existing timber roof trusses indicate that the original 2 storey building was increased in size by an extension at the rear. The rear wall at the time was altered but mainly stayed in position. To extend the roof over the new rear extension the trusses where extended by adding new top chords and bottom chords to provide support for the purlins and rafters.*

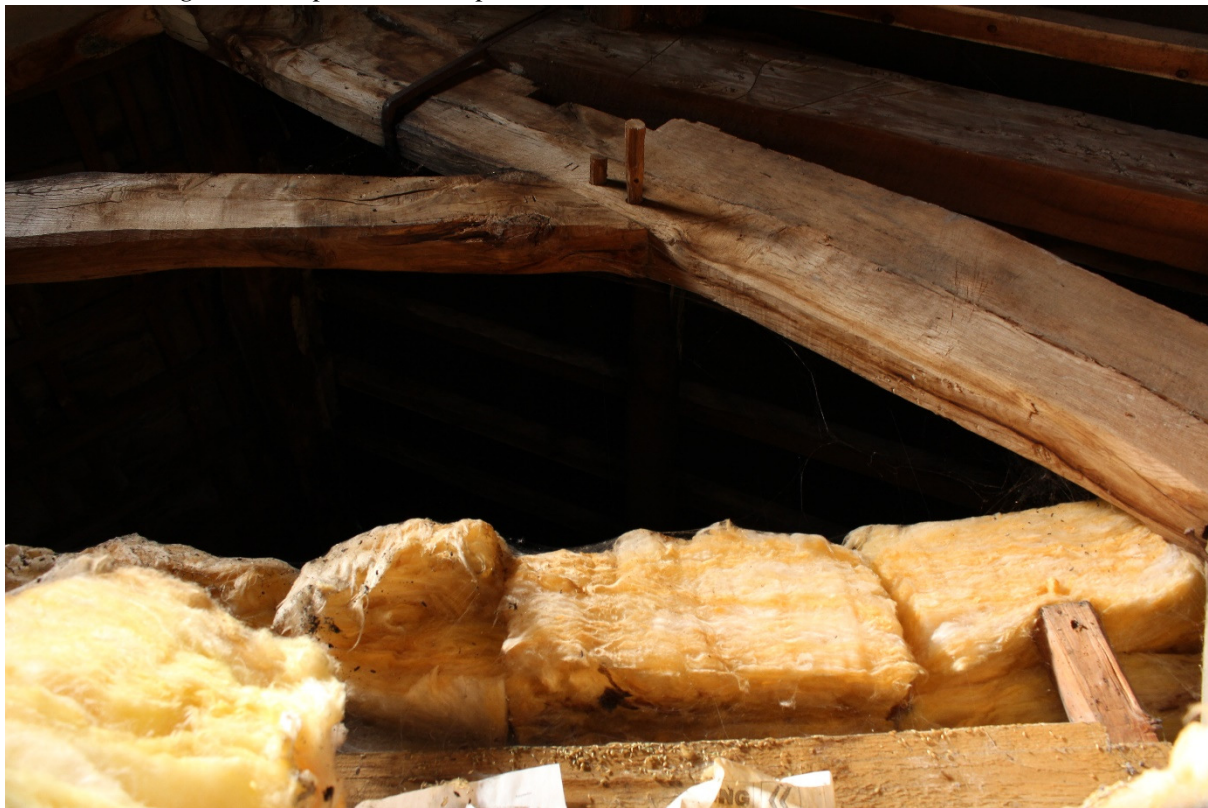
*Photo No.11*

*Photo of the altered roof truss.*

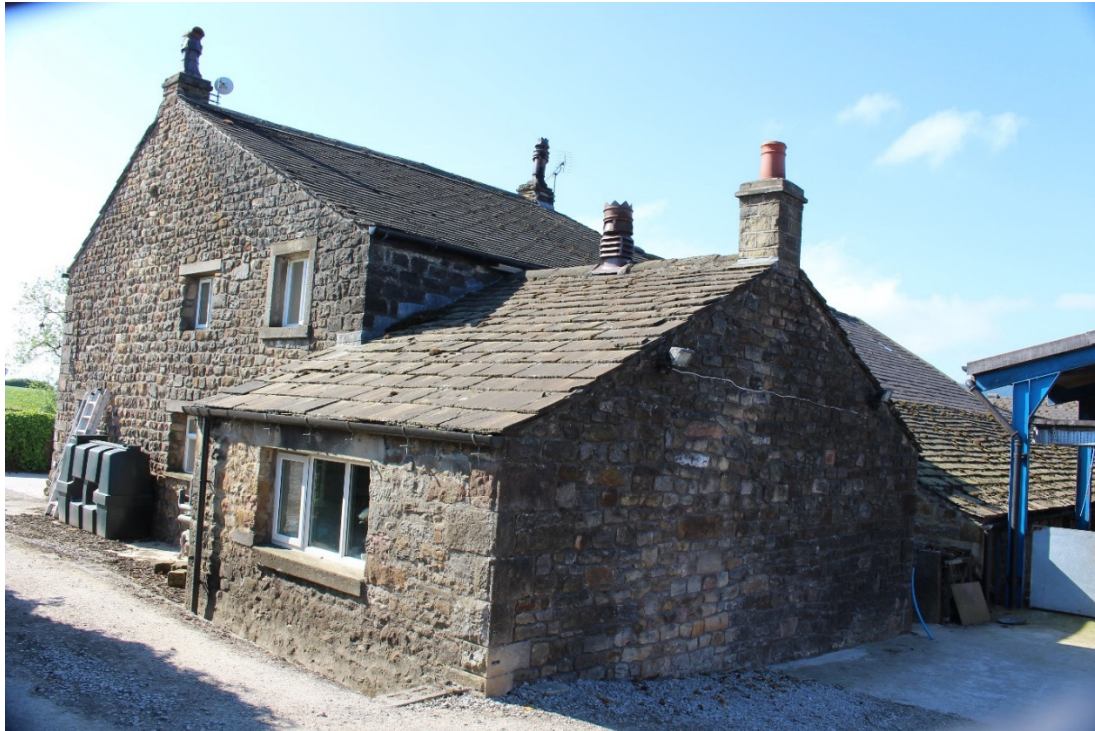
*Photo No4*

*This photo shows a later second single storey extension*

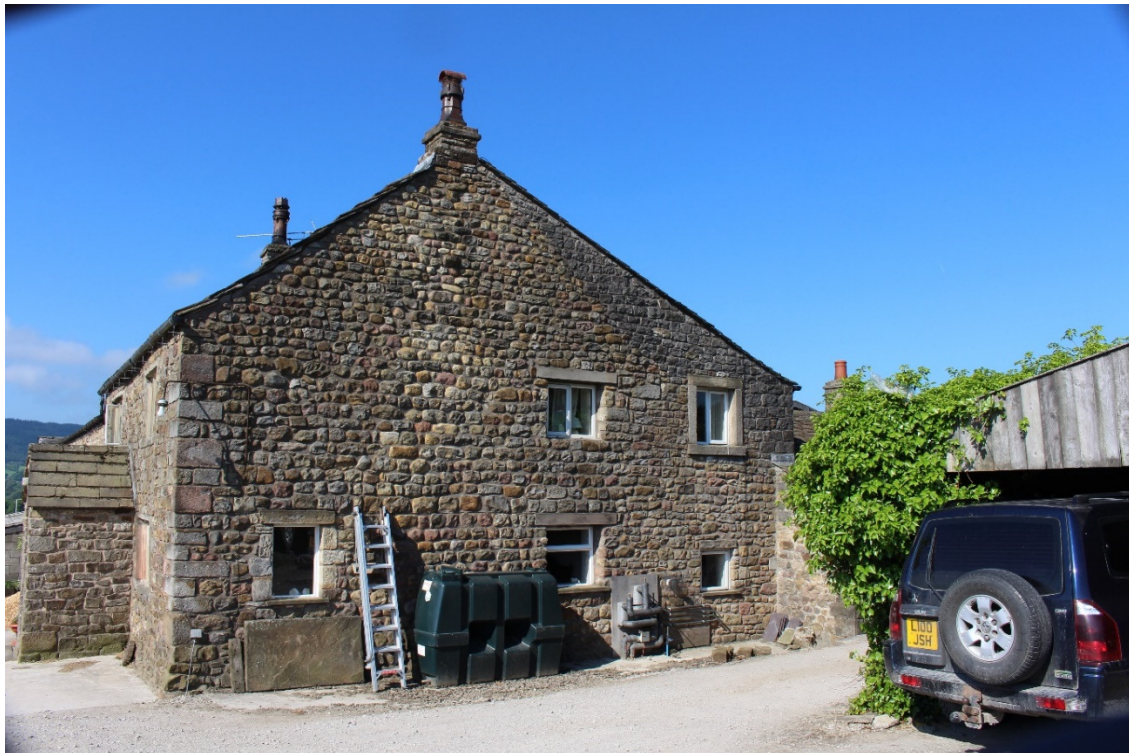
*There is external evidence of the extension to the two- storey farmhouse which is evident in the gable, where the difference in stone and the now off- centre chimney stack indicate that the building was extended some 2.800 meters.*

*These photo's shows a definite line where the stone changes colour.*

*Photo No.5 shows the altered rear roof pitch and change in stone colour*

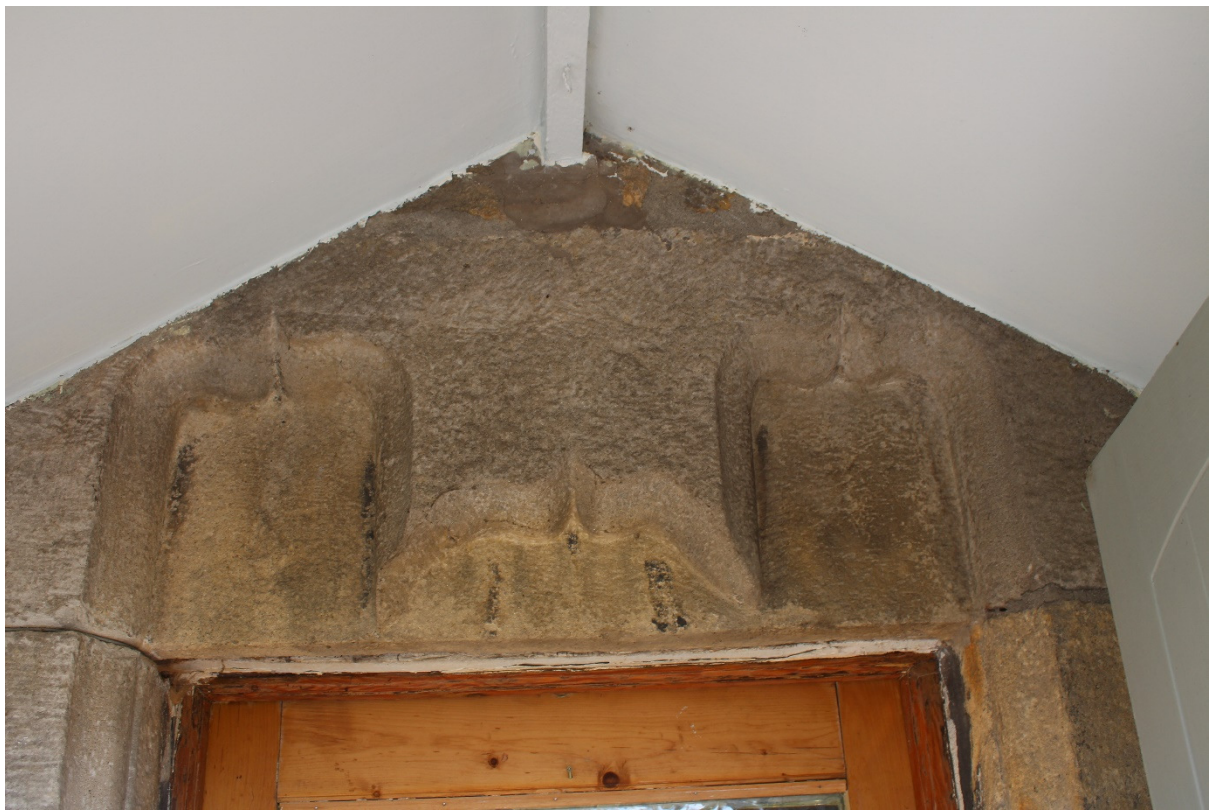
*Photo No.6*

*Door Lintel over front door*

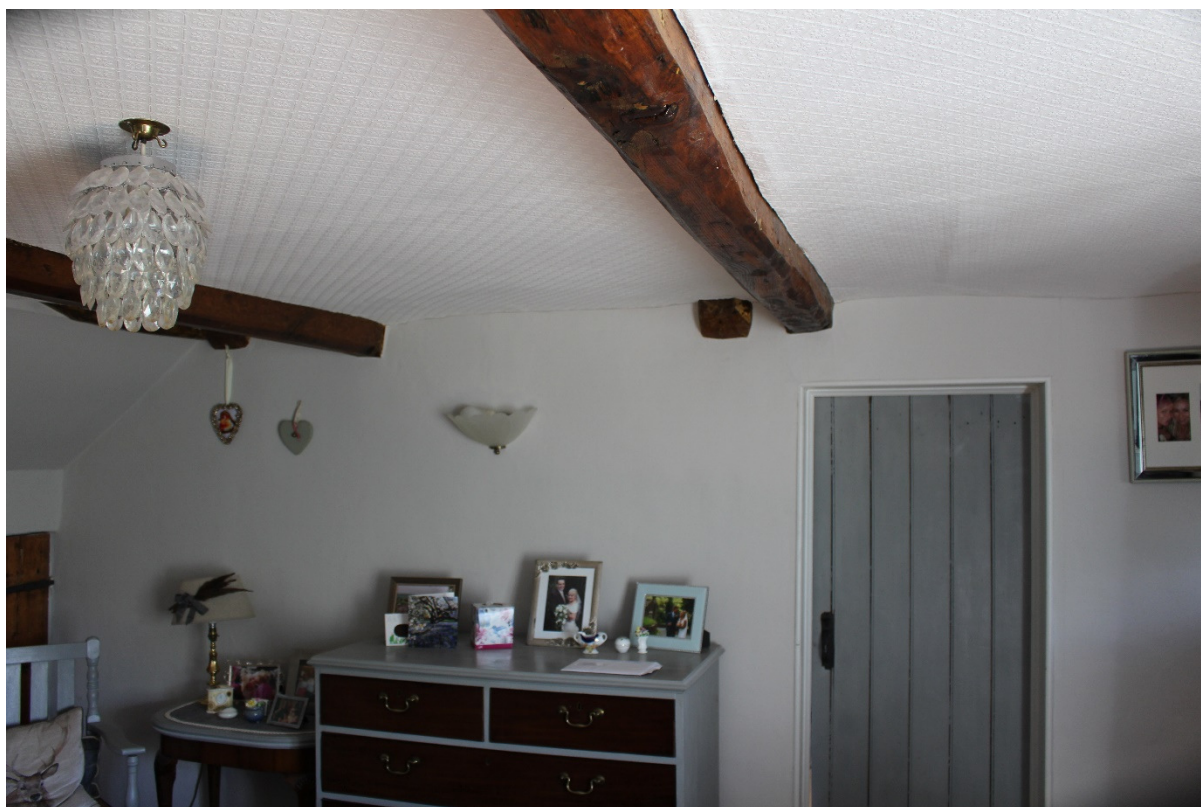
*Photo No13*

*Internal view of the proposed wall to be removed including the door style*

*It is proposed to form a door opening through the wall into the proposed pantry to allow access to form the kitchen into the pantry. The opening will be supported over stone lintels with 150mm seating. The door and casing will be formed to match the style and material type of the existing doors as shown in photograph No.13*

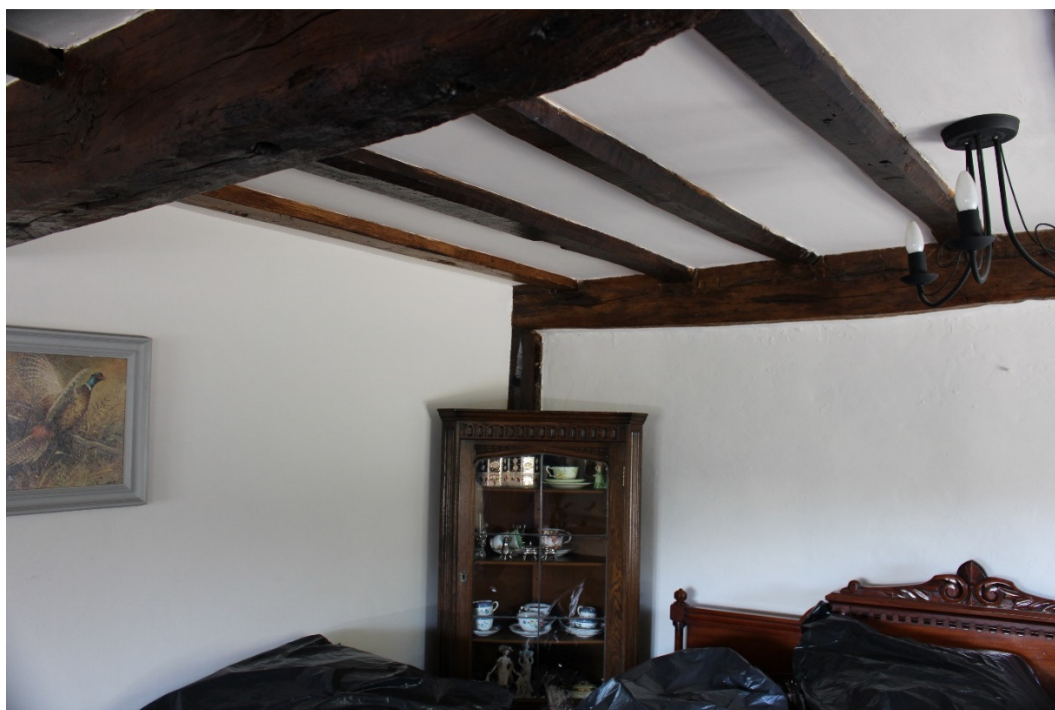
*Photo No.14*

*These photos show the wall from both sides and the beams supported.  
Beams and joists are visible. A vertical support in the corner is visible.*

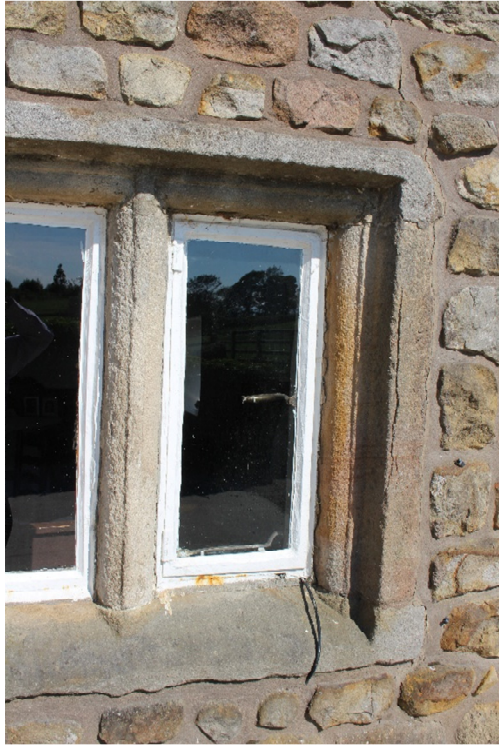
*Photo No.7*  
*Front window detail*

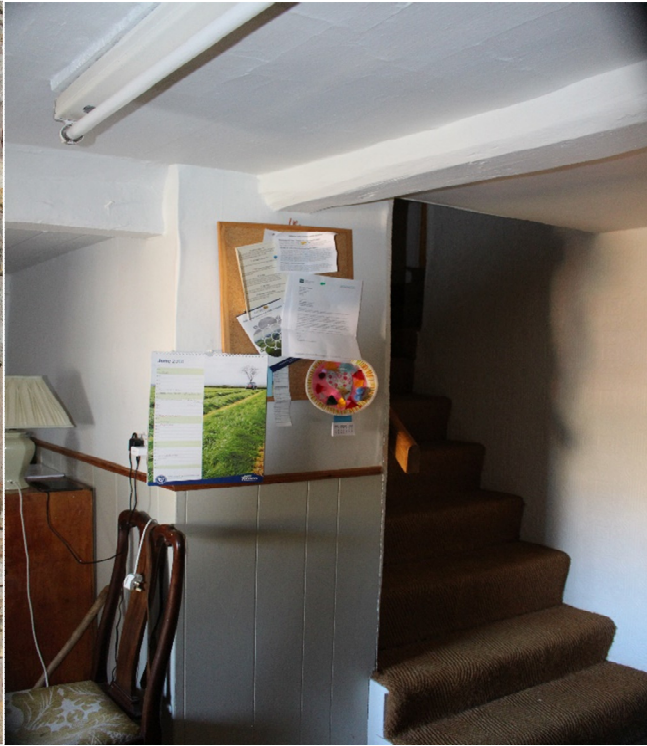
*Photo No.8*  
*Internal wall originally the rear wall & staircase*

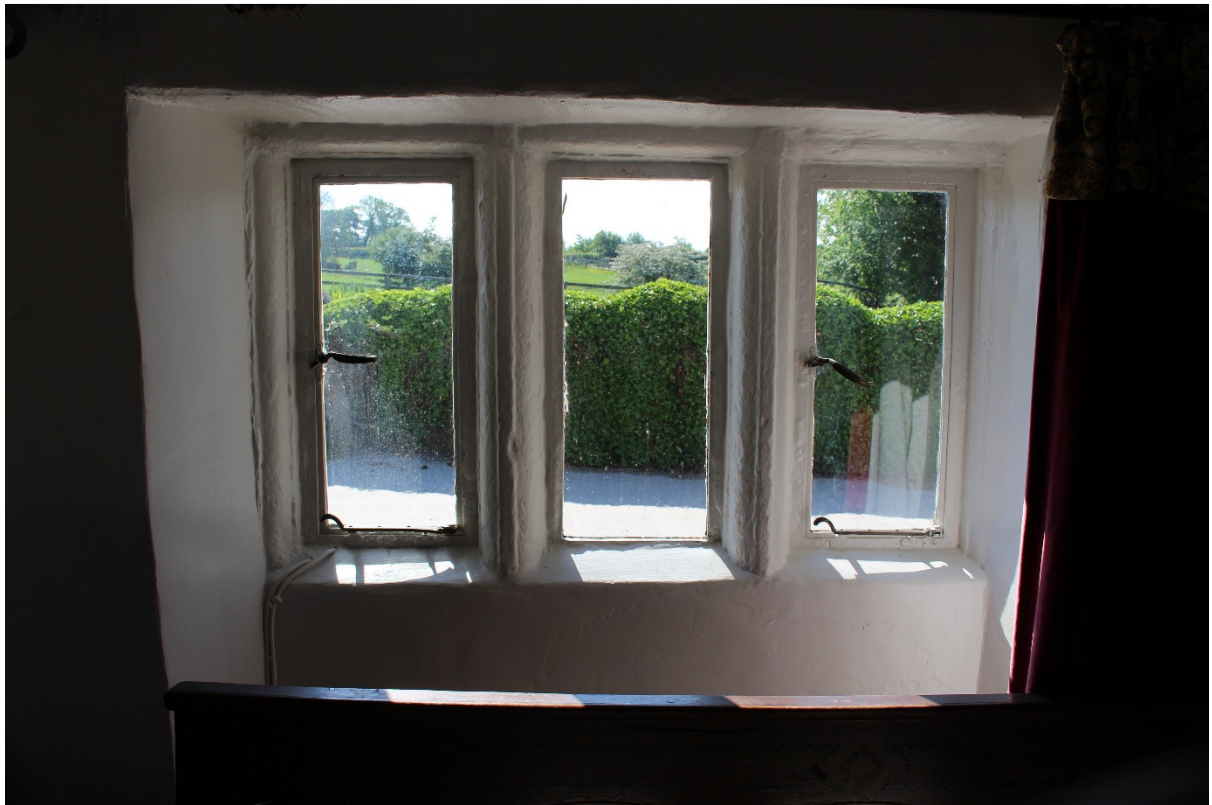
*Photo No.9*  
*Internal view of front window*
