Heritage Statement

The Whitewell Estate

New Laund Farmhouse, Whitewell

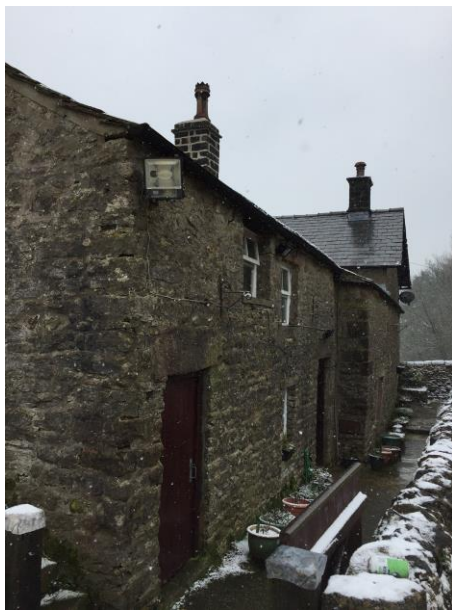
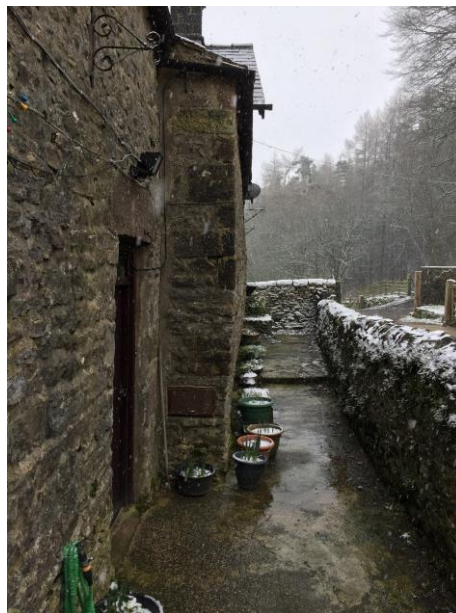
Earlier maps may illustrate a building adjoining the farmhouse at a right angle. We believe that the gable elevation which is currently bowing formed part of an adjoining building that at some point was taken down, perhaps to facilitate access into the quarry. There is a vertical straight joint between the main house and outer skin of stonework and the lack of any bonding or ties suggests that this was a separate structure or building.

Photos illustrating the outer skin of stonework which requires stabilisation works.

The proposal is to appropriately pin the elevation back to the existing elevation forming the farmhouse wall. Using a Cintec Anchor system 50mm cores are proposed to be drilled with wet diamond tip drilling at 1200mm lengths to appropriately tie the two skins of stonework together. When in place the tie bar is slightly inflated which compacts the inner fabric which in turn forms the bond between the two skins. Three of the cores are to be positioned on the internal load bearing wall, these will extend up to 2500mm in length and adequately ties in the structure where the movement is most significant. On completion the cores as previously removed will be re positioned and neatly pointed. These will not be noticeable without undertaking a close up inspection. The historic curve will still be present but the wall will be stabilised without incurring further movement.

The original secondary skin over the gable elevation will remain insitu and the anchor system will not be visible whilst providing a structurally sound solution for the long term maintenance of this asset. The historic curve will remain a historic part of the building and therefore we favor the proposed installation of the Cintec anchor system.
