## ***Bat Advice Note: New Laund Farm, Whitewell***

Bowland Ecology Ltd was commissioned by Savills to undertake an internal and external building inspection survey at New Laund Farm Whitewell, Clitheroe, Lancashire (NGR: SD 65509 47050), to assess the potential of the building to support roosting bats. The farmhouse is subject to maintenance works, to repair a bulging external wall on the buildings southern elevation. Works comprise the removal of the outer skin of stonework, a new footing will then be excavated on which the blockwork will be re-built. The re-built wall will also contain a cavity, partly filled with insulation. This advice note presents the survey results and makes an assessment of potential impacts to bats, with particular reference to legal requirements (Appendix A) and constraints to the proposed works. A plan showing the location of potential bat roosting features is shown in Appendix B.

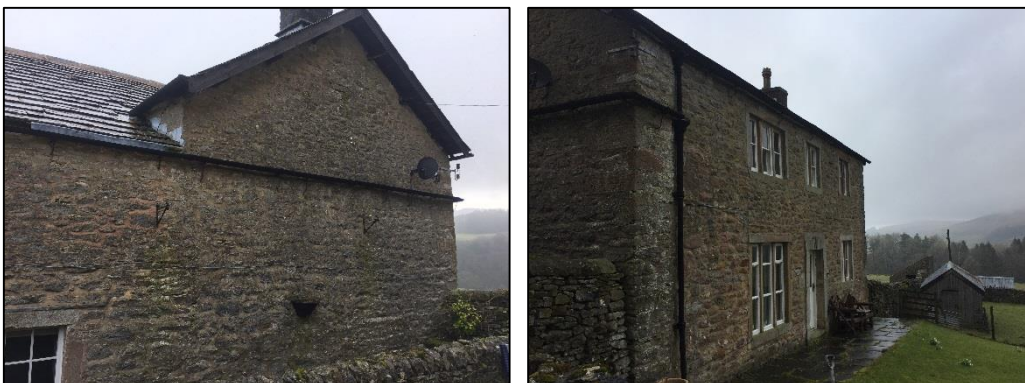
The building is a two storey, stone built, traditional farmhouse with a cross gabled, pitched, slate tiled roof and solid stone walls, offering negligible hibernation potential for bats due to the absence of a cavity. Timber framed windows and doors are present on all building elevations with guttering present along the wall tops. Two chimney stacks, in good condition are also located on the southern elevation of the roof.

*Plates 1 and 2: Southern and eastern elevations of farmhouse.*

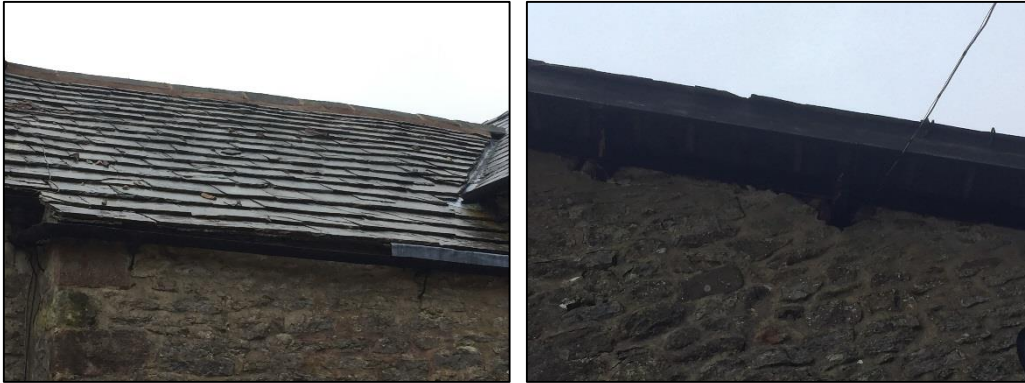
The roof has several slate tiles that are raised and slightly dislodged, which may provide habitat for small numbers of crevice dwelling bats (Plate 3). Generally the mortar between stonework is well sealed, however, where timber beams are protruding out of the masonry, directly below the overhanging eaves, on the southern gable end, small gaps are present which may potentially allow internal access into the roof void (Plate 4) and onto the wall tops.

*Plates 3 and 4: Missing & raised roof tiles & gaps in masonry at eaves of building.*

- Upon completion of the works gaps around timber beams on the eaves of the building should be created to ensure the continuation of bat roosting habitat.

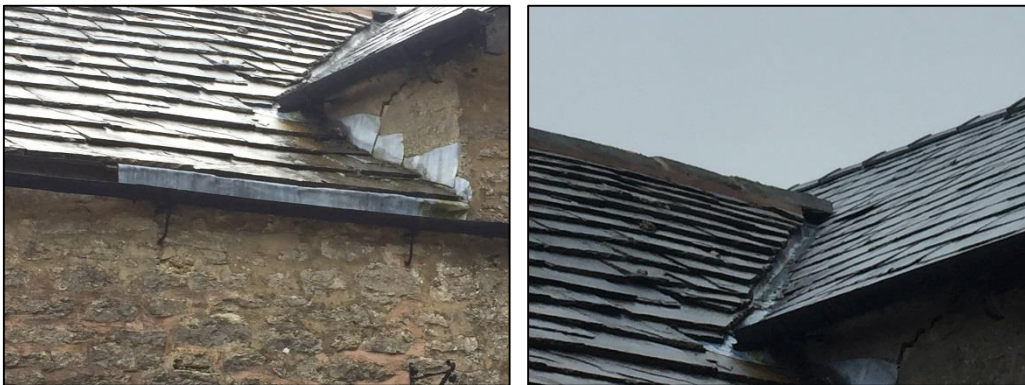
A relatively wide, structural crack is located in the wall at the base of the valley gutter, adjacent to the southern gable. The crack runs from the base of the wall to the top and potentially provides habitat for crevice dwelling bats (Plate 5). Ridge tiles along both pitches are in good condition, the only exception being a gap beneath the ridge tile that is located at the top of the valley gutter (Plate 6).

*Plates 5 and 6: Structural crack and gap beneath ridge tile at top of valley gutter*

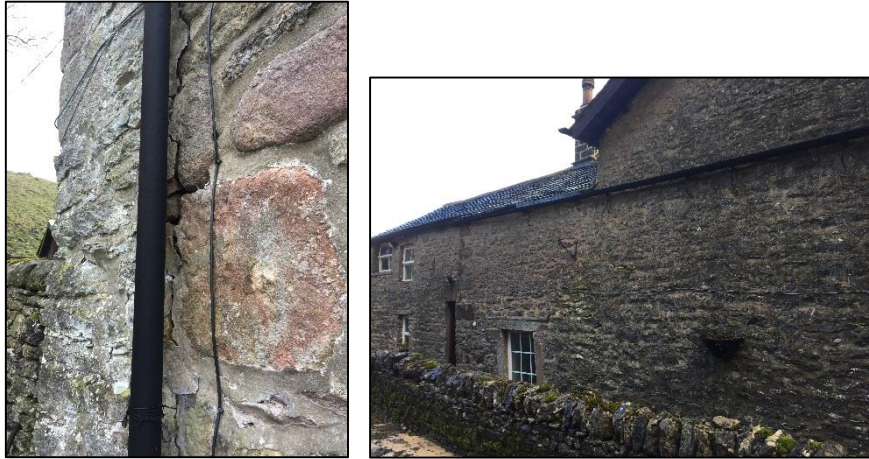
A gap of approximately 2 – 3 cm is located on the south western corner of the buildings eastern elevation. The gap is where mortar used to infill a crevice is falling away (Plate 7). The feature provides potential habitat for crevice dwelling bats. The stonework along the main section to be re-built is well sealed (Plate 8).

Plates 7 & 8: Gap in mortar on eastern elevation and southern elevation to be re-built

Proposed works comprise maintenance works to reinstate the bulging wall on the buildings southern elevation. Works are not anticipated to impact the roof structure or covering, therefore will avoid areas of the building considered most likely to be used by roosting bats. However, gaps in masonry beneath the eaves of the building, on the southern gable end has

the potential to be used by crevice dwelling bats during the active season (April to September inclusive). As such, works to re-build the wall could potentially result in the loss of bat roosting habitat, the killing and injury of bats, and disturbance to roosting bats, which would result in an offence if bats were present at the time of works (see Appendix A). As such, a minimum of one dusk/dawn emergence survey is required to assess the use of the building by bats.

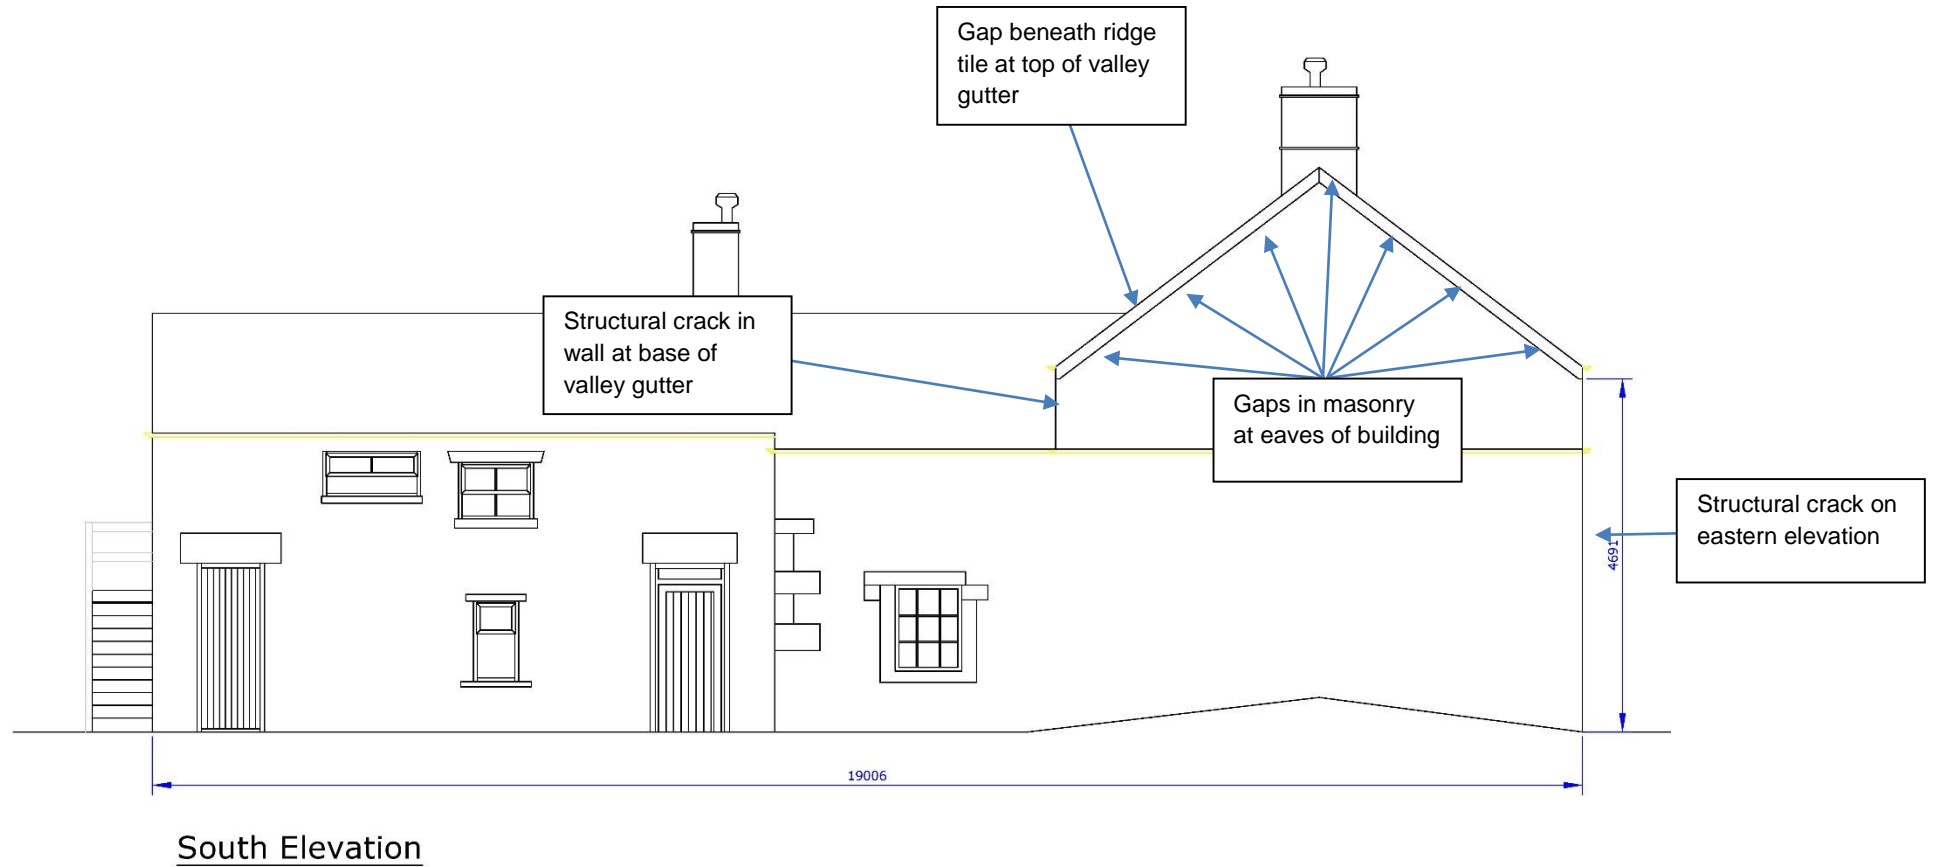
## Appendix B – Potential Bat Roosting Features Plan

- Raised and missing tiles on the roof;
- Gaps in masonry beneath the eaves of the building on the southern gable end;
- Gap beneath ridge tile at top of valley gutter;
- Structural crack in wall at the base of valley gutter; and
- Gap in masonry on eastern building elevation.
