Bat Advice Note: 29 Windy Street, Chipping

Bowland Ecology Ltd was commissioned by JYM Partnership LLP to undertake an external building inspection survey at 29 Windy Street, Chipping, Lancashire (NGR: SD 62320 43216), to assess the potential of the building to support roosting bats. The building is subject to maintenance works, comprising the following:

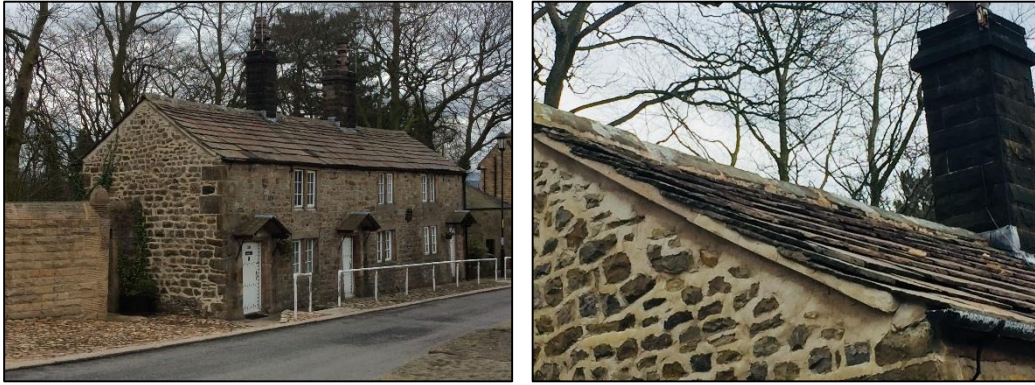
Plates 1 and 2: North-west and eastern elevations of farmhouse & lifted lead flashing

The building is a two storey, stone built, traditional building comprising three separate residential dwellings with solid stone walls providing negligible hibernation potential (Plate 1). The roof is pitched with slate tiles and stone ridge tiles with solid stone walls. Timber framed windows and doors are present on the northern and southern building elevations with guttering present along the wall tops. Two chimney stacks, in good condition are located in the centre of the roof. Lead flashing present at the base of each chimney is slightly raised (Plate 2), offering potential roosting habitat for crevice dwelling bats.

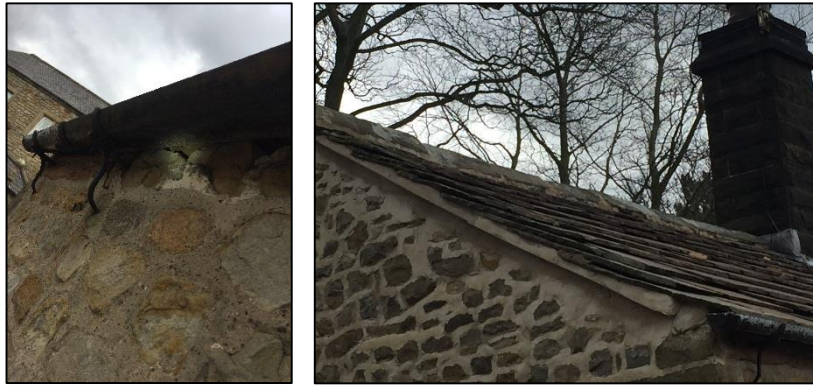
Plates 3 and 4: Gaps on wall tops & gaps beneath tiles on northern gable end

The mortar between the stonework on the walls is generally well sealed, except on the wall tops where the eaves of roof are not flush with wall tops, creating a gap potentially allowing access into the internal space (Plate 3). House sparrows (*Passer domesticus*) were noted entering a gap above the lintel on the first floor window of number 31. The roof is lined with bitumen felt, some of which is coming away from roofing tiles at the eaves of the building creating a gap suitable for roosting bats and potentially providing access into the roof void.

Gaps are present beneath the ridge tiles on northern gable end, and several of the slate roof tiles are also raised creating roosting crevices for bats (Plate 4). Mortar is missing beneath the ridge tiles along the buildings southern elevation. Light ivy cladding is located on the north-eastern gable end (Plate 5).

- Before any works proceed, all contractors should be made aware of the possible presence of bats and the signs to look for (Appendix D).
- Prior to the commencement of works, and when scaffold has been erected, gaps in masonry and beneath ridge and roof tiles should be checked using an endoscope by a suitability qualified and licenced ecologist, to ensure no bats are present.

- Upon completion of the works gaps along the wall tops should be created to ensure the continuation of bat roosting habitat.
- Work should cease immediately if any bats are encountered at any stage and only resume once further advice from the project ecologist has been sought. If the bat is in immediate danger it should only be picked up with gloved hands and placed in a secure container with air holes in a dark, quiet place until the licenced ecologist arrives at site.

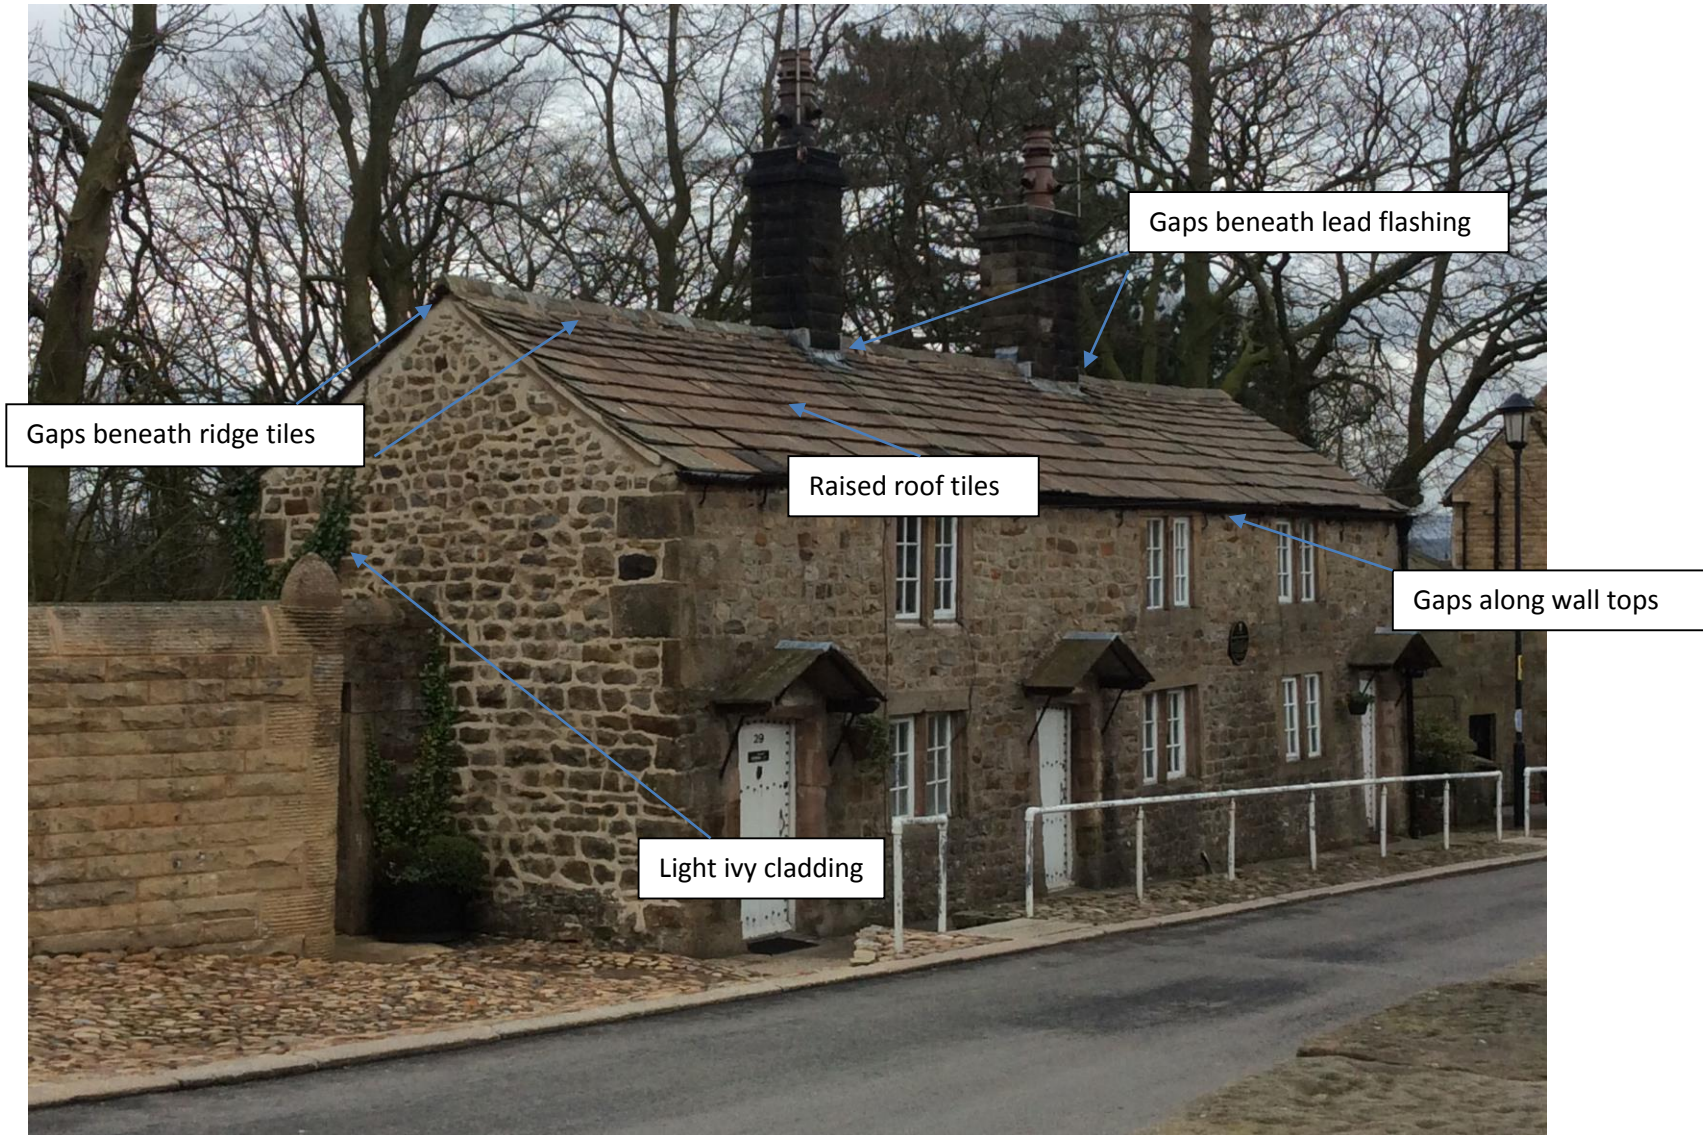
Appendix B – Potential Bat Roosting Features Plan

No evidence of roosting bats was observed during the external inspection of the building; however, a number of bat roosting opportunities were identified, including:

- Raised roofing tiles;
- Gaps in masonry between the eaves of the building and the wall tops on the northern and southern building elevations;
- Gaps beneath ridge tiles; and
- Light ivy cladding.

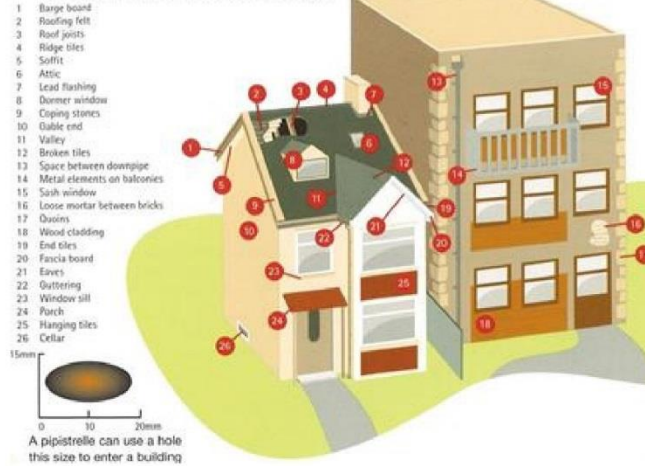
Schematic from www.bats.org.uk

Places that bats may use in buildings

Bats can roost in the following places:

- The top of gable end or dividing wall;
- The top of chimney breasts;
- Ridge and hip beams and other roof beams;
- Mortise and tension joints;
- All beams/ceilings/pipework (free hanging bats);
- The junction of roof timbers, especially where ridge and hip beams meet;
- Behind purlins;
- Between tiles and the roof lining;
- Under flat felt roofs;
- Under barge boards;
- In cavity walls;
- In cracks in stone or concrete;
- Behind peeling paint/wall coverings;
- Gaps behind window and door frames;
- Between window panes and timber boarding.
- In trees (cracks/holes/ivy cladding).
