Bat Survey - Preliminary Roost Assessment

3 Airey Houses Clitheroe Road, Knowle Green, Lancashire PR3 2YS

320180749P

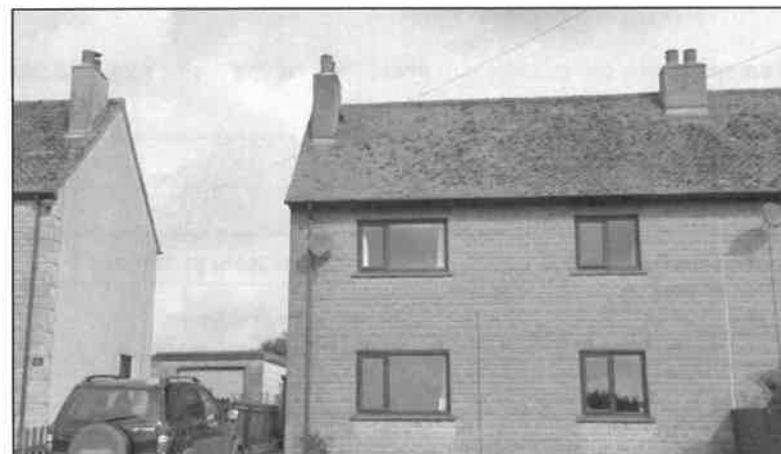
B1 is a semi-detached brick built residential dwelling with a pitched roof with concrete tiles. Windows and doors are wood framed and tight fitting. Stone cladding is present on the south elevation and this is in a good condition.

Two chimney stacks are present, one at the western gable and one on the eastern side of the roof. Lead flashing at the base of the chimneys is tight fitting providing no suitable roosting area for bats. The chimneys are rendered and this is also in a good condition with no gaps or cracks visible.

Photo 1: South elevation of B1.

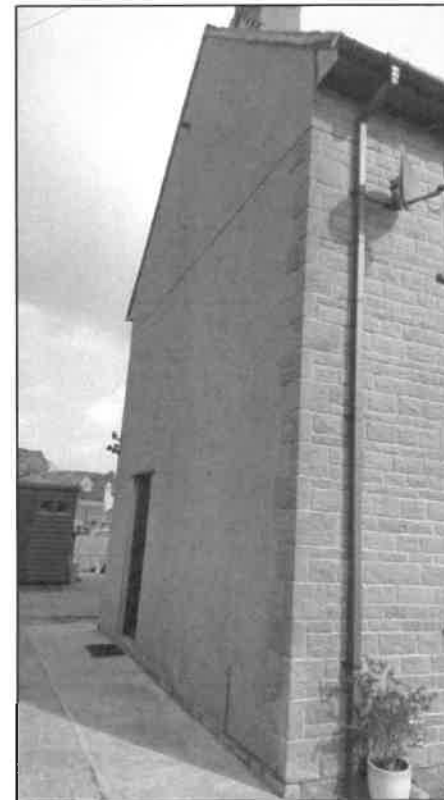
The west gable end is pebble dash rendered and this is in a good condition with no cracks present.

The mortar at the edges of the roof tiles is intact therefore there is no access to the space between the roof and bitumen felt lining.

Photo 3: Western gable.

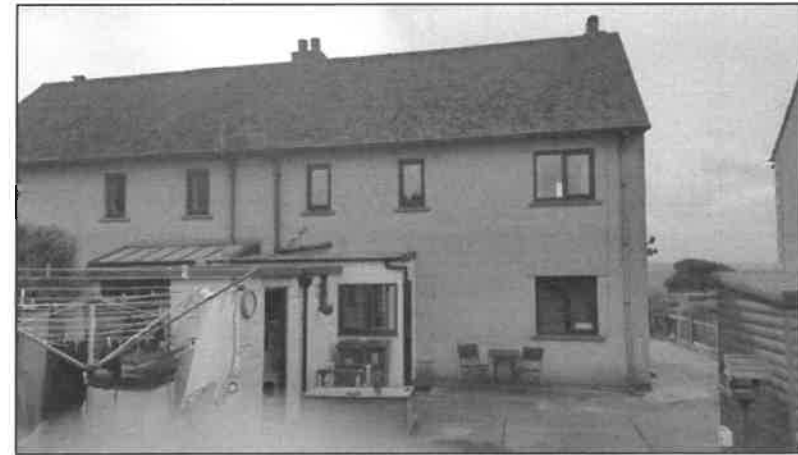
A single storey flat roof section is attached to the main two storey dwelling. This is brick built and white washed and is in a good condition with no gaps in the brickwork with tight fitting windows and doors.

Photo 4: Southeast elevation of B1.

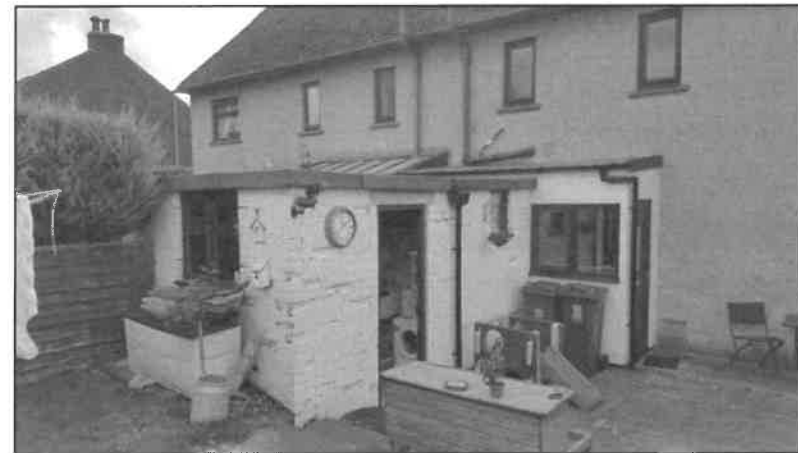
Photo 5: Flat roof sections on north elevation of B1.

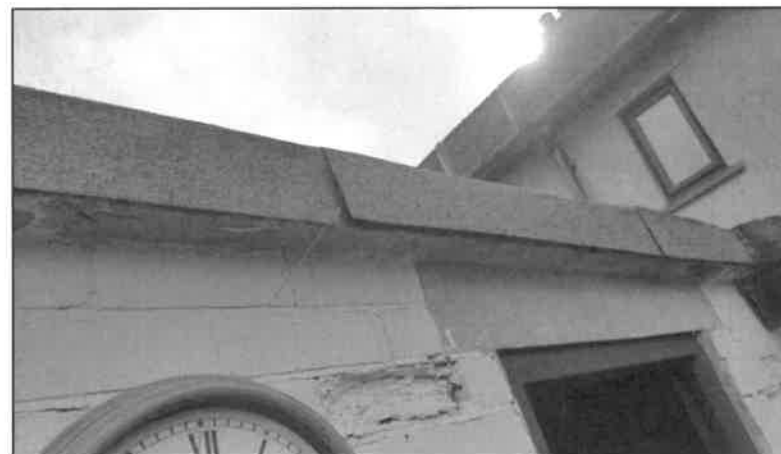
The flat roof is concrete and covered with felt. This is tight fitting with the exception of one small area where there is a gap in the overlapping fold (shown in the photo opposite). This is not assessed to provide a suitable roosting area for crevice dwelling bats as the gap is open at one side and will therefore be exposed to the elements.

Photo 6: Gap in overlap fold of felt roof of flat roof section – arrow indicated where it is open at one side.

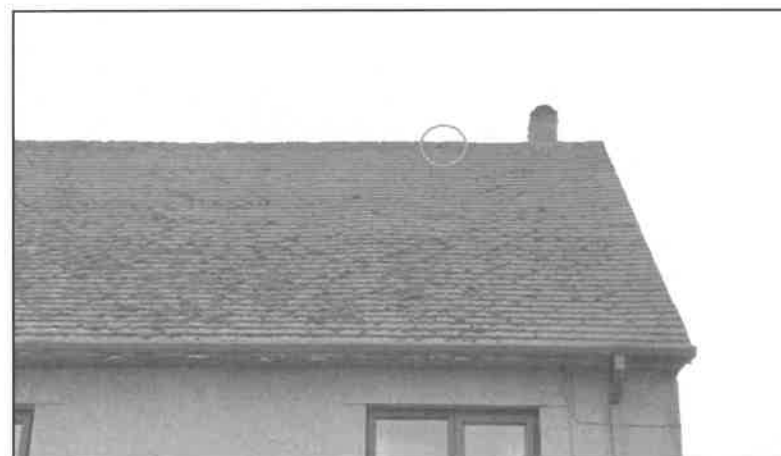
There is a broken ridge tile on the north elevation pitch. This could provide a suitable roosting feature for crevice dwelling bat species such as common pipistrelles as it will provide access to the chamber within the ridge line. This area will be unaffected by the extension (see proposed plans in Appendix 2 which show the extension roof connecting to the existing roof well below the ridge line). As the roof tiles can also be seen to be tight fitting on this elevation pitch any bat roost present will be confined to the ridge line only and will therefore be unaffected by the development.

Photo 7: Broken ridge tile

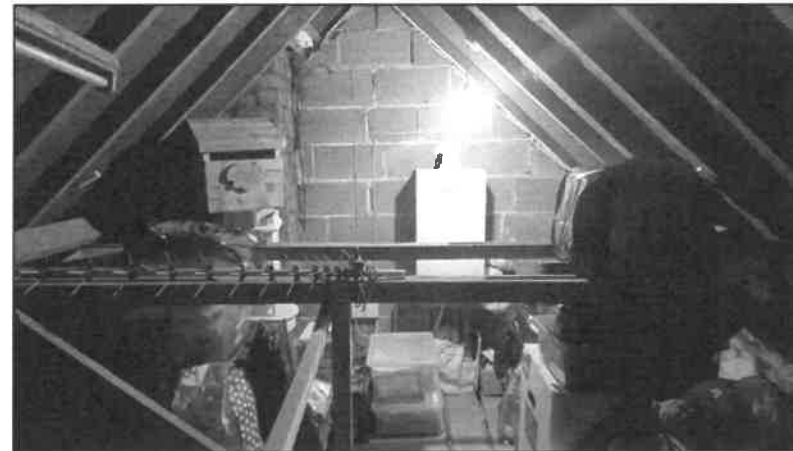
Internally there is one loft space. This has a built in loft ladder and is used for storage with an electric light fitted. The roof is lined with bitumen felt which is in excellent condition with no gaps present.

No daylight is entering the loft space. The central ridge beam and the gable ends are covered in dense cobwebs indicating a lack of recent disturbance by void dwelling bat species such as brown long-eared bats.

Photo 9: Loft space facing east towards the dividing wall of the semi-detached properties.

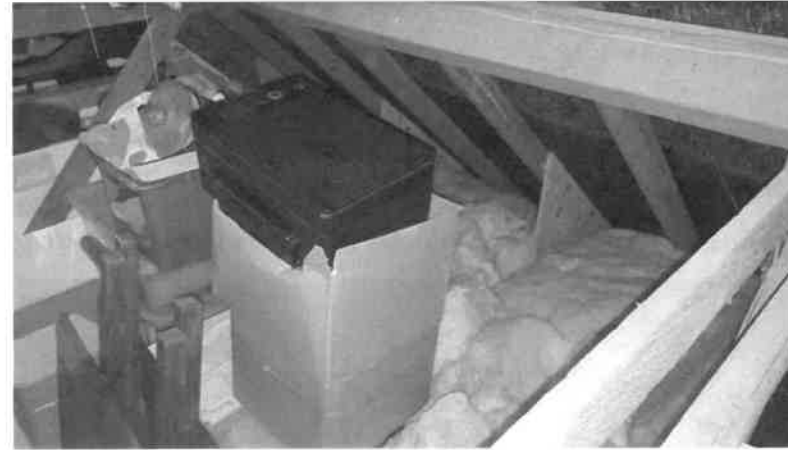
The centre of the loft space is boarded and loft insulation is present at the sides. A full inspection of the loft space was completed as the loft is fairly small and all areas, including the eaves, could be clearly seen through the use of a high powered torch.

The loft space measured approximately 2m in height from floor to ridge, 7m in length and 6.5m wide.

Photo 9: Stored items on the loft insulation.

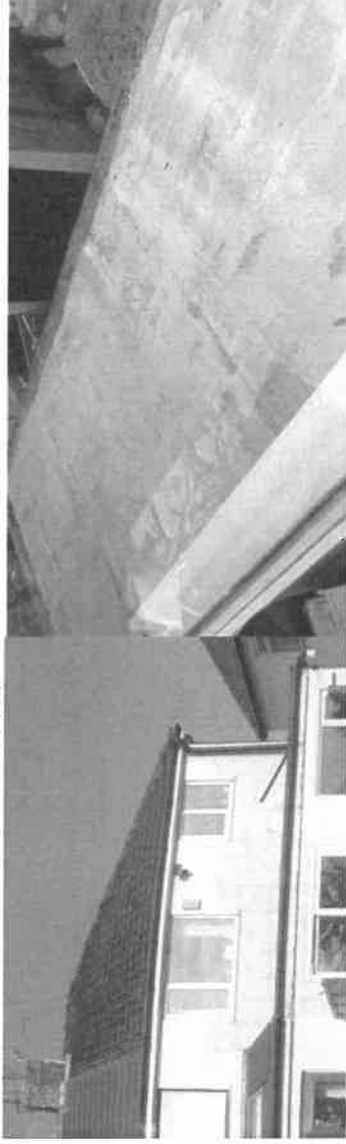
Flat roof finish

The roof is a hipped construction with a tile finish, the eaves overhang has upvc fascias and soffits. The flat roof is felt with flush timber fascias .

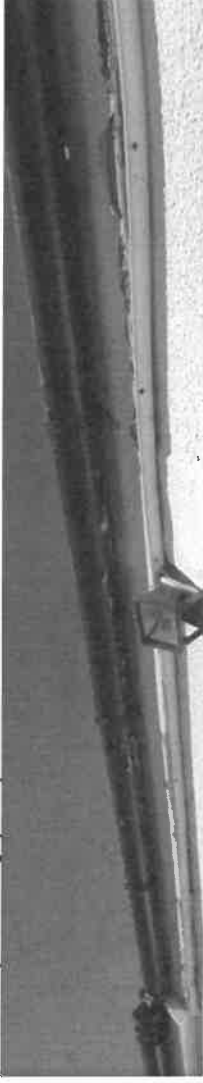
Flat roof fascias

The flat roof covering was in good condition as viewed from above, the fascias are flush fitting and did not provide any suitable gaps to provide bat access.

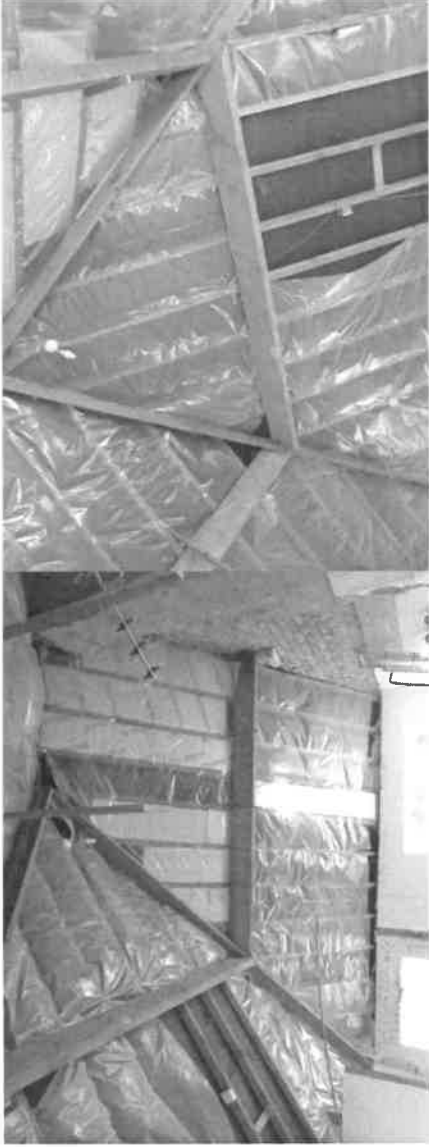
As renovation has commenced at this property the ceilings have been removed hence there is no enclosed roof void. All the structure is visible from the first floor, the timbers were in good condition as was the underlay.
