**Meadow Brook Barn, Saccary Lane, Mellor, Blackburn,  
BB1 9DL**

**Phase One Habitat Survey and Bat Building Inspection  
and Activity Survey**

**Simply Ecology Limited**

**August 2018**

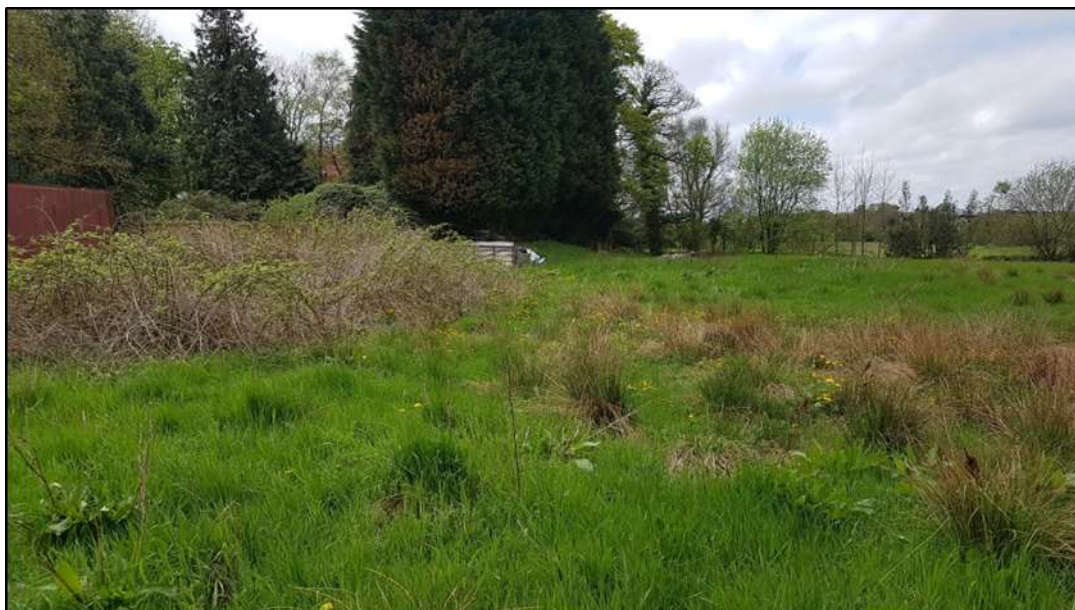
Plate 1: Semi-improved grassland in foreground with scrubby ruderals to left.

- 4.1.9 This was an area north of the building that had little botanical provision, and comprised of encroaching brambles over paved concrete breeze blocks as seen in Plate 1 (left side of the picture).

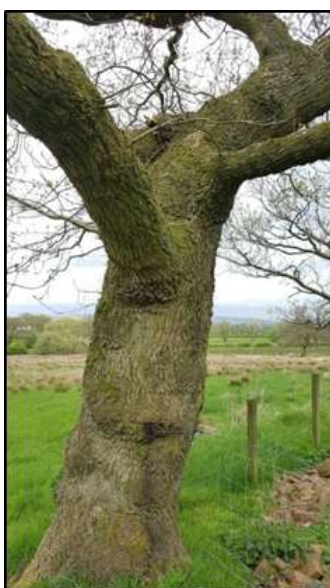
Plate 2: A mature English Oak on the eastern side of the boundary.

- 4.1.7 Along the entrance from the gate to the building, either side of the driveway were planted tree species of varying maturity, as well as trees scattered along the southern edge of the property. Notable matured tree species recorded was a single oak (*Quercus robur*) on the north-eastern boundary. This had a superficial knot hole, yet was determined as no PRF for bats. Mature Cypress (*Cupressus x leylandii*) trees were present as mentioned above, encouraging forb species at the grassland level. Elder (*Sambucus nigra*) trees were frequent at the southern boundary of the site, with no PRF present. Semi mature sycamores (*Acer pseudoplatanus*) were planted on the north side of the driveway adjacent to the Cypress trees. Similarly to the oak, they held likely looking PRF, yet after thorough inspection was regarded as not.

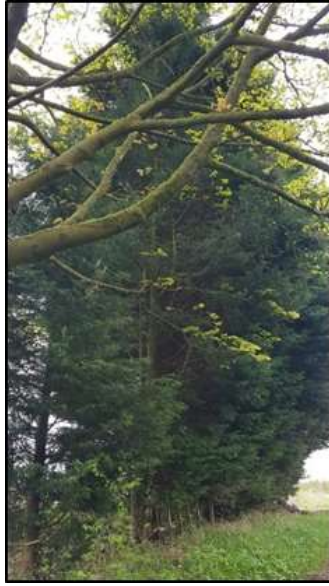
*Plate 3: Planted Cypress lining the side of the driveway impacted on grassland community species composition due to shading.*

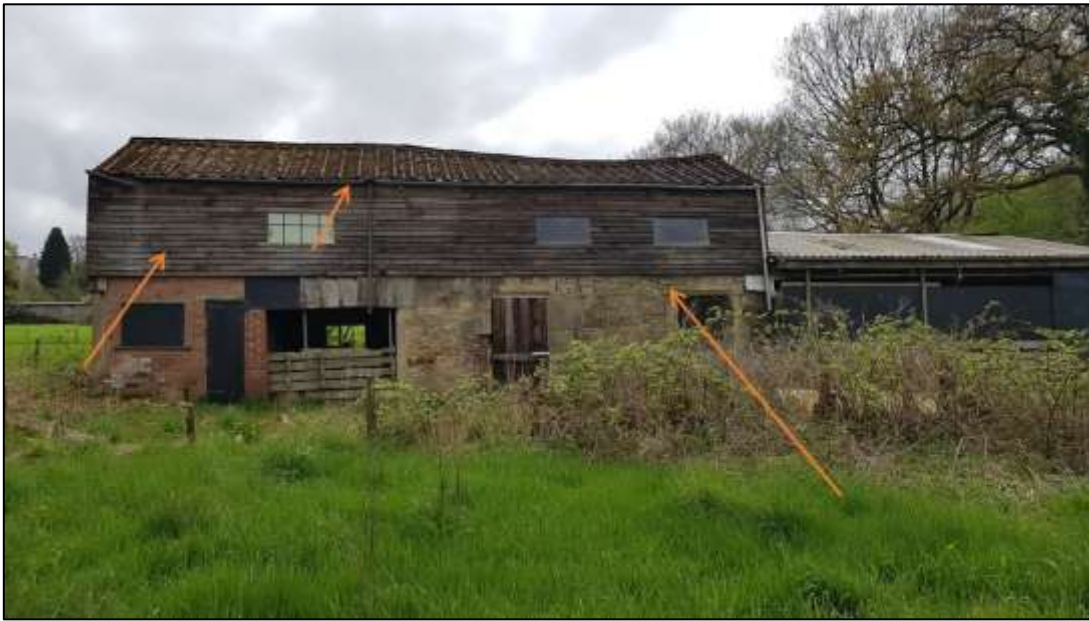
- 5.1.3 The external conditions of both barns are generally poor, with obvious bat potential access. Gaps are evident between stones of the main barn (see Plate 4), providing potential bat access points. On the eastern gable end, the wall has boards missing, providing access areas for bats and other wildlife (see Plate 5). The wooden cladding on the main barn has lifted slightly exposing potential bat access points (see Plate 3).

*Plate 4: View of the barns from the northern side of the building. The arrows show gaps between stones on the barn and exposed gaps underneath tiles due to lack of fascia. The weatherboard is highlighted to show where gaps are.*

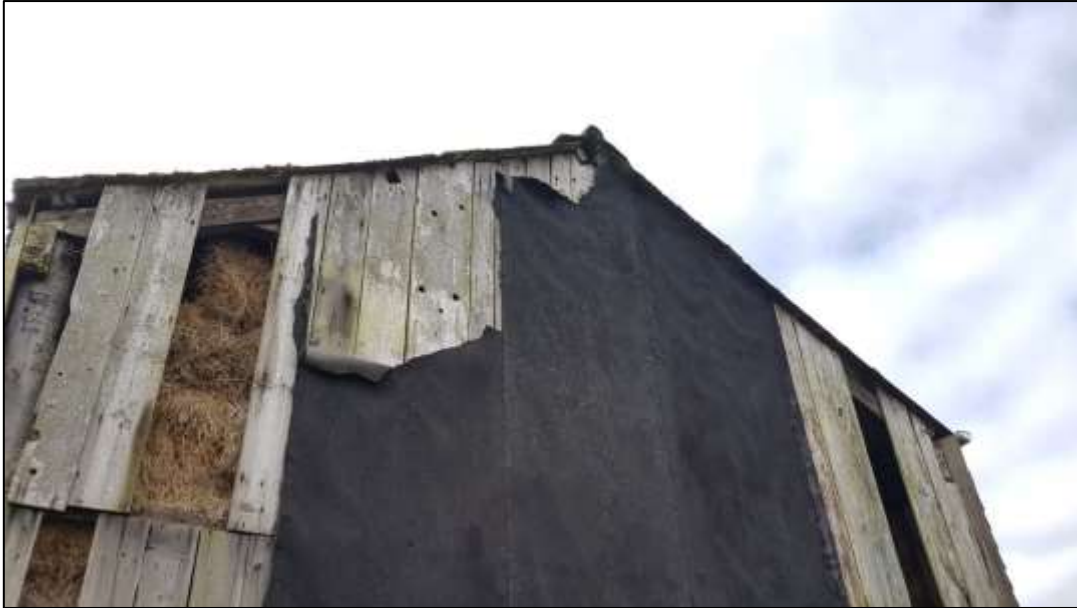
*Plate 5: The gable east end of the main barn. Large holes exposed due to missing timber beams.*

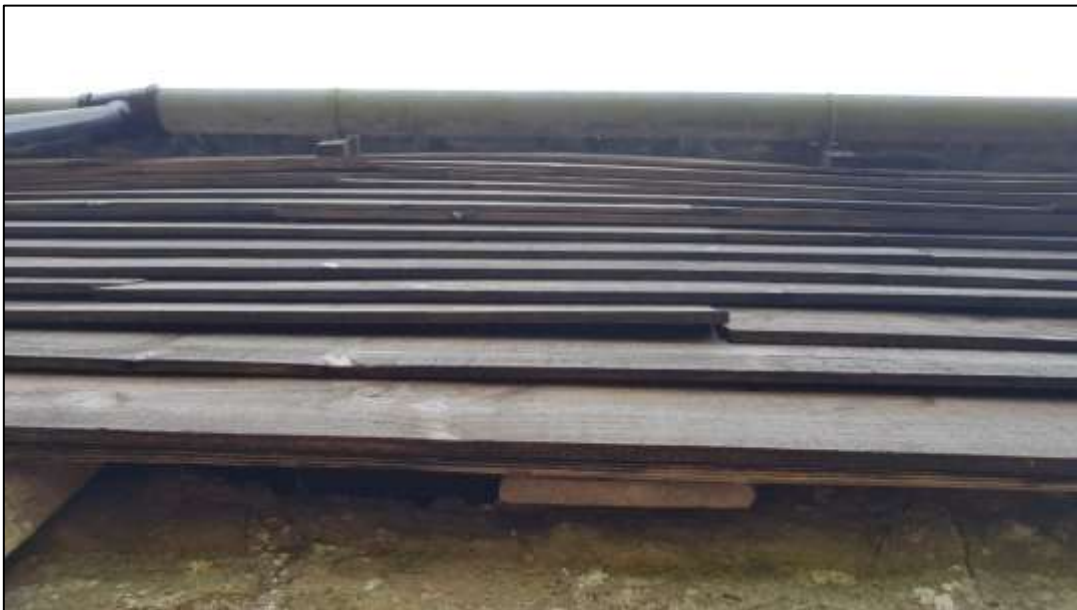
*Plate 6: A view of the cladding on the north side of the main barn. The overlapping wooden planks exposed gaps, allowing potential bat access*

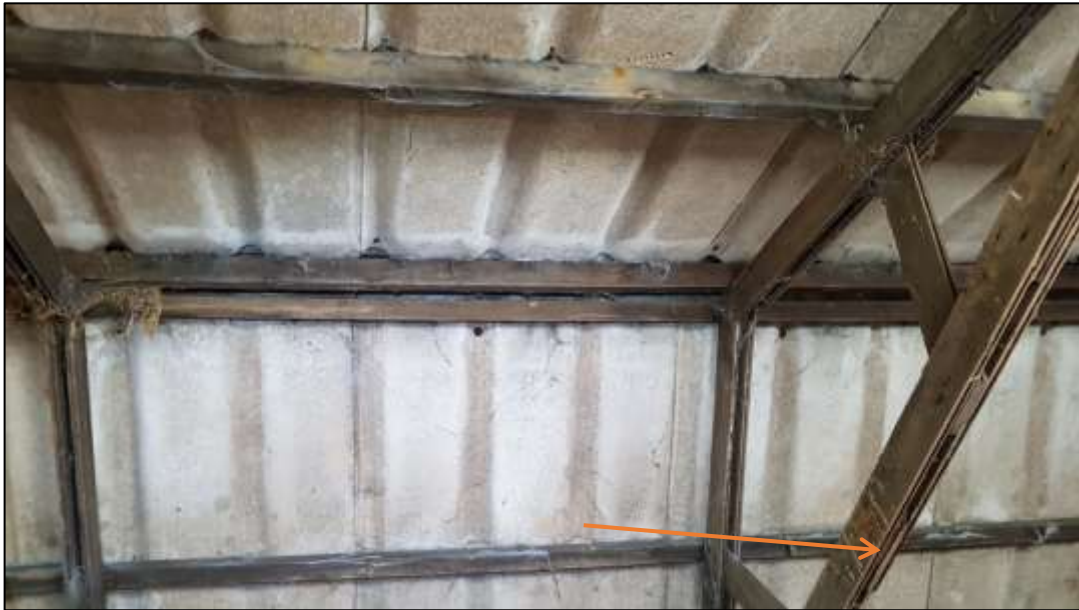
*Plate 7: The structural beams of the barns had slotted gaps which were potential bat roost structure.*

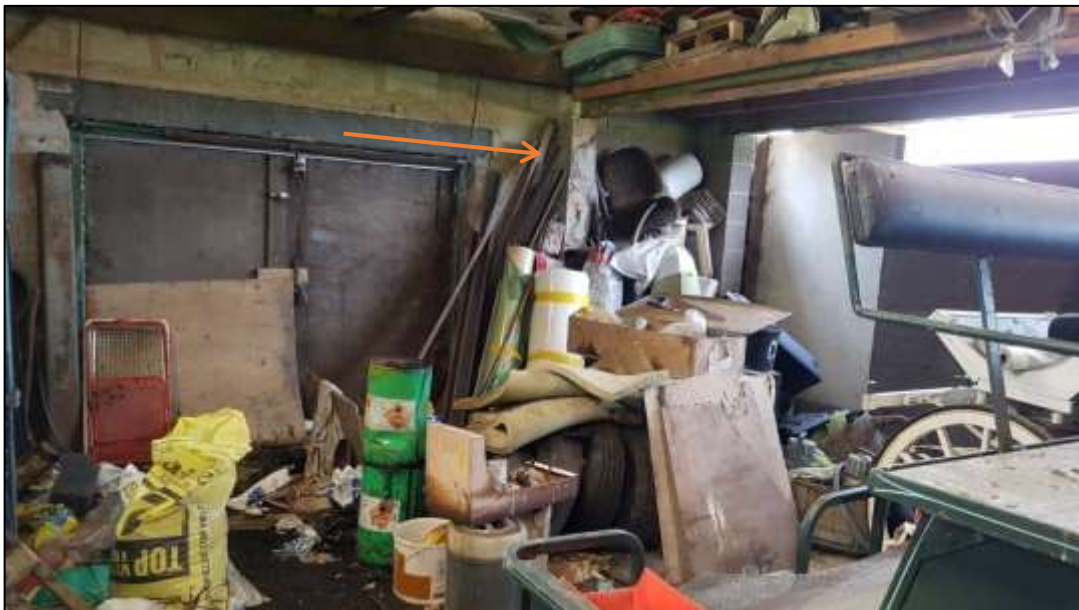
*Plate 8: The interior of the main barn. Small gaps between concrete blocks suggesting potential roost access points.*

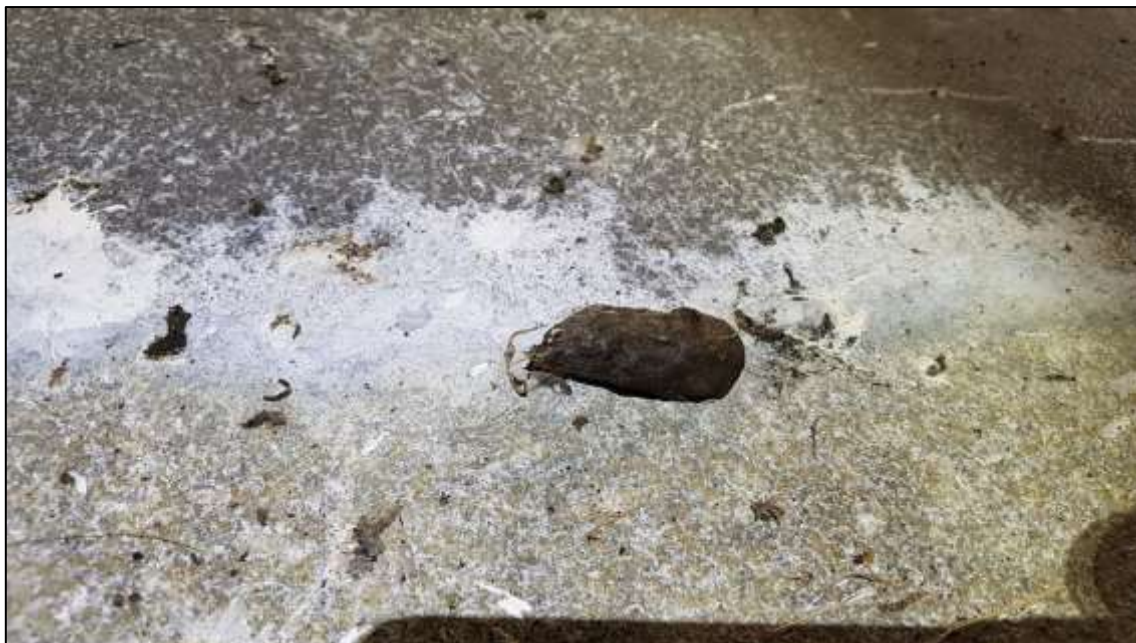
5.2.3 There were no signs of bats (droppings or urine staining) however, there were many signs of owls, with droppings and pellets observed (see Plates 6 and 7). The overall bat roost potential for this site was low.

Plate 9: Owl pellet observed in the barn, providing evidence of owl activity in the site

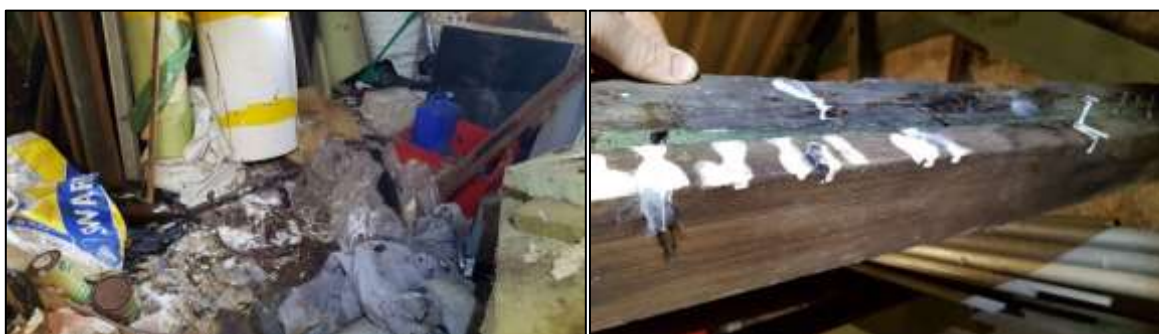
Plate 10: 'White wash' bird droppings and feathers recorded in the main barn, supporting evidence of owl activity.

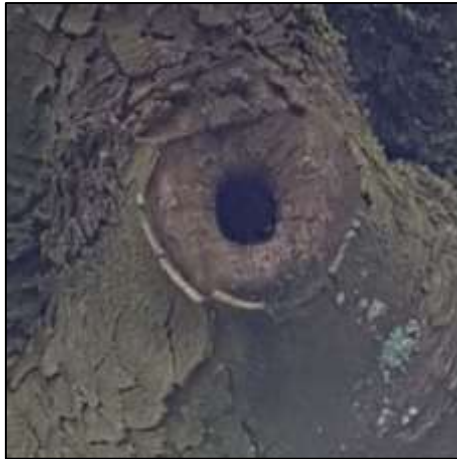
*Plate 11: A semi-mature sycamore tree at the entrance of the site from the road. Knotholes were inspected and found to be shallow and had no roosting potential.*

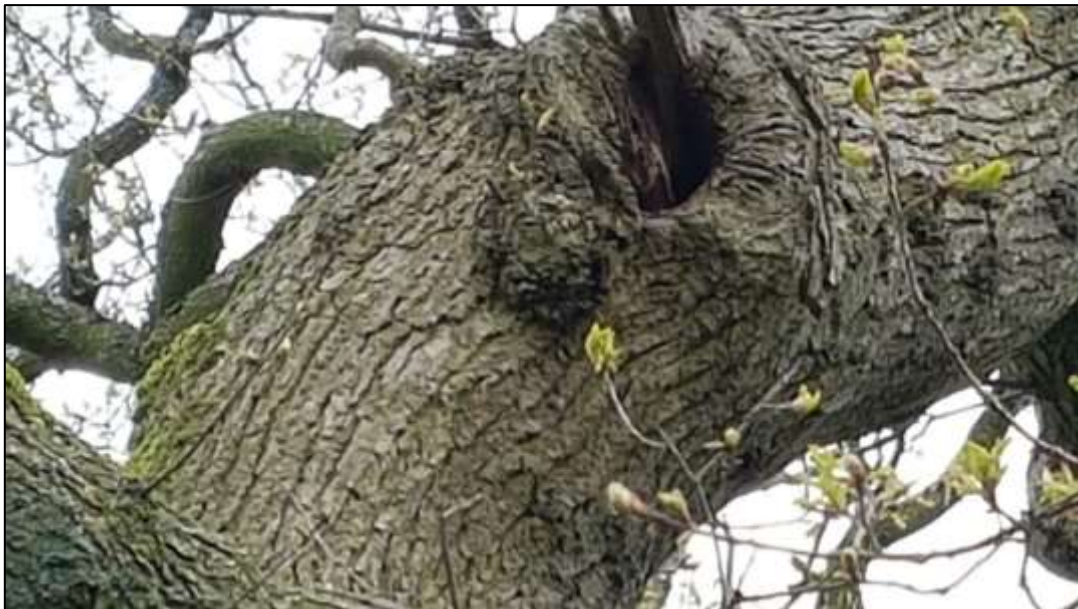
*Plate 12: A mature oak tree on site, with a PRF. but inspection found the hole to be shallow.*

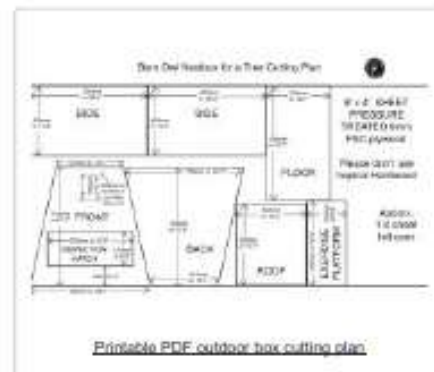
[Printable PDF outdoor box cutting plan](#)

- Our deep nest box design is much safer for owlets due to a 450mm drop from the entrance hole to the floor and a landing tray with a raised edge.
- If you wish to vary from this owl box diagram, please check our [essential criteria for exterior Barn Owl boxes](#).
