**BAT SURVEY AT -
2 THE COTTAGES
MITTON ROAD
WHALLEY**

**DATE AND TIME OF VISIT
1st Nov 2018 3.30pm**

REFERENCE. 1118-1

**LYNNE RUSHWORTH
6 PENDLE VIEW
BARLEY
BURNLEY
LANCS
BB129LA**

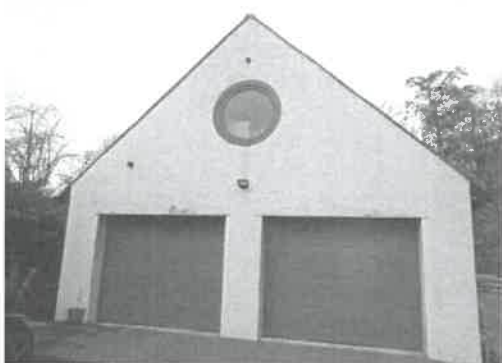
South elevation

Detached garage with a first floor used for storage and the ground floor used as garaging Located in the garden of a semi-detached cottage. The garage appears to be a relatively new construction.

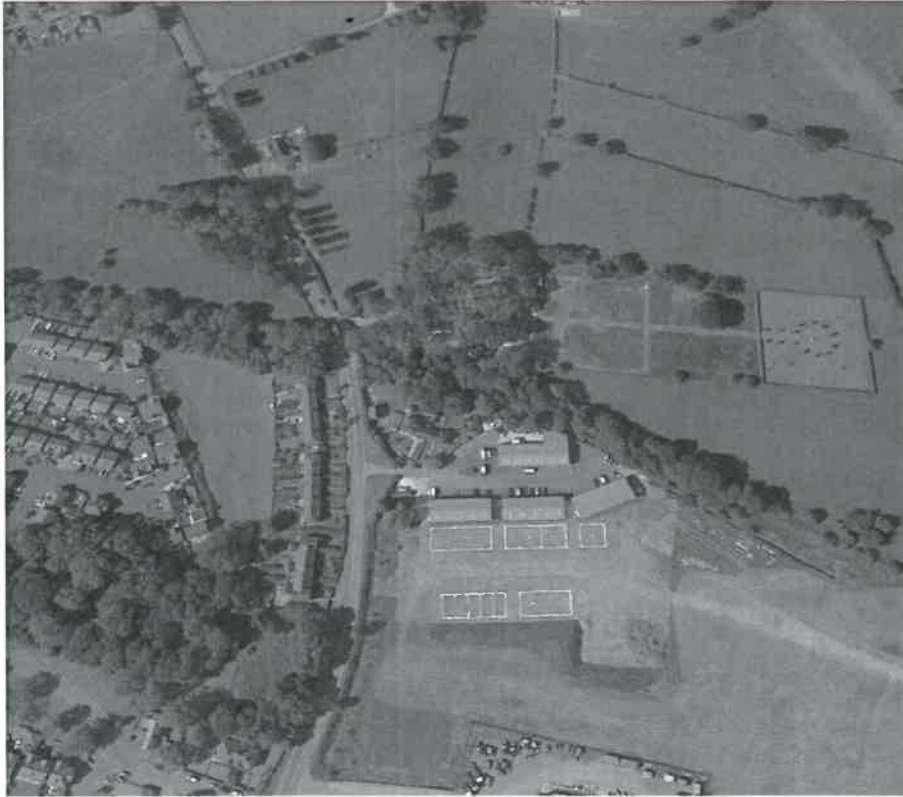
The site is located on the edge of Nethertown a satellite area approx 1.4km to the north west of Whalley town centre .The garage is in the garden of a semi detached cottage with its west elevation immediately adjacent to the boundary fence next to Mitton road.

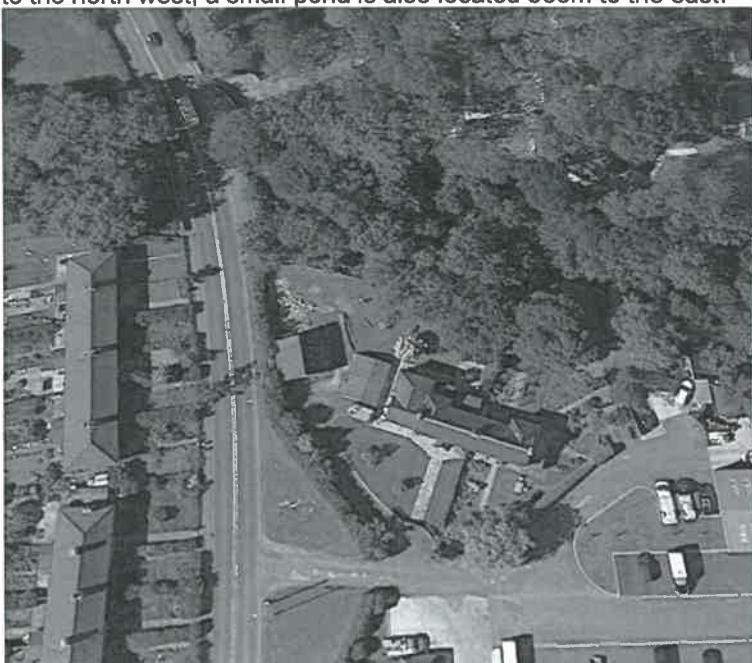
The garage is next to Mitton road adjacent to the garden boundary hedge .To the north is a large area of mature trees which extends to the west and east in a linear form. There is a further significant area of mature trees 600m to the south west within the grounds of the old Calderstones Hospital. The foraging potential in the area is optimal however the nearest water in the form of a brook is 433m to the north west, a small pond is also located 560m to the east.

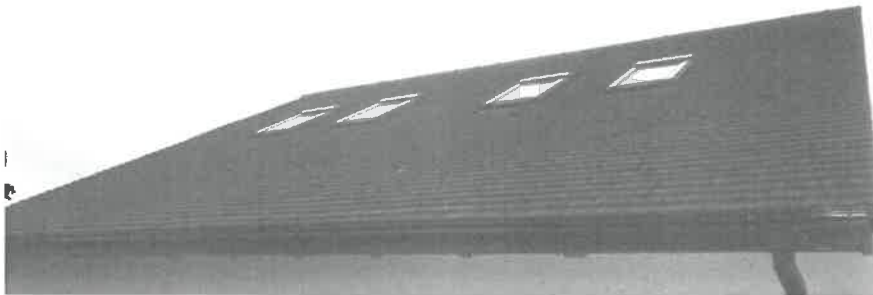
The roof is pitched with 4no roof windows in the east pitch, there is a slight overhang at the eaves with exposed rafter ends and boarded soffits between. Rain water gutters are fixed to timber fascias. The finish is Rosemary tile.

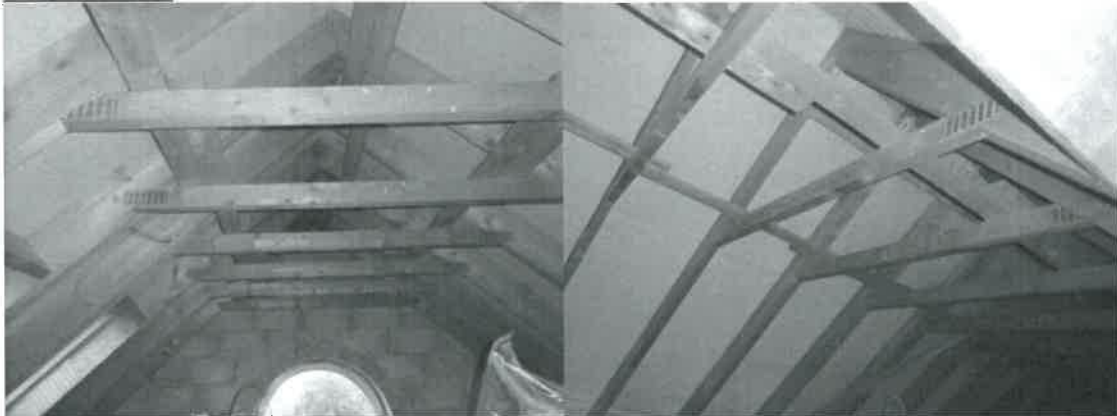
The roof space easily examined from the first floor, the structure is exposed with no roof void. The timber trusses are in excellent condition as is the felt. all the structure was closely inspected no cracks, crevices or gaps were present which could provide bat habitat. The floor was clean and devoid of any dropping or feeding evidence. The space provides a sub optimal roost potential. No bats were present nor were any signs of past use.
