**BAT SURVEY AT -
WISWELL EAVES HOUSE
PENDLETON ROAD
WISWELL**

REFERENCE NO. 5603

Removal of existing conservatory and demolition of the existing garage prior to the construction of a new garage. Convert outbuildings to form additional living accommodation with glazed link to the main house.

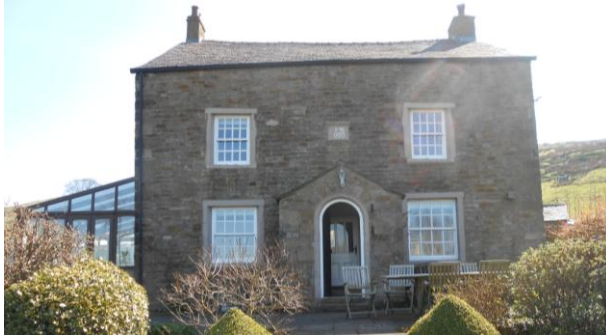
Front elevation of house

The main house is a detached property in the Georgian style dating from 1766. There is a conservatory to the north elevation which is a contemporary addition.

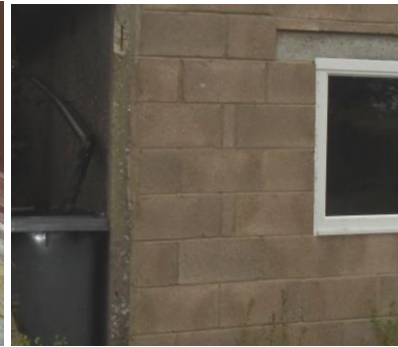
The garage is a precast concrete construction with concrete block gable wall.

Garage - no access points cracks or crevices, very good condition.

The garage does not provide any roost or forage potential for bats, the demolition of the garage will not remove any bat roost or forage potential, and the scale of the proposed replacement will not have a detrimental effect on any bat population. No mitigation required or timing restraints.

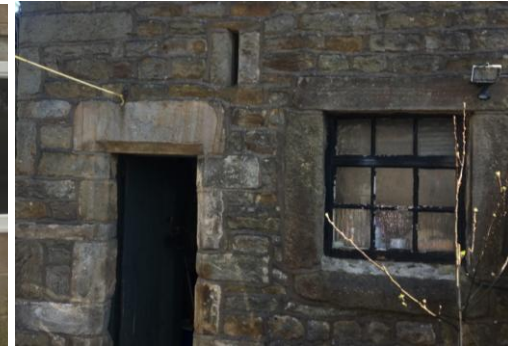
The outbuilding is solid stone.

Outbuilding - Stone walls in good condition as is the pointing with the exception of the north gable at slate verge there are some small gaps in the pointing. The vent holes are blocked so no access to the interior.

The outbuilding although not currently used by bats nor were there any signs to suggest that bats have historically used the building, it does have some external gaps which have the potential for future use. It is recommended that the gaps are re pointed or netted so as to prevent any potential future ingress prior to the commencement of work. If the works on the outbuilding are to commence during the activity period (April - September) an emergence survey should be carried out .

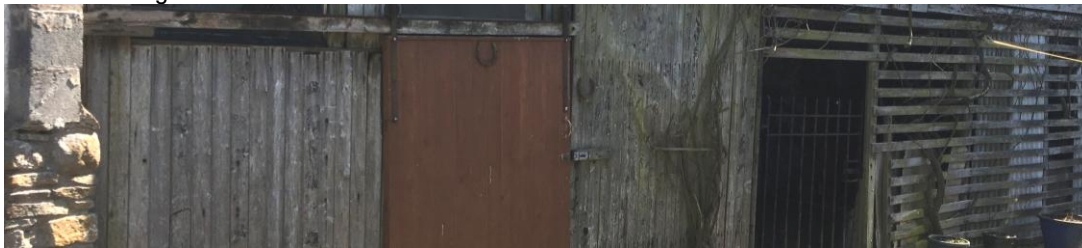
Timber sheds constructed against natural stone back wall. Boarded and slatted timber walls.

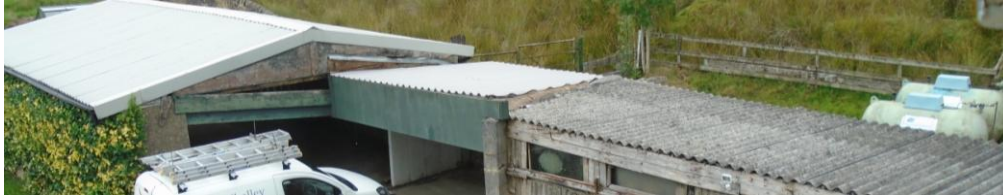
Garage and shed roofs

The garage roof is a slight pitched corrugated steel sheet with verge trims.

The sheds have mono pitch corrugated fibre cement sheets with no rainwater gutter.

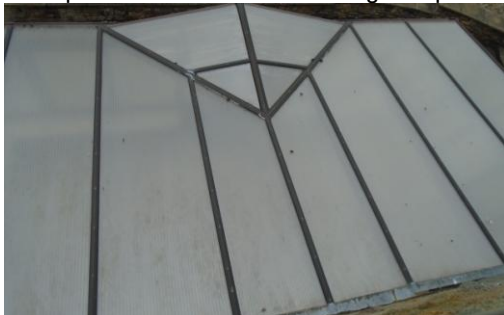
The conservatory roof is plastic sheet lean to with gutter to the front edge.

Conservatory roof has no access points

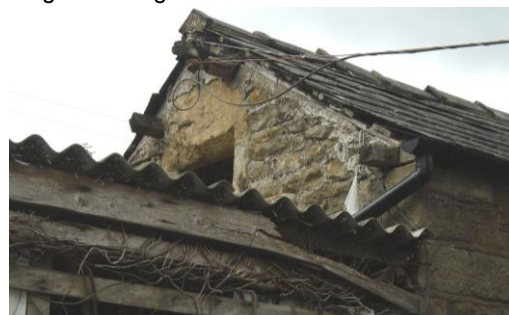
outbuilding gable and part shed roof

Slate pitched roof to the outbuilding with pointed verges to the gables

The outbuilding has external crevices in the north gable at slate abutment which have the potential to be used by bats. There is also a ridge slate which has a gap under.

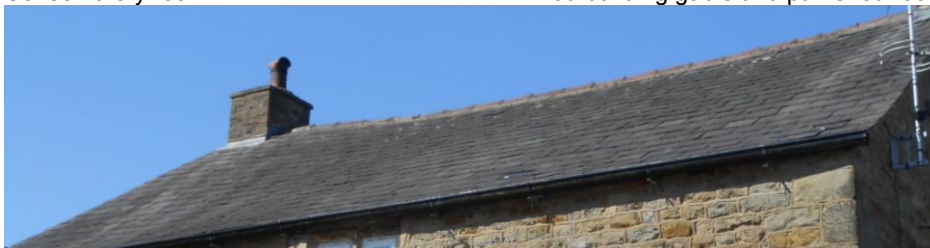
The rear main roof pitch in which it is proposed to insert velux roof windows, is slate pitched with pointed verges, gutters on brackets.

The main roof is in good condition all slates are tight fitting as are the eaves. No access points were found.

The main roof slates do not provide any access points for bats, the installation of the roof windows in the main house roof will not disturb or harm any bat population. No mitigation required or timing restraints.

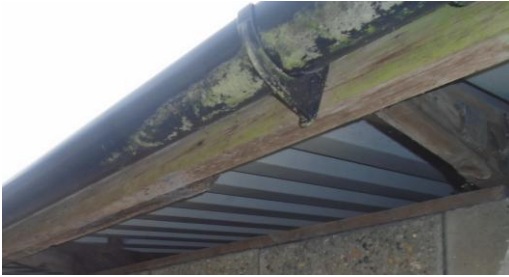
The garage roof is new and in excellent condition and does not provide any access points or crevices, however the abutment of the roof sheets and the walls have small corrugation gaps.

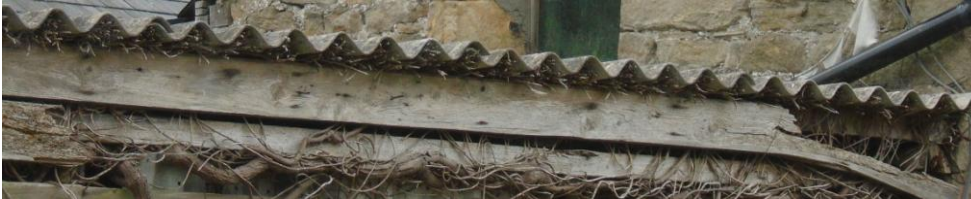
The shed sheet covering is in very good condition and does not provide access points however again the corrugations provide gaps

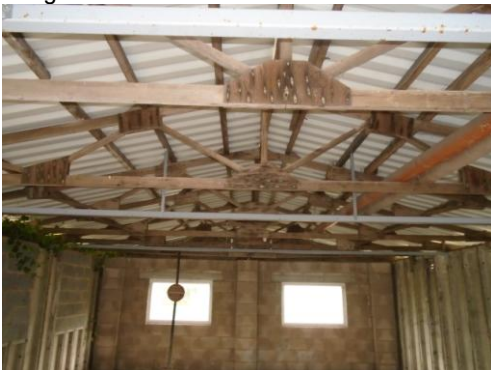
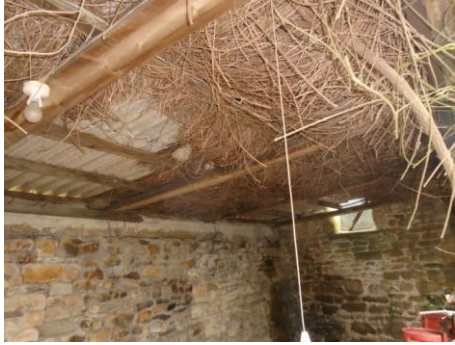
The garage roof structure is a combination of timber and steel trusses with timber purlins. Sheets fixed directly over, no enclosed roof space. All timbers are in good condition. The space does not provide any potential roost or forage habitat for bats.

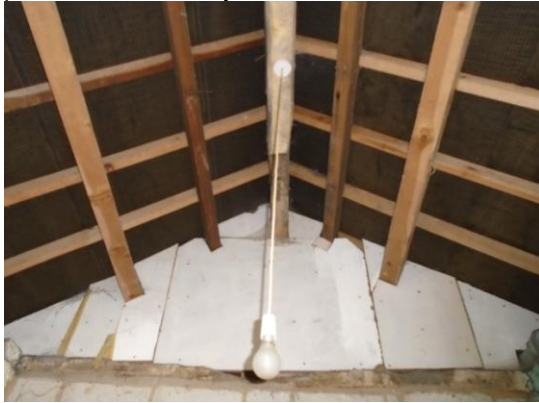
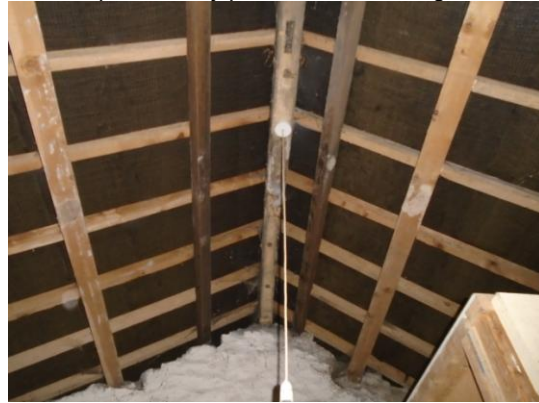
Shed lean to roof is timber purlins and rafters with fibre cement sheets fixed directly over. Timbers and sheets are in good condition with no cracks or crevices however there has been tree ingress and the dead branches remain insitu. All the structure was easily examined no evidence of past or current use by bats was recorded. The roof does not provide any potential for roosting.

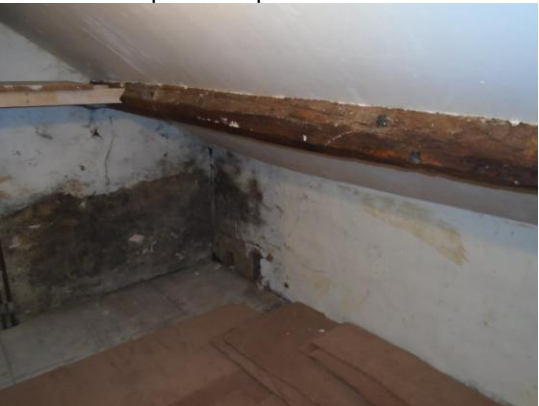
The outbuilding roof appears to have been replaced quite recently all the timbers, rafters and felt are in excellent condition with no cracks or crevices. The south gable wall has some gaps at the abutment of the rafters and wall. The gaps were inspected with the endoscope, no evidence of bat presence past or current was found.
