**BAT SURVEY AT -  
SAGAR FOLD HOUSE  
CLITHEROE**

**DATE AND TIME OF VISIT**  
14<sup>th</sup> Aug 2018 2.15 pm

**REFERENCE NO. 5660**

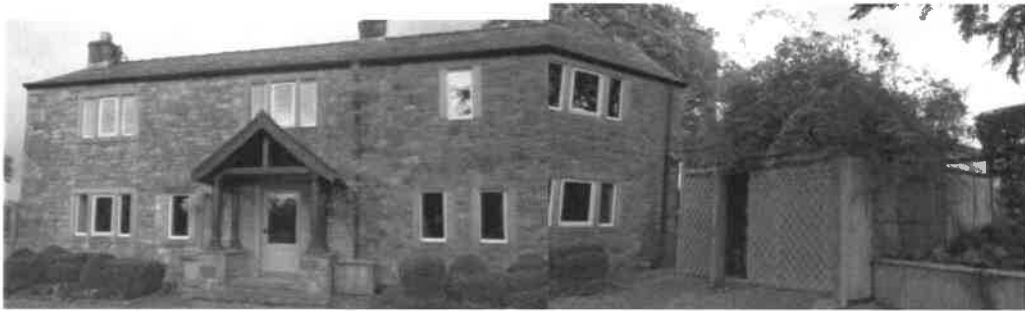
Front west elevation with porch

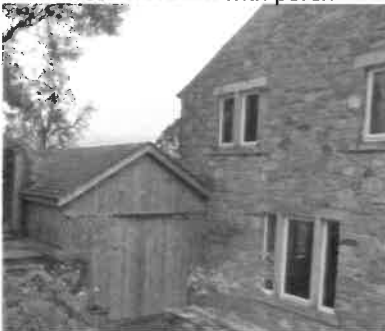
Timber garage north elevation

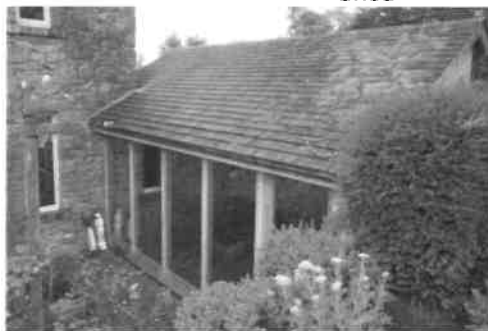
Garage west elevation

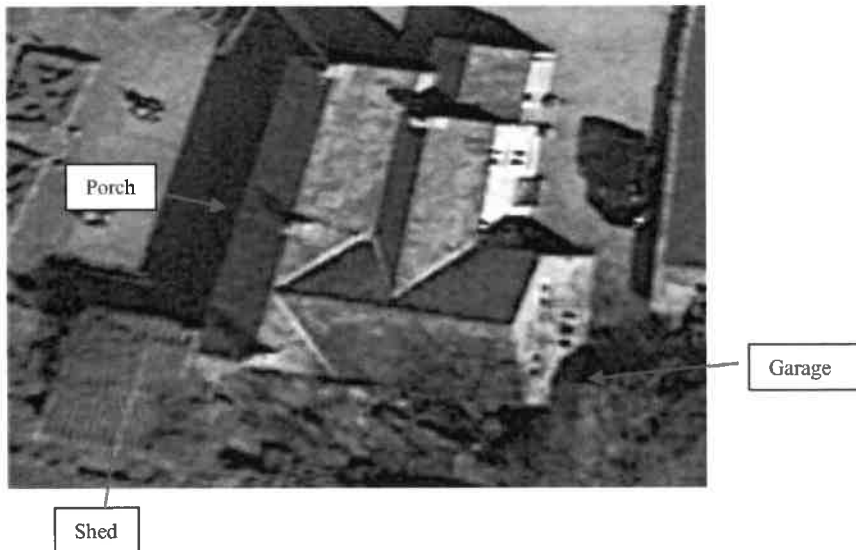
Garage: The garage timber boarding is in excellent condition. There are no areas of rot, the boards are tight fitting. There are no possible cracks or crevices which have the potential to be used by bats.

Garage : The shingles are in good condition and tight fitting. There is no rot however there is excessive moss coverage. The overhangs could be examined closely they are very tight fitting. No possible access points into the structure.

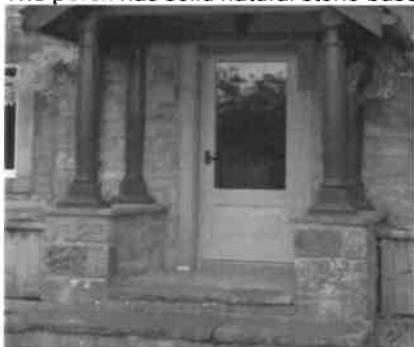
The porch has solid natural stone base walls, with turned timber posts.

Porch: The stone walls are solid and well pointed with no cracks or crevices. The timber posts are also in excellent condition with no rot or cracks. There are no possible cracks or crevices which have the potential to be used by bats.

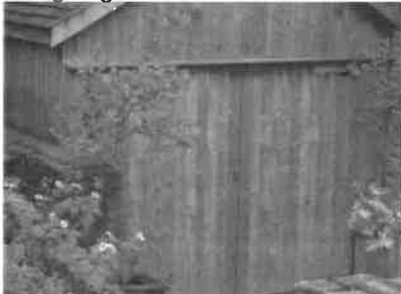
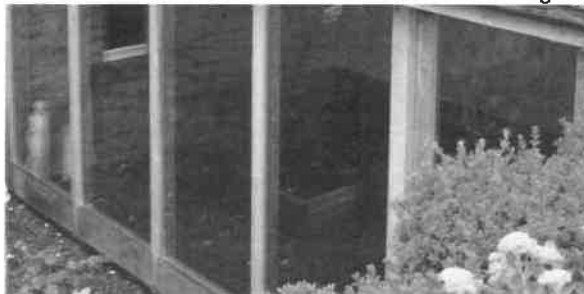
The garage had boarded timber walls to 3 elevations. The west elevation is timber framed glazing.

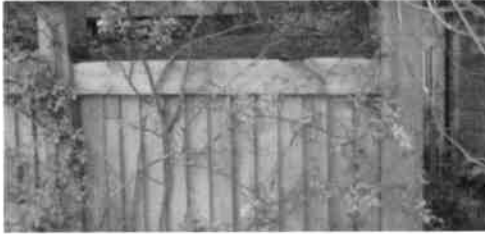
The shed has timber vertical boarded walls.

Shed: The shed timbers are in excellent condition. There are no areas of rot, the boards are tight fitting. There are no possible cracks or crevices which have the potential to be used by bats.

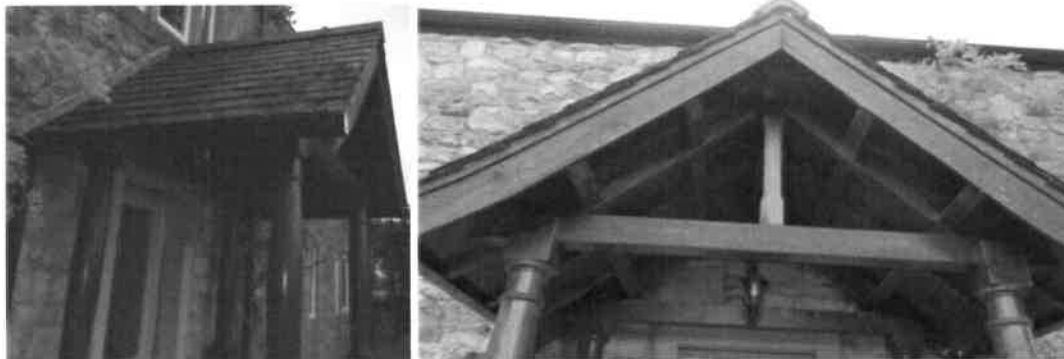
The porch roof is an open pitch with a natural blue slate finish and ridge tiles. The roof is lead flashed to the house wall with a timber barge board to the front gable.

Porch : All the slates and ridge tiles are very tight fitting as is the lead flashing. No possible access points into the structure.

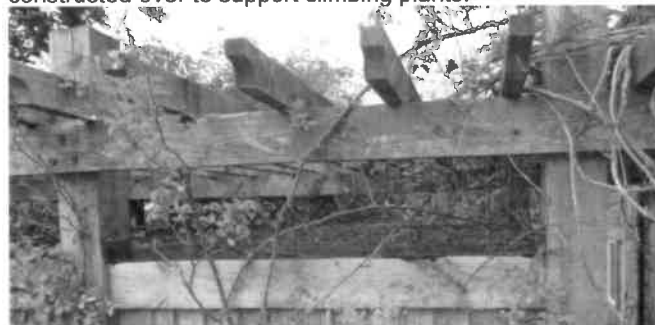
The Shed roof is flat with a Bitumen type finish, approx 300mm above there is a gazebo type structure constructed over to support climbing plants.

Shed: The bitumen looked quite new and was in excellent condition. There is no eaves overhang, close inspection did not reveal any access points.

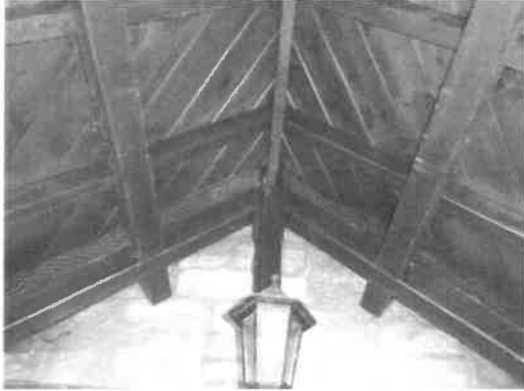
The porch roof is open to the underside, the timber rafters and purlins with boarding over was exposed there was no enclosed roof space. It was possible to closely examine .There were no access points or crevices into which bats could enter. Wire mesh has been used to prevent nesting birds.

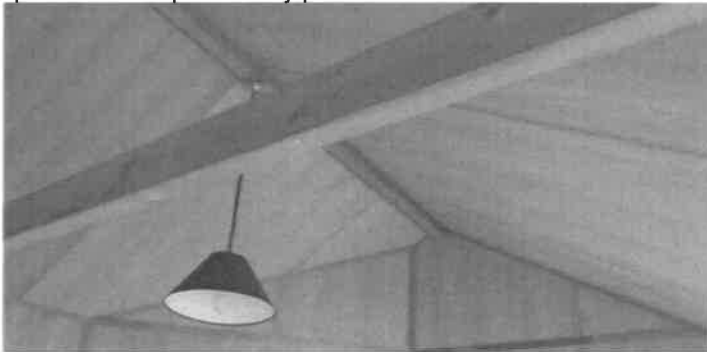
The garage roof does not have an enclosed roof space the rafters are lined to the underside with ply with only a truss tie member visible. The structure appears to be quite new. All the joints in the ply are tightly sealed, the space does not provide any potential bat habitat.
