**BAT SURVEY AT -  
36 CHESTERBROOK  
RIBCHESTER**

DATE AND TIME OF VISIT  
27<sup>th</sup> June 2018 4.00pm

The property is a semi detached house possibly dating from 1950's. It is currently empty and undergoing internal renovations.

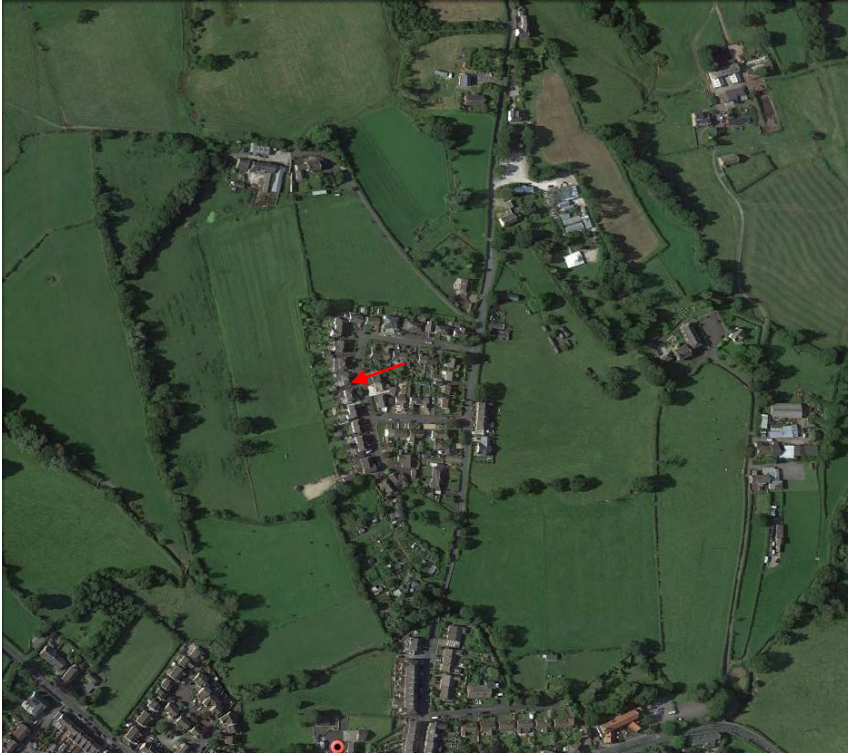
The bungalow is located on a housing estate surrounded by properties of a similar type and age. The estate is slightly remote from the main settlement area of Ribchester accessed via Stoneygate lane. Pastureland surrounds the estate.

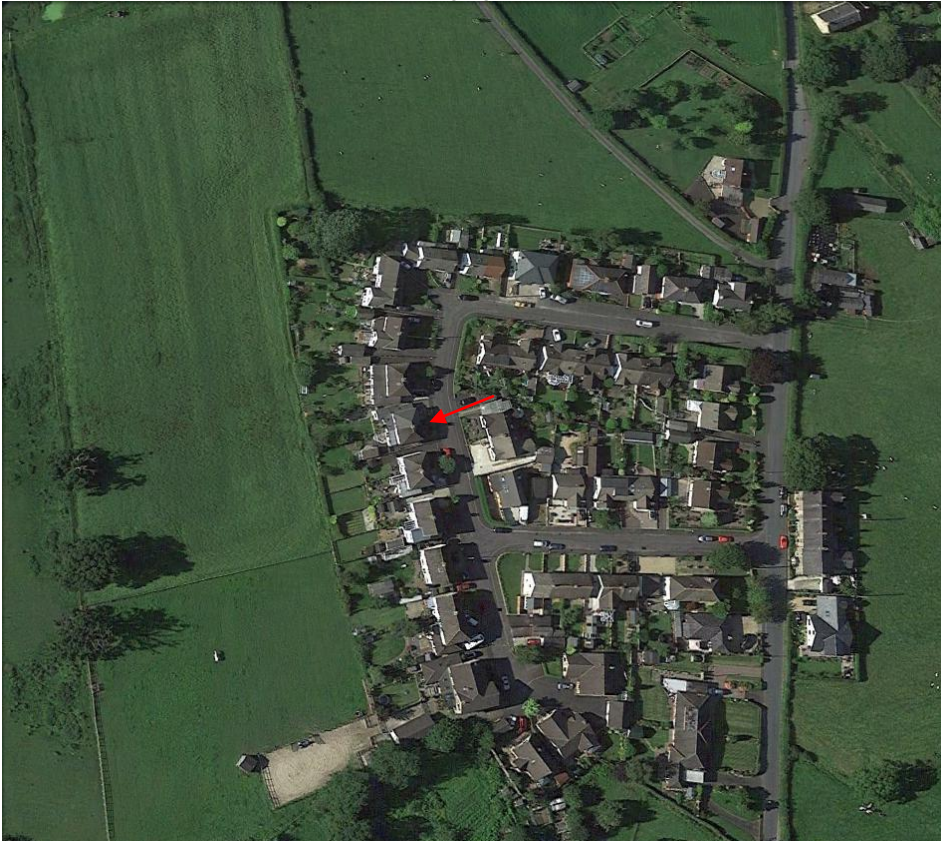
There is mainly domestic planting with occasional broad leaf trees in the immediate gardens. The rear boundary of the garden adjacent to the field is fenced, a hedge/trees 100m to the west form the boundary to the field. There are no significant wooded areas in the immediate locality and no water courses or areas of standing water within 200m of the site.

This site provides low / medium value foraging potential for bats.

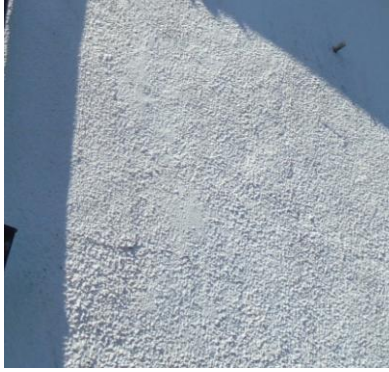
The walls are white painted render, with a brick plinth.

The walls are in perfect condition with no access points.

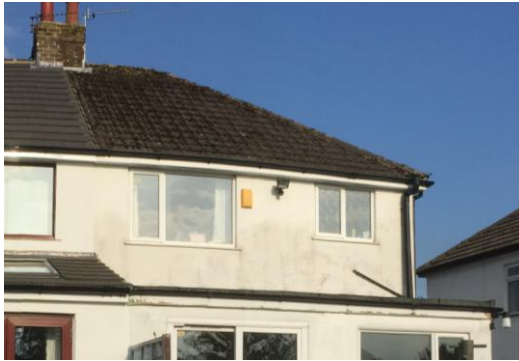
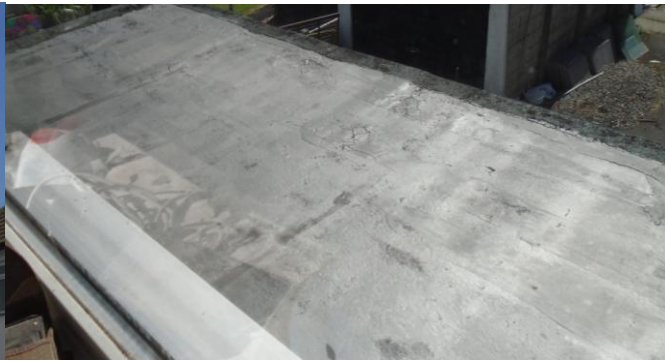
Flat roof finish

The roof is a hipped construction with a tile finish, the eaves overhang has upvc fascias and soffits. The flat roof is felt with flush timber fascias.

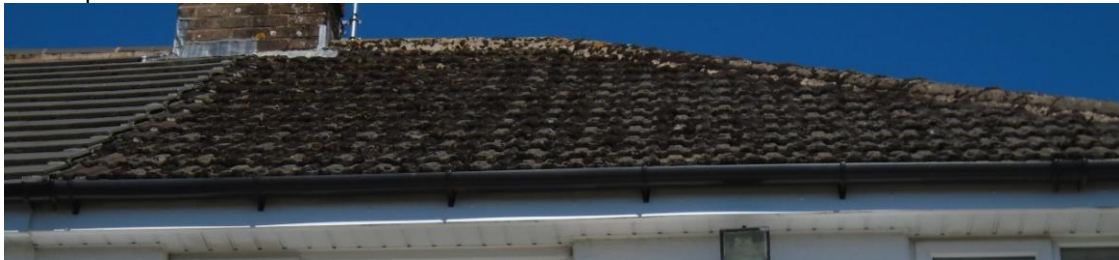
Upvc soffits

The roof appeared in reasonable condition, no broken, slipped or missing tiles. There is extensive moss coverage on the roof there did not appear to be any gaps between. The lead flashing to the chimney appeared to be in good condition and tight fitting. The upvc eaves soffits are very tight fitting. This roof did not provide any access points.

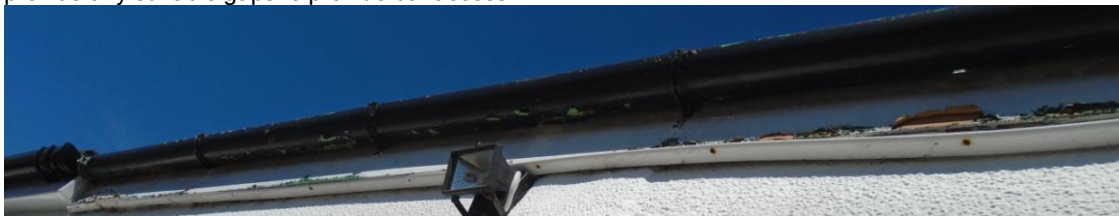
Flat roof fascias

The flat roof covering was in good condition as viewed from above, the fascias are flush fitting and did not provide any suitable gaps to provide bat access.

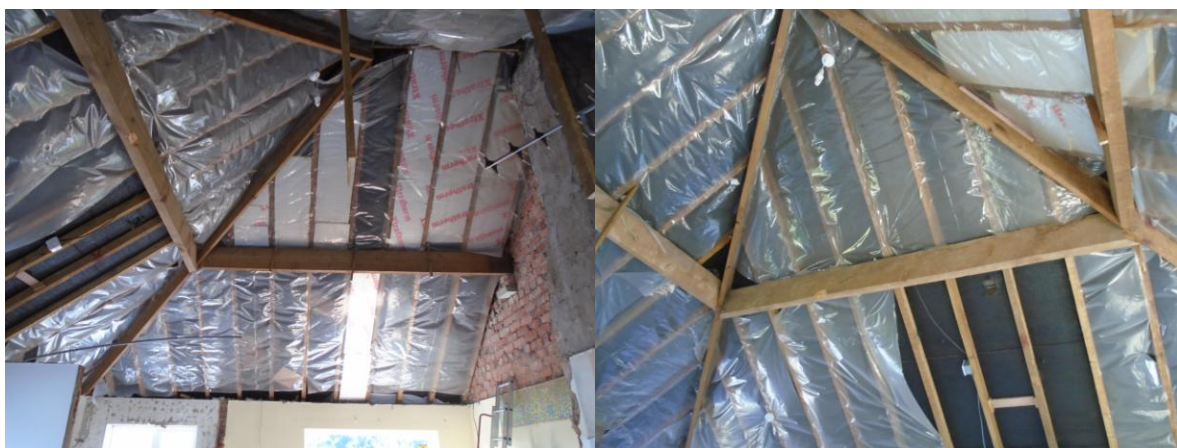
As renovation has commenced at this property the ceilings have been removed hence there is no enclosed roof void. All the structure is visible from the first floor, the timbers were in good condition as was the underlay.
