**BAT SURVEY AT -
THE MANOR HOUSE
BRIDGE ROAD,
CHATBURN, BB7 4AW**

DATE AND TIME OF VISIT
10th Oct 2018 3.30pm

REFERENCE. Mr Harrison

LYNNE RUSHWORTH
6 PENDLE VIEW
BARLEY
BURNLEY
LANCS
BB129LA

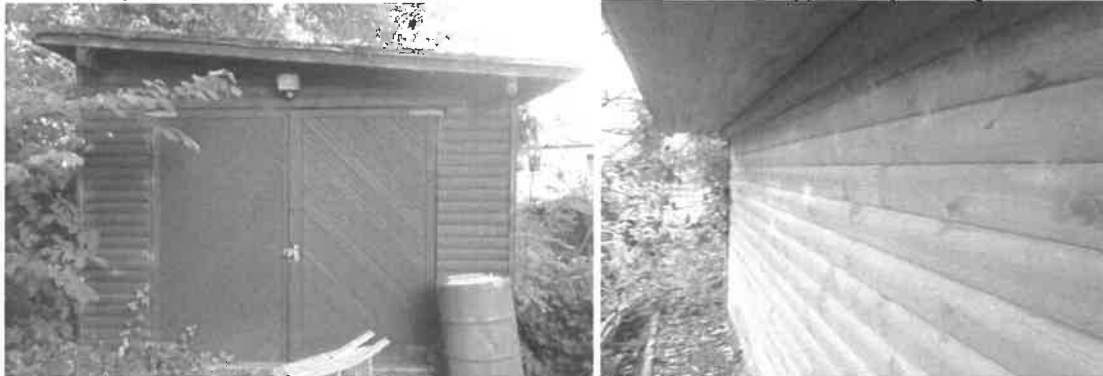
The building is a store shed for the adjacent care home. It was constructed approx 15 years ago.

Front elevation (south east)

(north east) side elevation

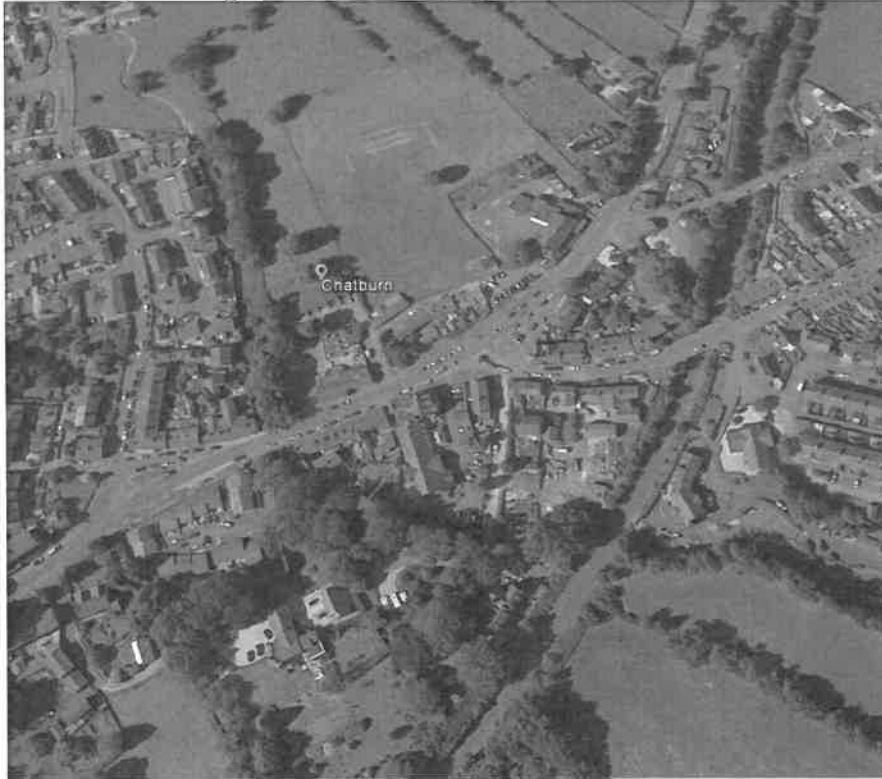
The shed is located in the garden of Manor House Care home in the centre of Chatburn village.

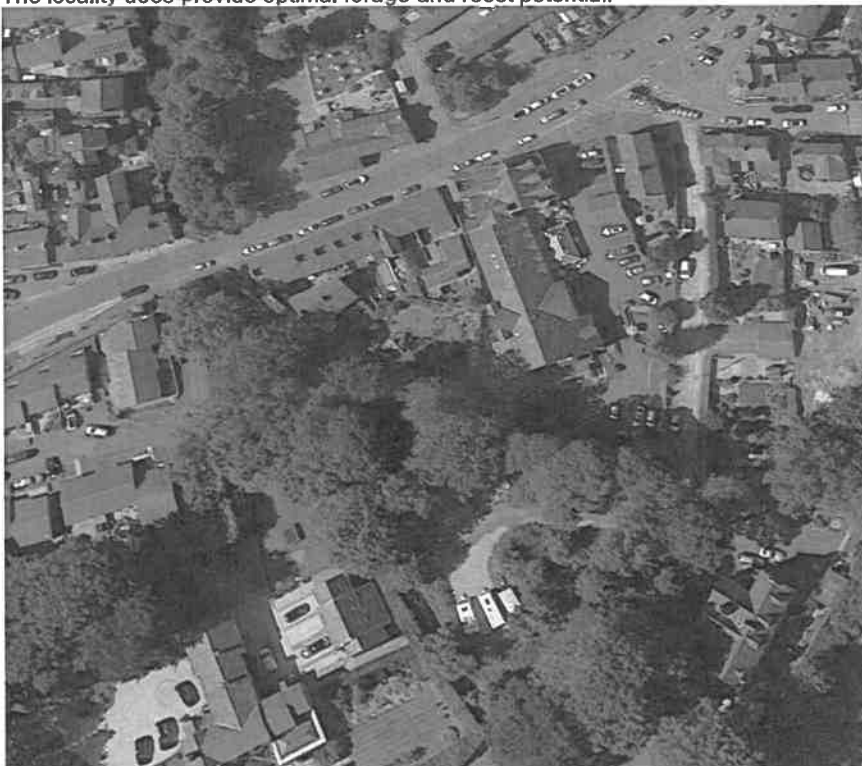
The shed is located in the garden of the Manor house surrounded by mature broad leaf trees and is directly on the south bank of Heys brook which runs through the garden. The trees extend towards the railway line in a south easterly direction and connect to hedge /tree field boundaries to the south. The main road through the village is 50m to the north however the shed is in an extremely secluded position. The locality does provide optimal forage and roost potential.

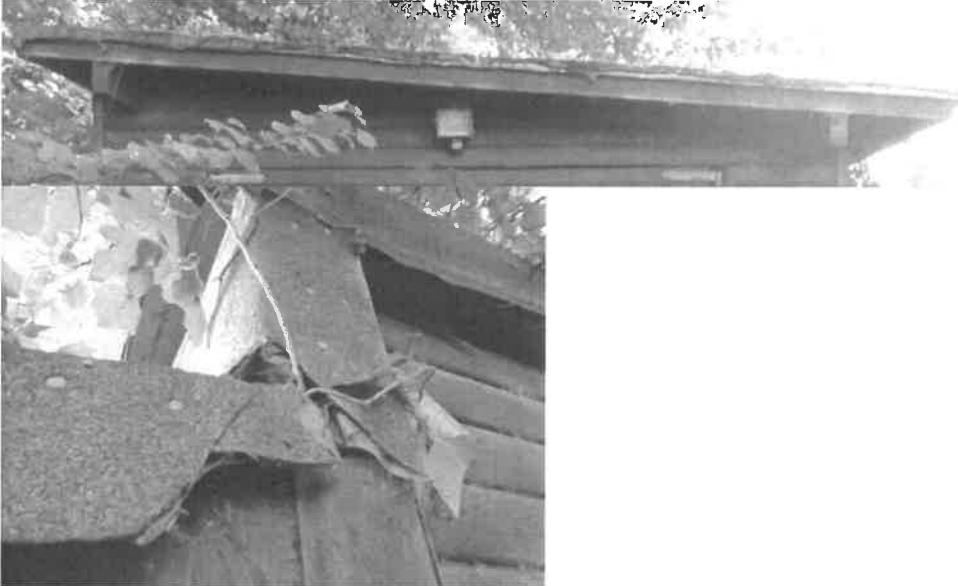
The roof has a mono pitch with a large overhang at the eaves. The roof is covered with mineral felt however due to the proximity of the trees it is entirely covered with moss and weed growth.

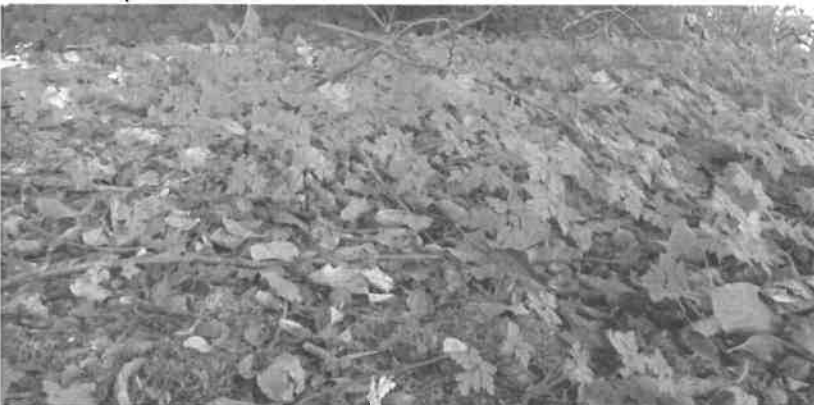
The roof steps down towards the rear of the shed.

The felt roof has the appearance of a green roof.

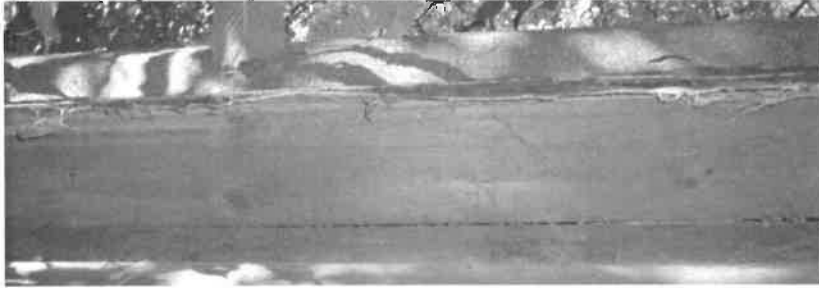
The overhang has a single board soffit, the felt is lapped over the edges.

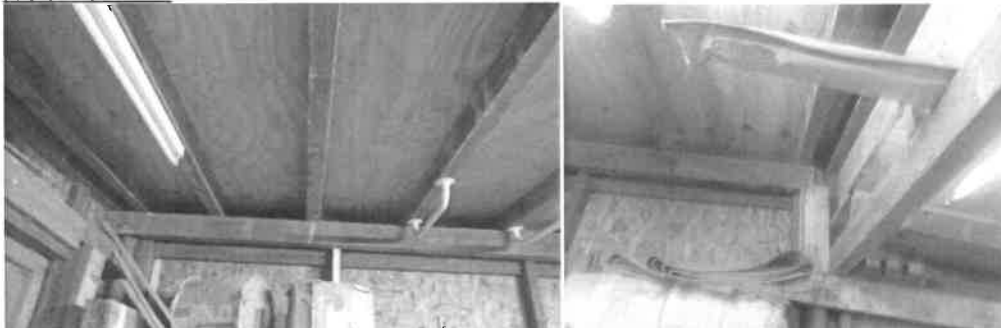
ROOF SPACE

There is no enclosed roof space, all the timber structure is visible. The joists and osb / ply is all in good condition with no rot or crevices suitable as bat roosts.

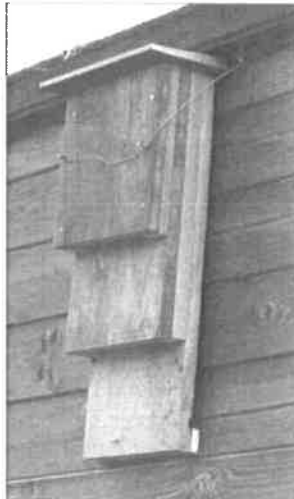
The Kent bat box

Simple to construct, self-cleaning and low maintenance.

The only critical measurement is the width of the crevices—these should be no larger than suggested. Other measurements are approximate.

Box to be made from untreated rough-sawn timbers
 Timber should be c.20mm thick
 The box should be rainproof and draught-free
 Crevices can be between 15 and 25 mm wide
 Fixing may be by use of brackets, durable bands or wires

However as the building is located in an optimal location it is suggested that the roost potential be enhanced with the addition of a couple of external wall mounted Kent bat boxes. See below.
