Preliminary Geo-Environmental Risk Assessment

Clitheroe Road, Whalley

Presented to Trafford Housing Trust

Delta-Simons Project No. 18-0886.01

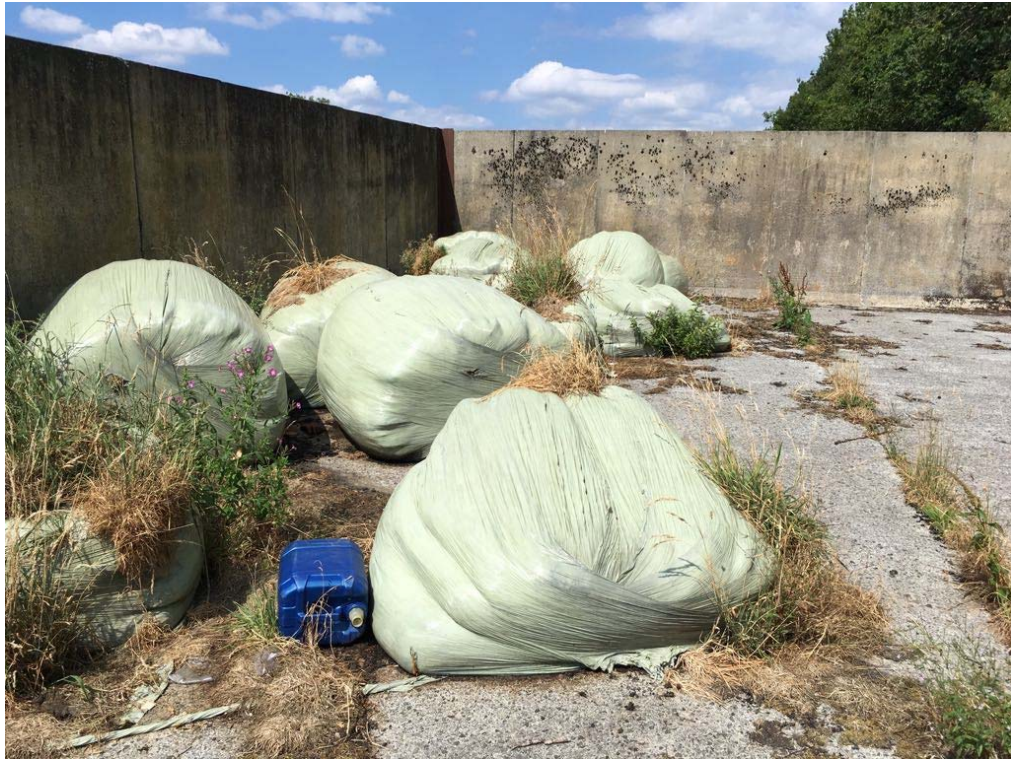
Photograph 1: Silage/Haylage Bales

<ul style="list-style-type: none"> ▲ In the northeast of the Site there is a small area of concrete hardstanding formerly used to store silage/haylage. A few disregarded silage/haylage bales were still present (Photo 1); ▲ At the time of the walkover a portion of the Site was occupied by a construction compound in operation by Urban Regen who were constructing attenuation basins for surface water run-off from the adjacent Redrow development and the Site (Photo 2); ▲ The Site can be accessed from the A671 or via a track off Brooke's Lane; ▲ The gravel access track from Brooke's Lane is lined with dense vegetation and mature trees (Photo 3); ▲ A below ground aqueduct (the Haweswater aqueduct) cuts through the central part of the Site and manhole covers and access points (manholes) are visible at the ground surface along the Site's eastern boundary; ▲ Adjacent to the aqueduct is a maintenance building owned by United Utilities and a telecoms mast (Photo 4); and ▲ Topographically the south of the Site is relatively level; however, to the north of the aqueduct the land rises to the north and east.

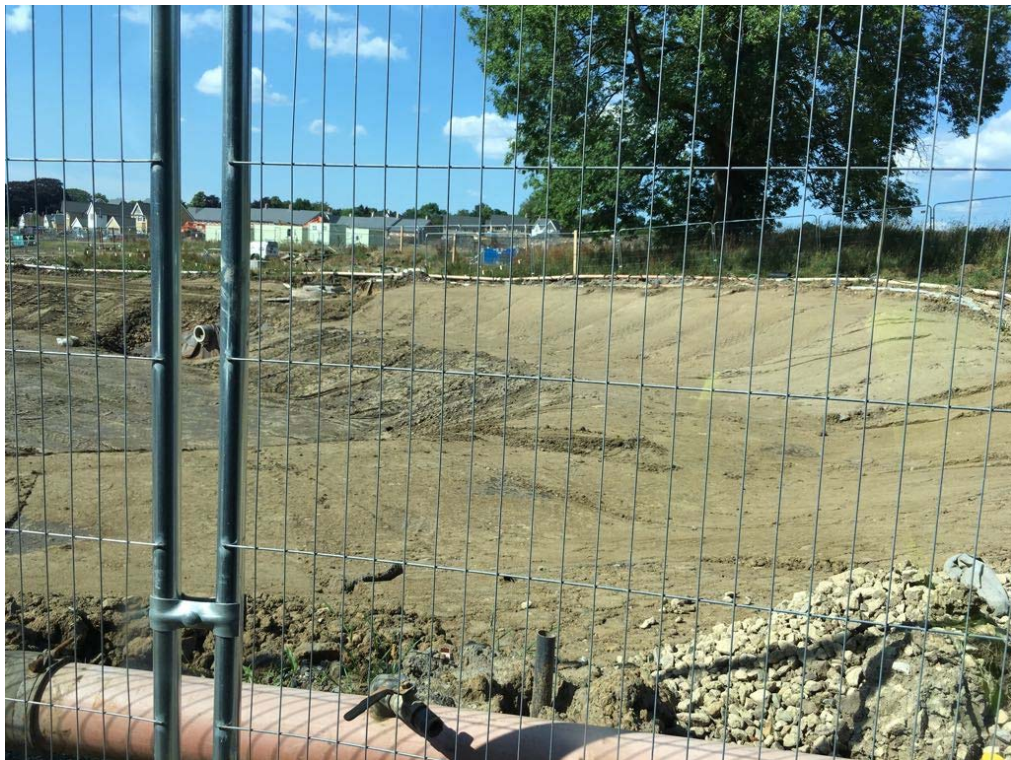
Photograph 2: Attenuation pond being constructed
