**BAT SURVEY AT -
ABBAY BARN
NETHERTOWN CLOSE
WHALLEY**

**DATE AND TIME OF VISIT
1st Nov 2018 4.00pm**

Rear extension and widening an existing link on a detached single storey barn conversion.

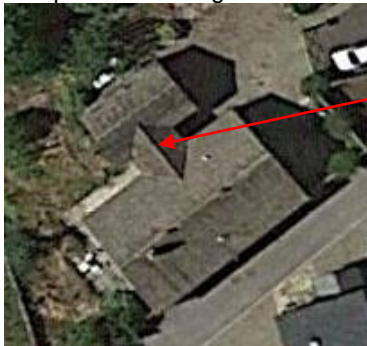
Location of extension

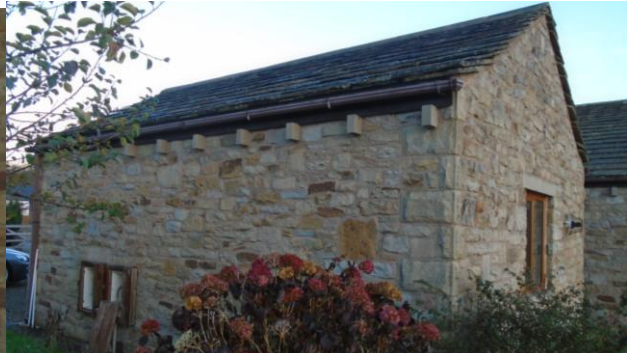
north west elevation

Gable to be extended

Link

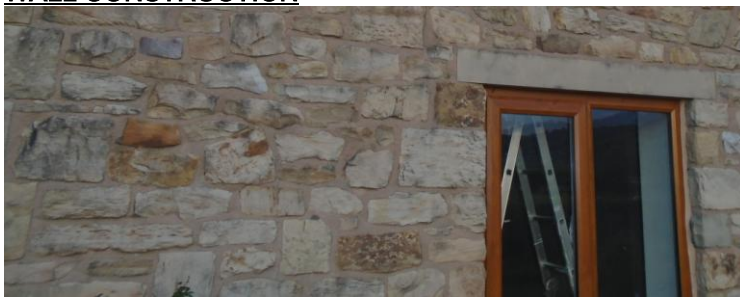
WALL CONSTRUCTION

The walls are random stone with block backing and flush pointing.

The walls and pointing are in excellent condition with no access points to the interior or cracks and crevices with the potential for use by bats.

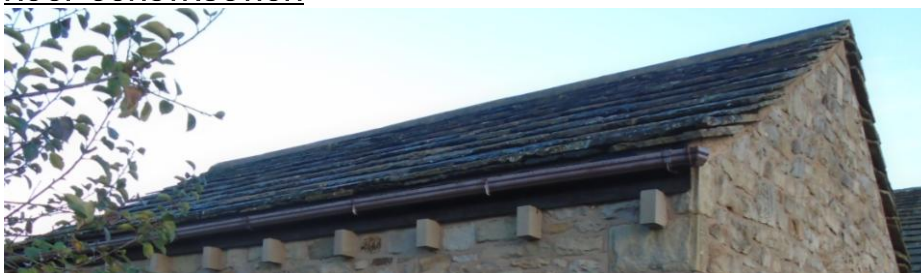
ROOF CONSTRUCTION

The roofs are pitched with a grey slate finish and timber fascia boards. Lead valley gutters to the link roof abutment.

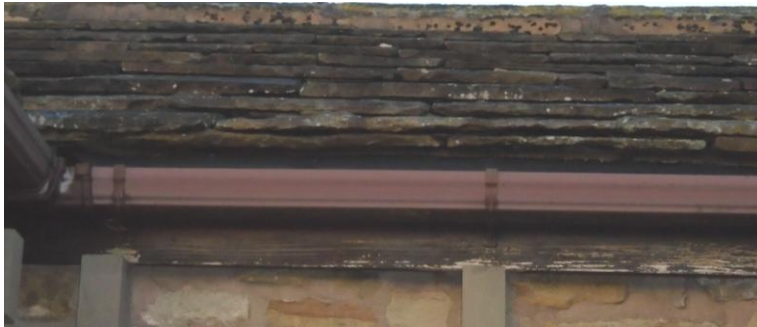
BAT ACCESS POINTS IN ROOF

The gray slate is in good condition with no slipped or missing slates, the slates are relatively tight fitting and does not provide any gaps suitable for bat usage. The ridge slate pointing is in excellent condition as are the lead valley gutters. The timber fascias project slightly from the wall forming a small gap behind but it was possible to examine closely, it did not provide access to the roof space and with the use of an endoscope it can be confirmed that bats do not use the void as roost habitat.

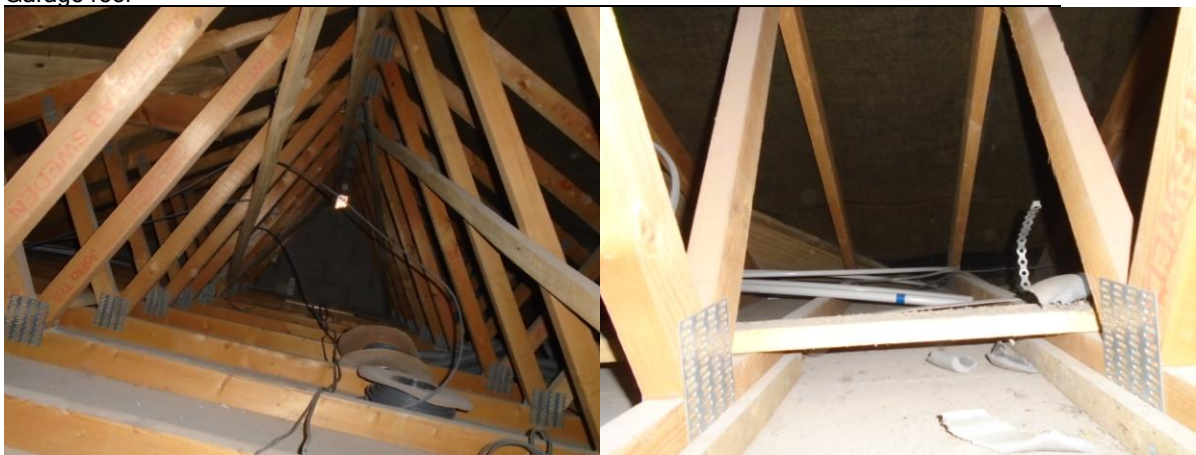
Garage roof

The main roof and the garage roof were both accessible and the link was visible from the main roof void. The structure in the garage was timber trusses with felt all in perfect condition, all the surfaces were clean and devoid of any insect remain or dropping evidence. The spaces were not accessible and did not provide high value roost potential.

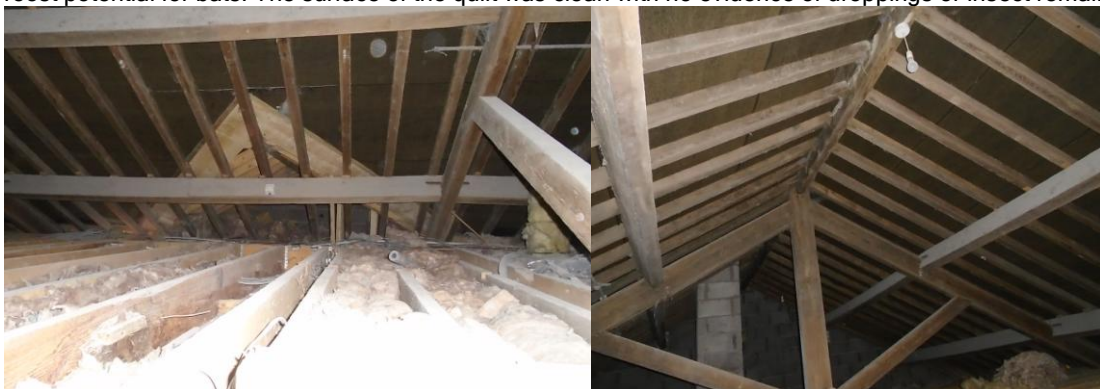
The main roof was timber trussed with rafters, purlins and felt. Insulation quilt is laid between the ceiling joists. The timbers were in reasonable condition and did not provide any crevices or cracks which would provide any roost potential for bats. The surface of the quilt was clean with no evidence of droppings or insect remains.

Main roof void looking towards the link.
