320181042P

**BAT SURVEY AT -  
TALBOT BRIDGE COTTAGE  
BASHALL EAVES  
CLITHEROE**

DATE AND TIME OF VISIT  
3rd Dec 2018 3.30pm  
11<sup>th</sup> Dec 2018 3.00pm

REFERENCE. Mr and Mrs Jackson

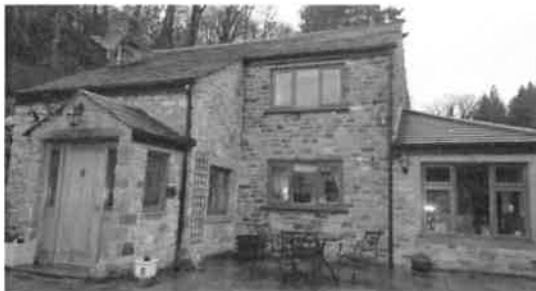
Front elevation

The stone work and render on the house is in excellent condition with no cracks crevices or access points.

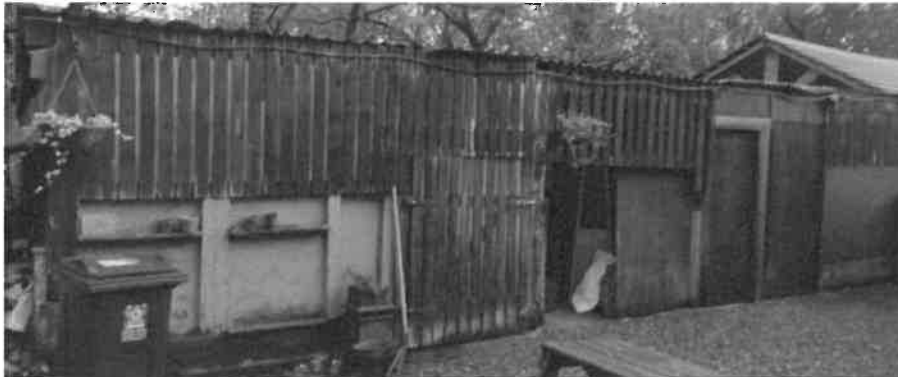
West elevation shed

The shed is a detached ad hoc construction which is currently used as a workshop and store it is located to the east side of the cottage.

The shed roof was inspected from the interior and whilst the sheets were in excellent condition and did not provide access points, at the abutment with the walls the corrugation formed gaps through which bats could potentially enter.

The shed roof is steel sheet fixed to timber pulins which appear to be relatively new and in good condition. There are no possible

The shed does not provide high value habitat for bats and there is no indication of any historic or current presence, however as mentioned before future use cannot be completely discounted and for this reason it is recommended that the shed be removed during the winter inactivity period Oct - April before bats become active and start summer / maternity roosts.

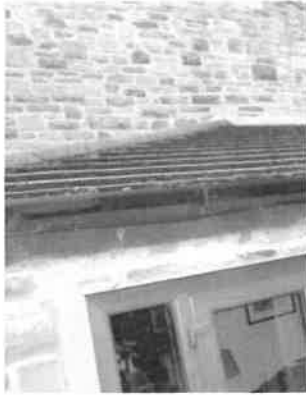
House walls are natural coursed random stone with flush pointing, assuming the original house is solid and the extension is a cavity construction.

Gable and extension walls and

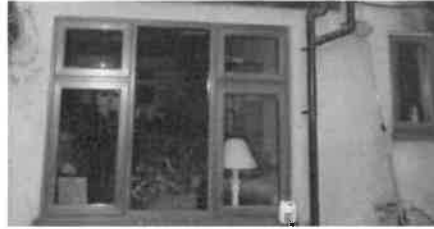
The rear elevation has a smooth render finish.

rear wall being affected by the extension

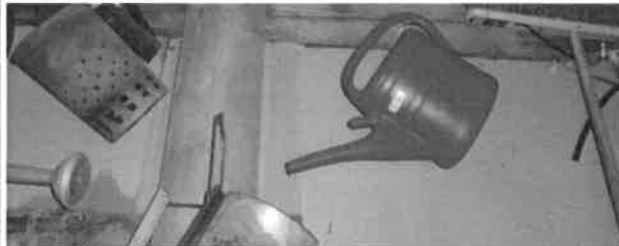
The timber shed appears to have originally been constructed in Yorkshire boarding and has been extended over the years. A recent addition appears to be the internal lining with ply.

Internal lining

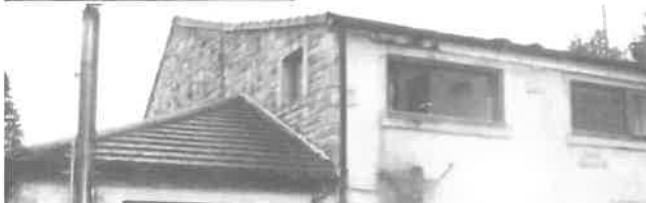
The extension roof is hipped with a tile finish and lead flashed into the house gable wall. The timber fascia is flush to the wall.

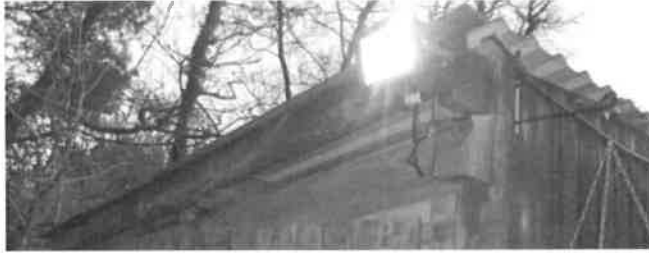
The shed roof is mono pitched and is not the original structure . It is corrugated steel sheet with a slight overhang to the front and rear.

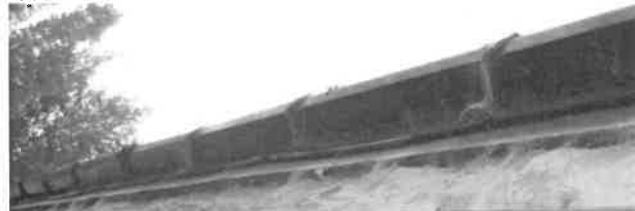
The fascias are tight fitting and have significant cobweb coverage. No access points or any crevices were recorded .

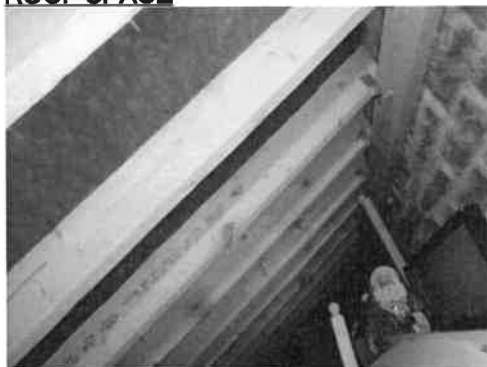
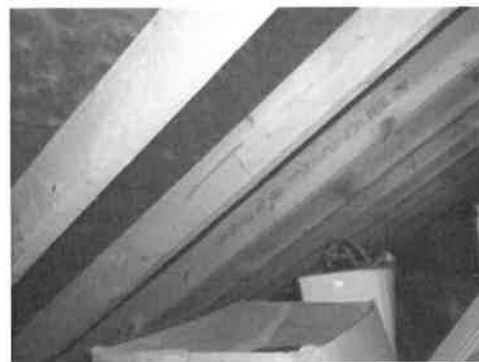
The extension roof was accessible via a ceiling hatch, the space is used for storage it was clean and dry. All the surfaces were examined for any droppings or feeding evidence, the result was negative. The timbers and felt were in perfect condition with no cracks or crevices. , the space did not provide a high value roost potential.

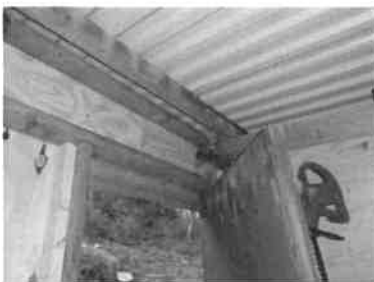
The interior of the shed is damp and draughty, all walls and floors were examined closely. They were clean and free from any evidence listed above. The space does not provide any potential for hibernation however although there was no evidence of past or current use, it cannot be discounted from possible future use by transient opportune bats during the activity period.
