**ENVIRONMENTAL SCREENING FOR:**

**LAND AT THE SOUTH SIDE OF RIDDINGS LANE  
WHALLEY  
BB7 9SF**

**THE BROCKHALL PROPERTIES SYNDICATE SIPP**

**REPORT DATE: 1 NOVEMBER 2018**

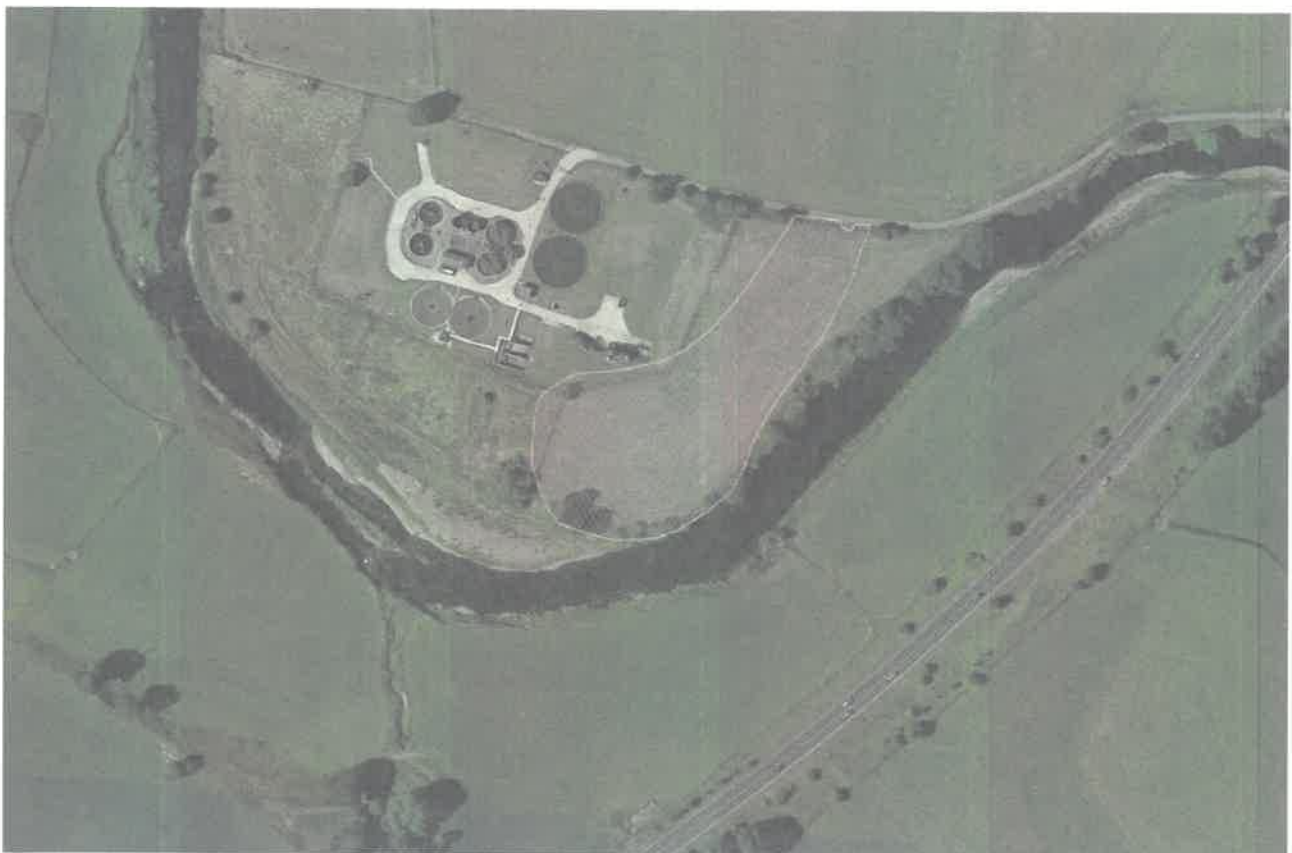
- 6.6 The aerial extent of the landfill according to the Environment Agency is as follows:-

- 6.7 This historic landfill ceased operation on 31<sup>st</sup> December 1973. It is known as the “Whalley Sewage Works” site and has the waste reference EAHLD07127. The organisation that deposited the waste is not known. It contained the following waste classifications:

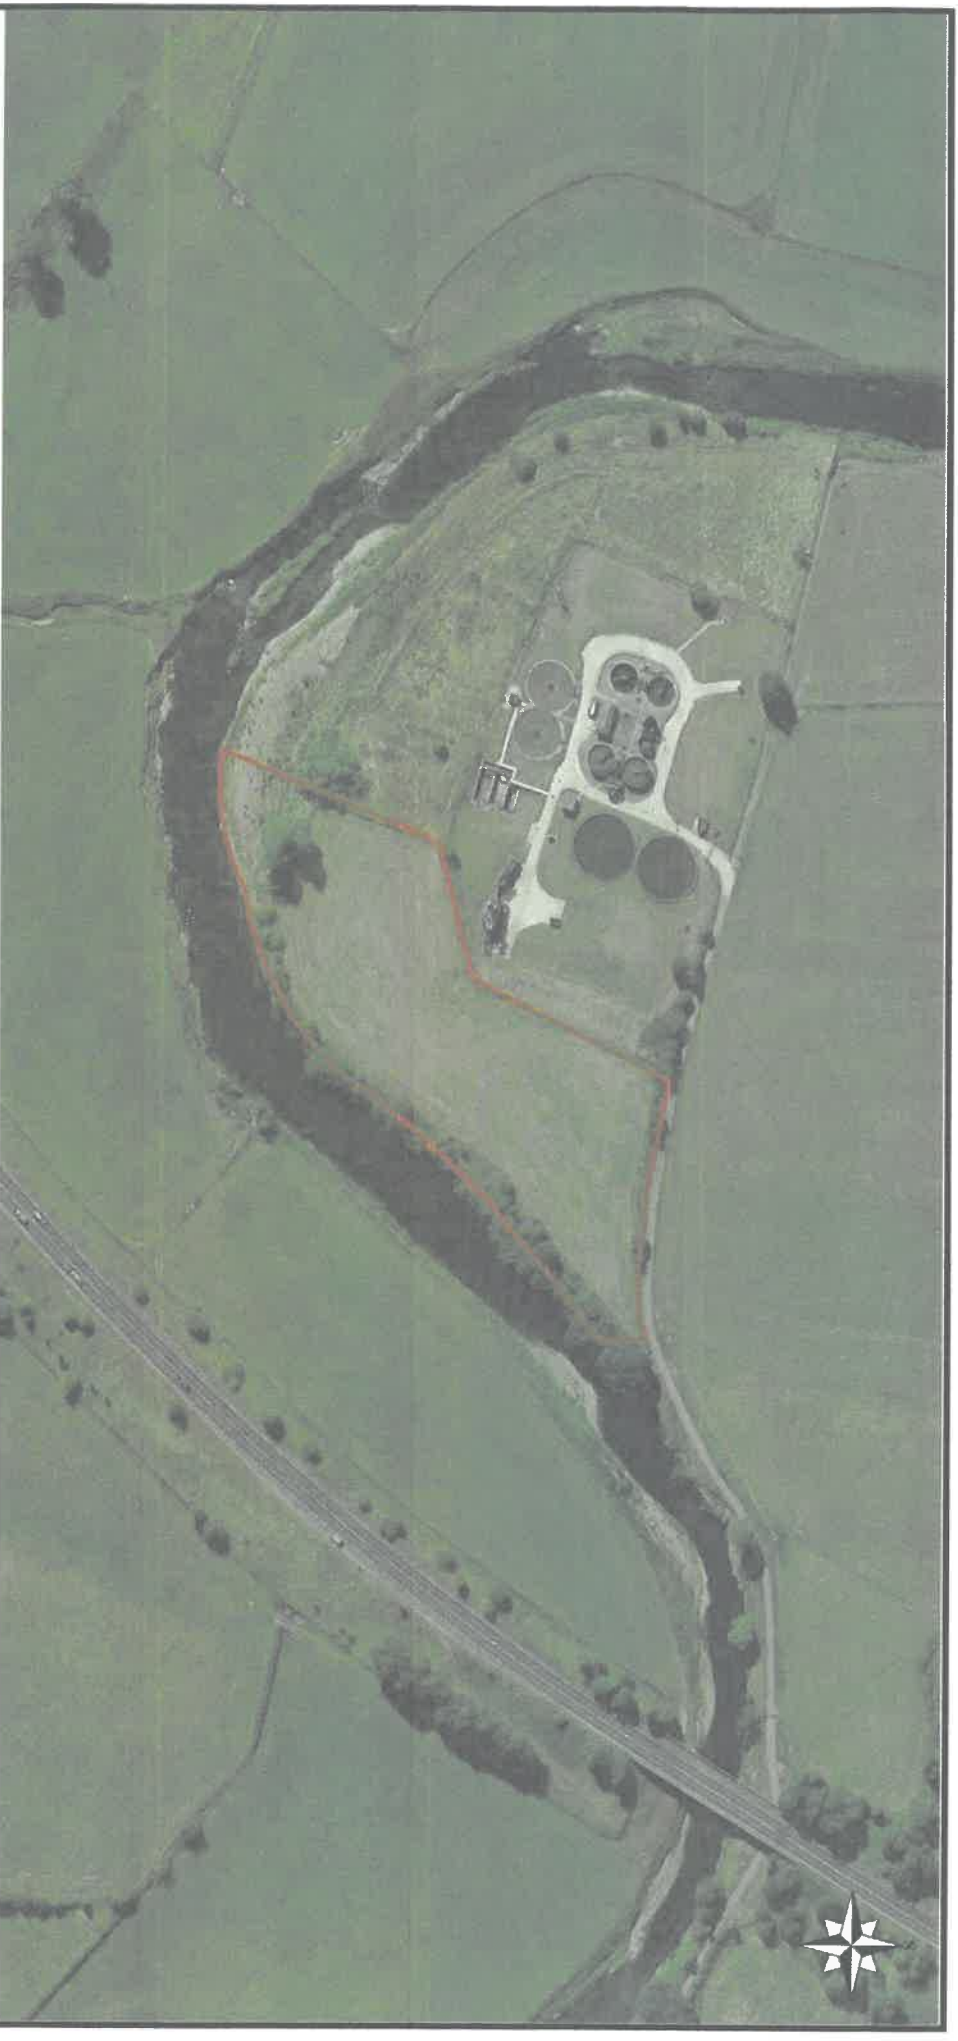
| <b>Date:</b> | <b>01 November 2018</b> | <b>Drawing:</b> | <b>12</b> |

- 2.17 There are no material changes from the preceding aerial extract.

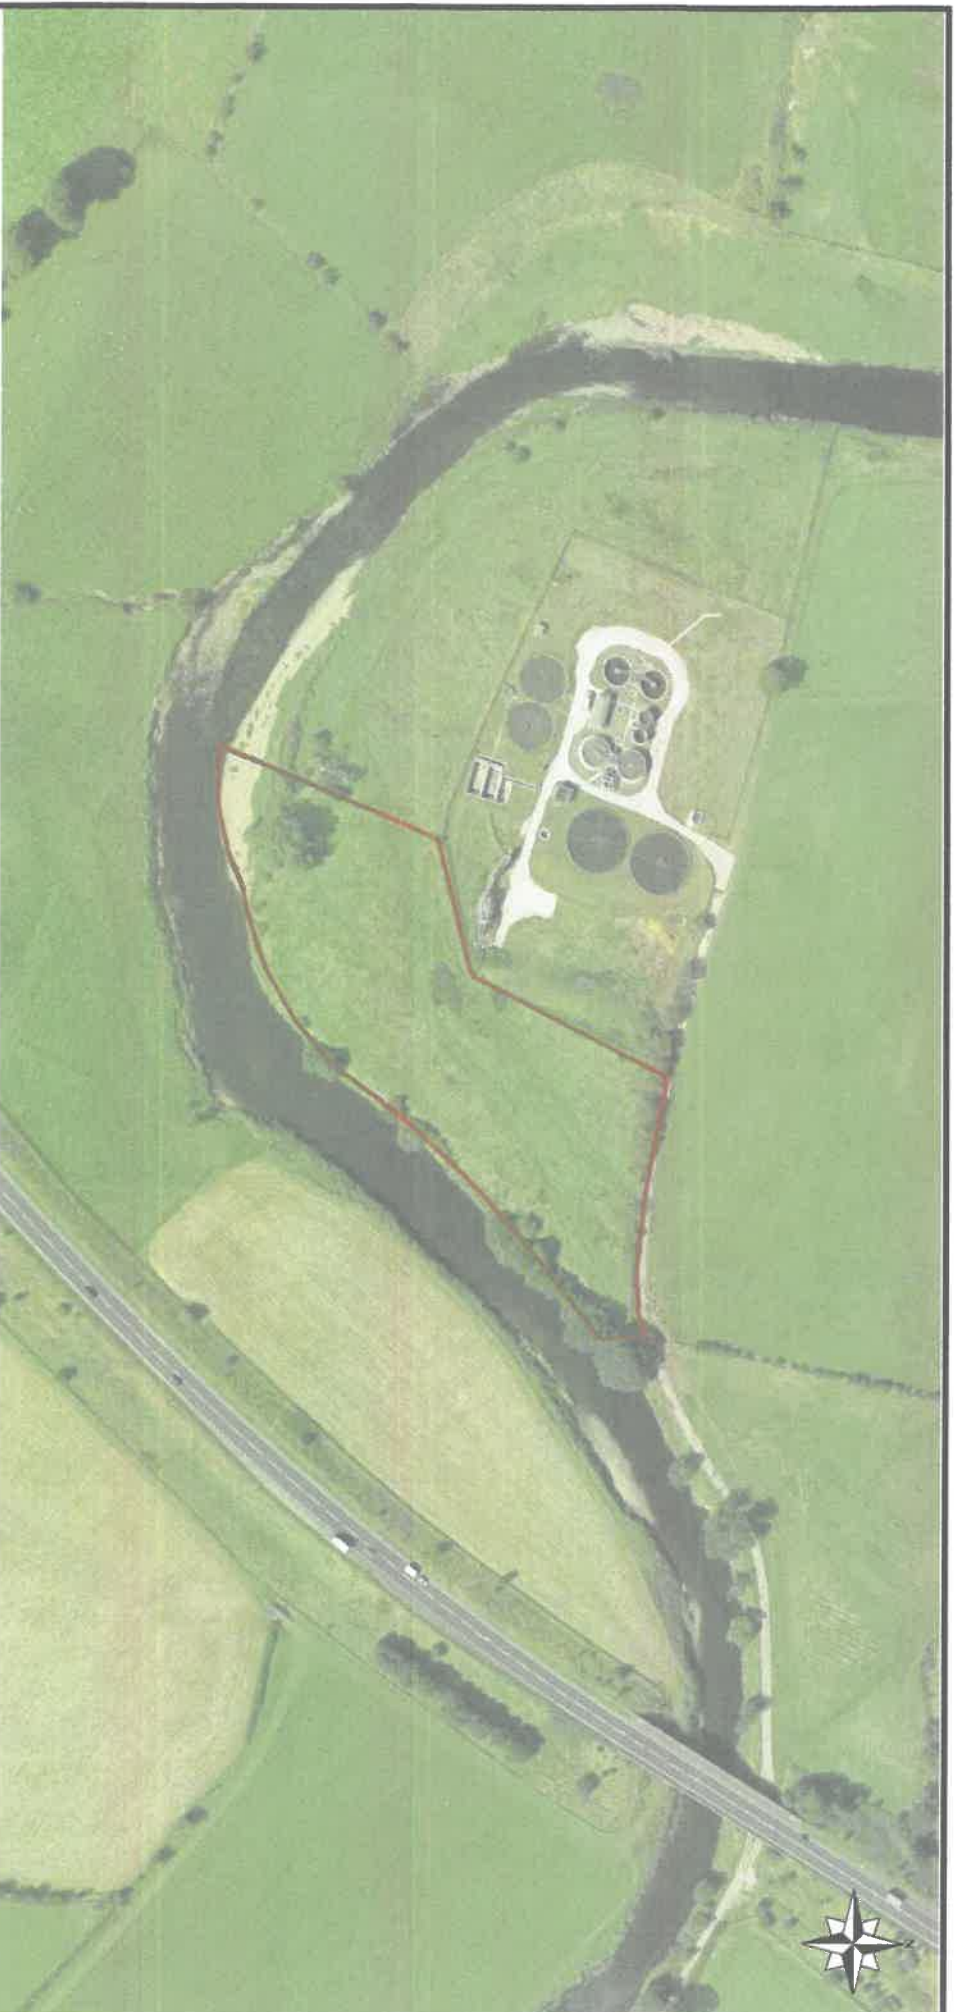
| Client: | <b>The Brockhall Properties Syndicate SIPP</b> | Title: | <b>Aerial<br/>Photograph<br/>Extract from<br/>2005</b> |

- 2.16 The sewage works has been regenerated and the subject site remains in agricultural pasture use.

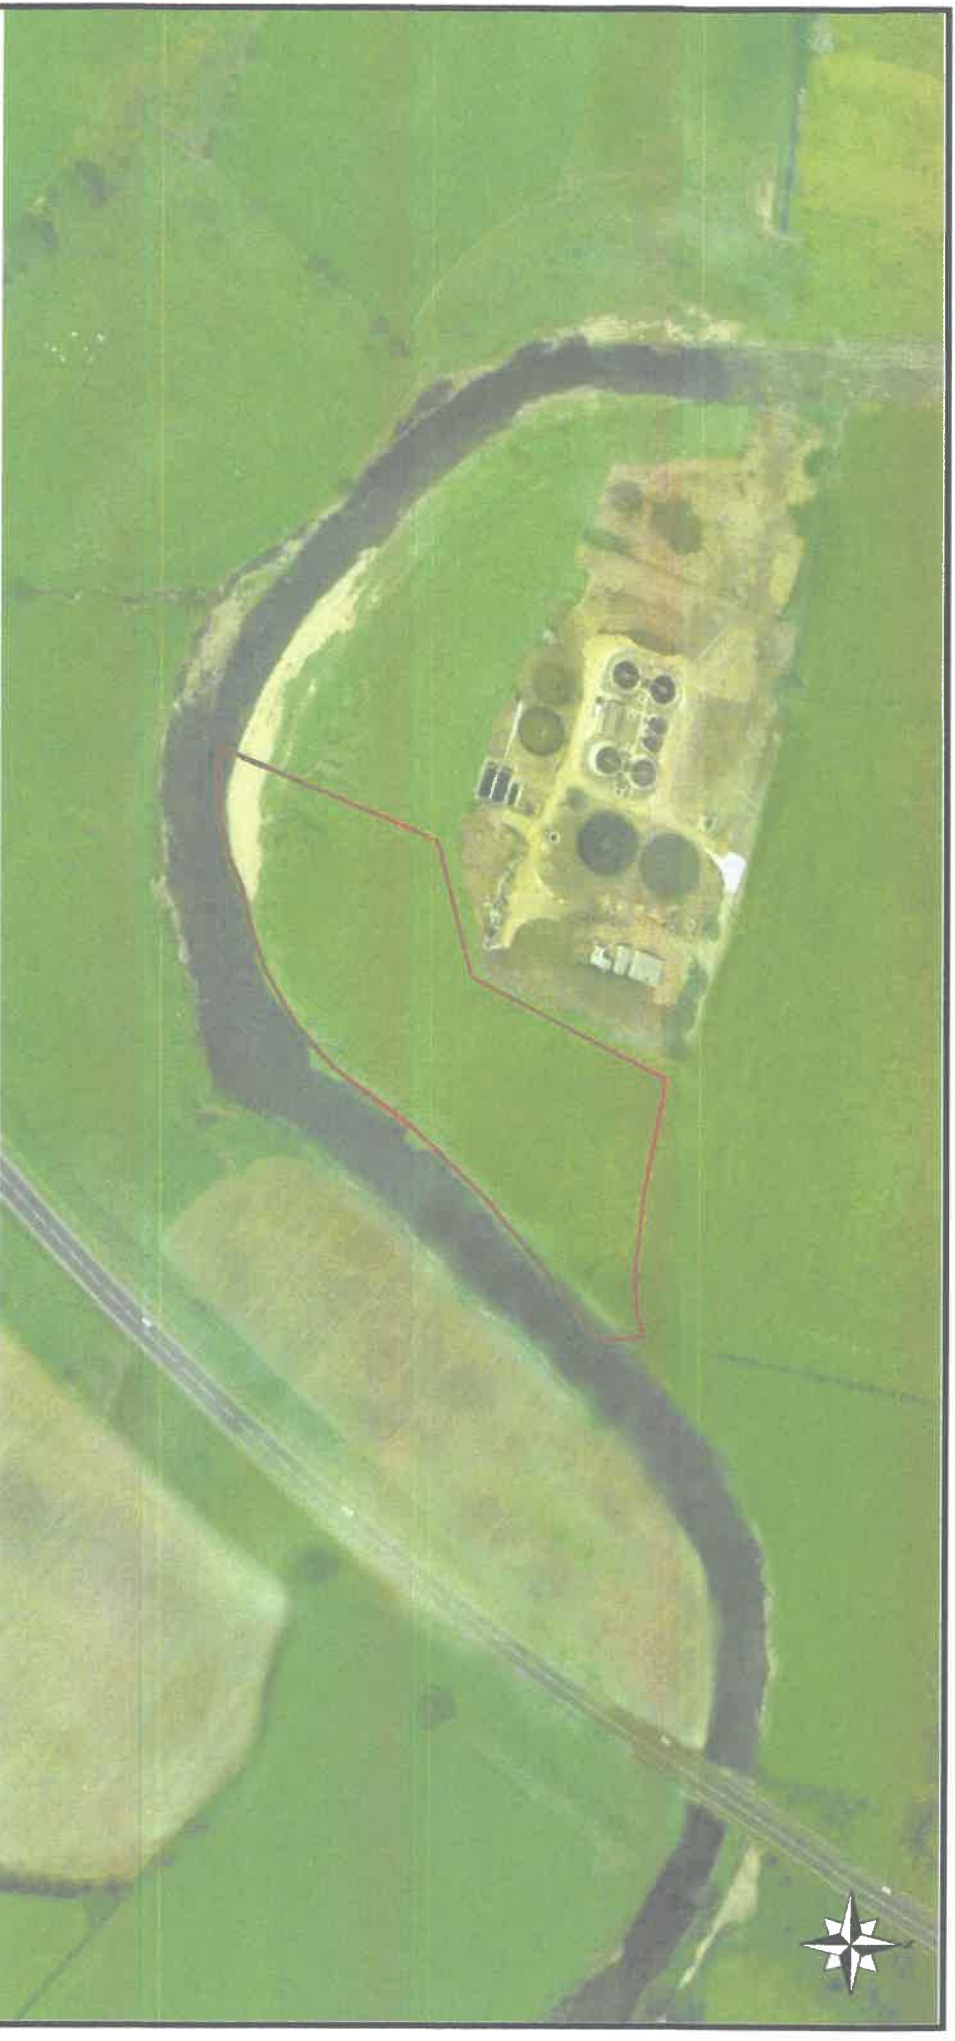
| <b>Project:</b> | <b>Land at the south side of Riddings Lane,<br/>Whalley BB7 9SF</b> | <b>Drawing:</b> | <b>10</b> |

- 2.14 Although not clear the site was used as a land fill with the last operation taking place in 1973. However, this operation was related to heaped materials not after an excavation. Henceforth the modern topography where the land rises significantly higher than the surrounding agricultural land and the sewage farm.
- 2.15 The route of Riddings Lane is not visible and the sewage works to the west appears to be no longer in use. The site appears derelict

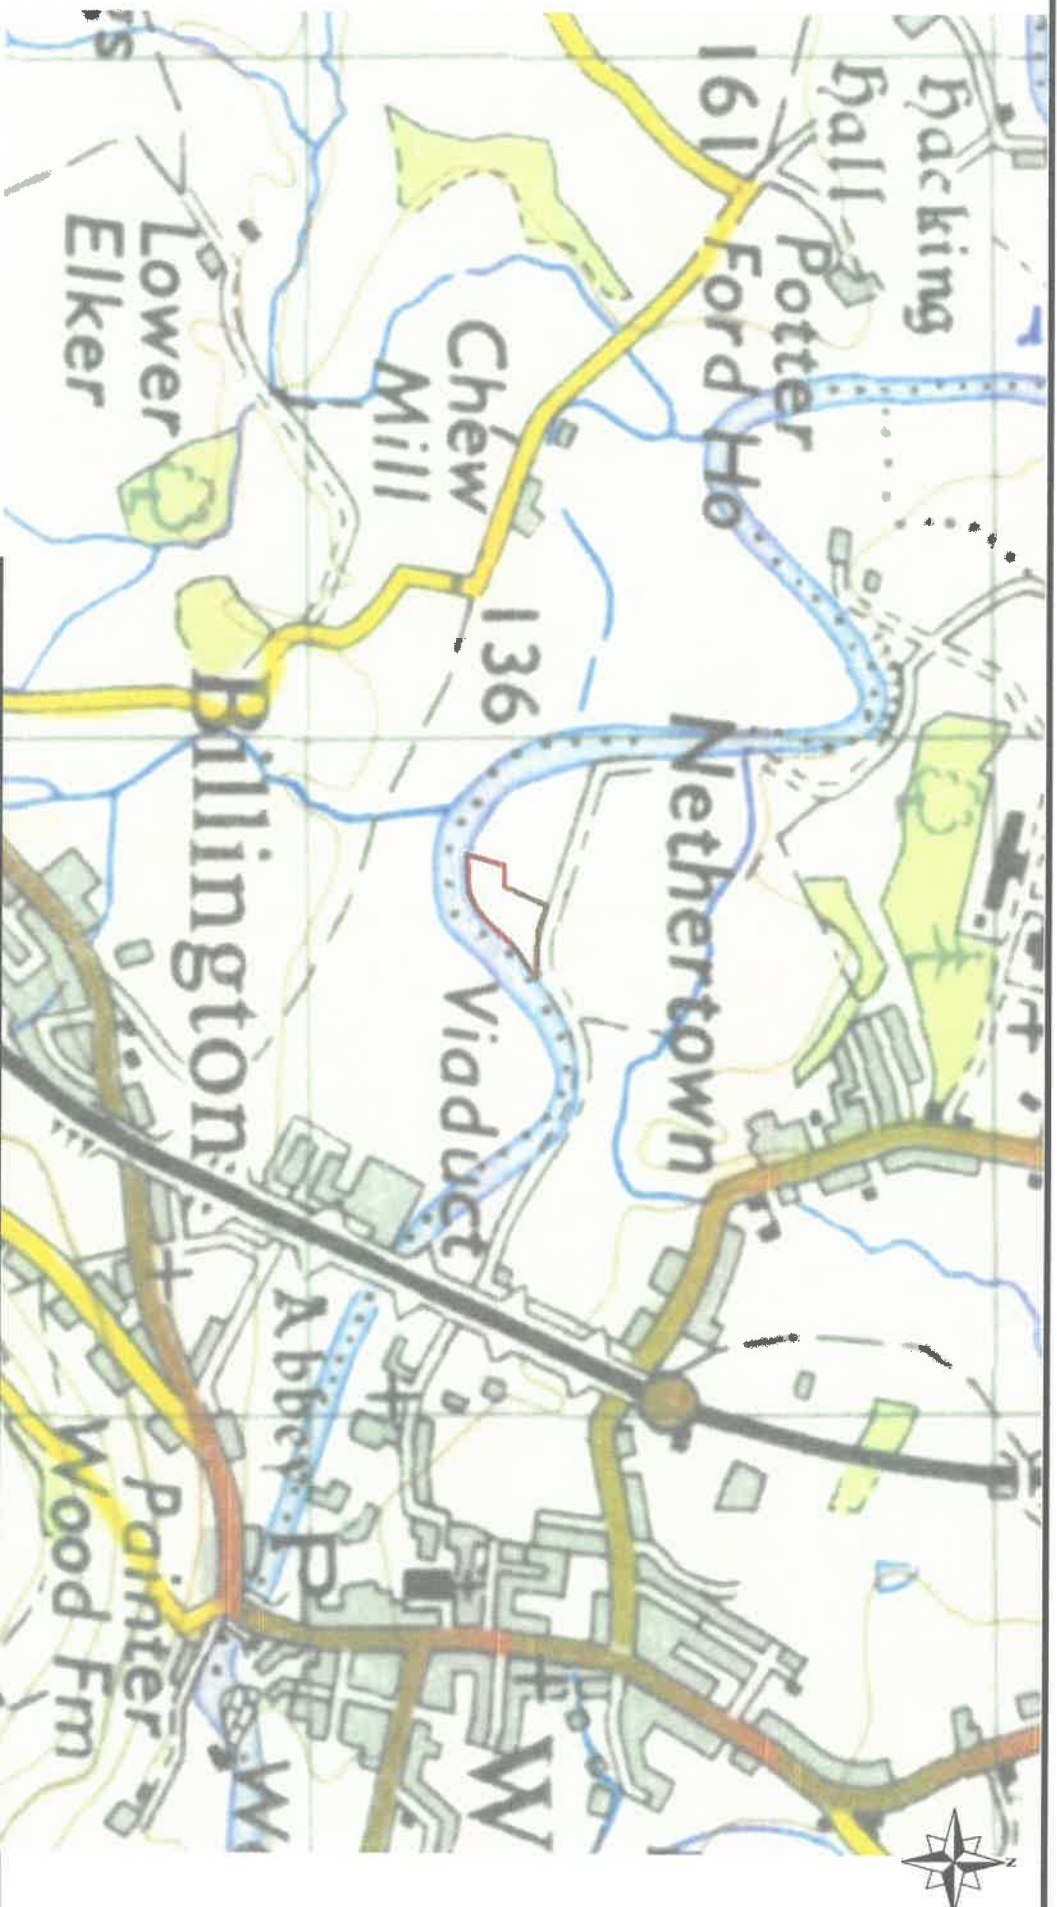
| Client: <b>The Brockhall Properties Syndicate SIPP</b> | | Title: <b>Extract From<br/>Ordnance Survey<br/>of 1961</b> | |

- 2.13 There are no material changes from the preceding extract of the Ordnance Survey.

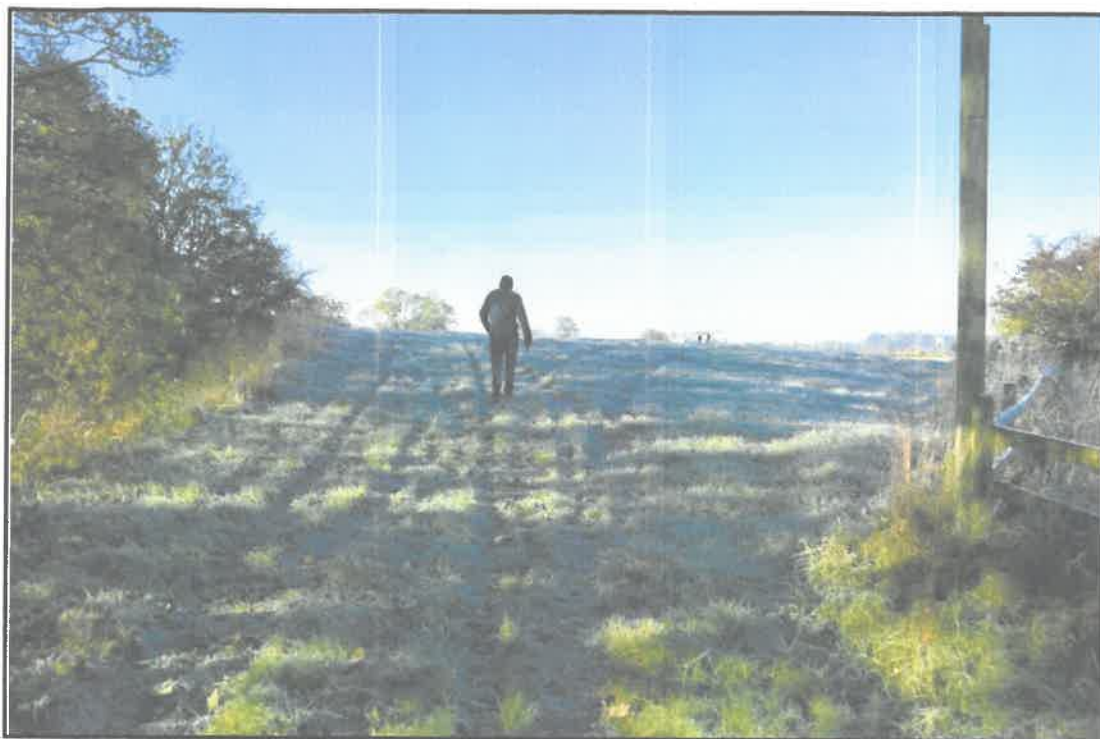
- 3.6 The site comprises pasture which is verdant and in good condition. Topographically the site rises to form a small raised area reflecting the deposit of materials on it in 1973. The site is approximately 4 metres higher than the surrounding land at its peak.
- 3.7 There is no evidence of vegetation die-back associated with gassing landfill.
- 3.8 The topography comprises heaped materials but there is no evidence of subsidence or visual evidence of what was deposited in the site in 1973.

**Plate 3      Raised heap from the main entrance**

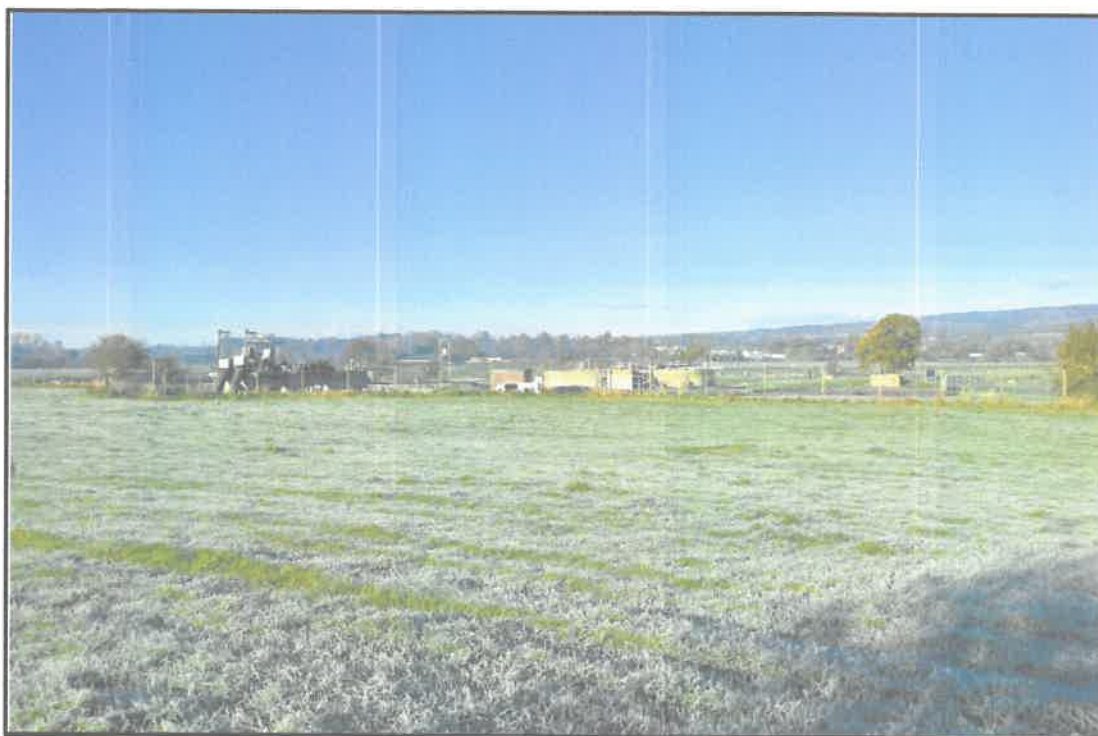
- 3.9 The onsite representative reported that the site has not flooded. It is certainly significantly higher than the surrounding area

**Plate 4      Elevation above the neighbouring sewage works**
