**BAT SURVEY AT -
LOWER HUD LEE FARM
LONGRIDGE ROAD
HURST GREEN**

DATE AND TIME OF VISIT
16th Oct 2018 10.00am

REFERENCE NO. 5634

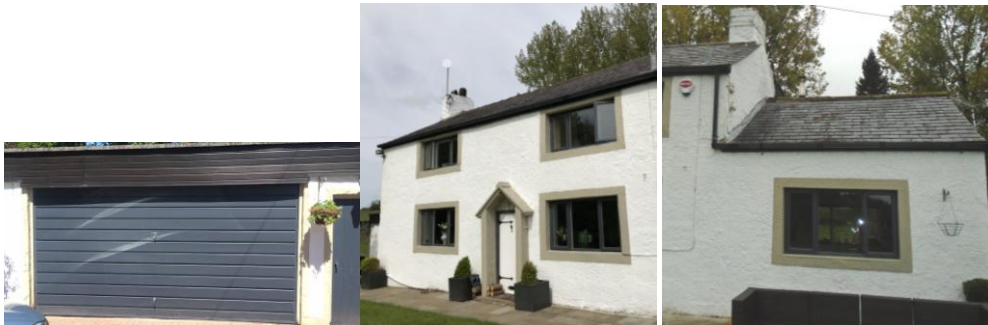
Front south elevation

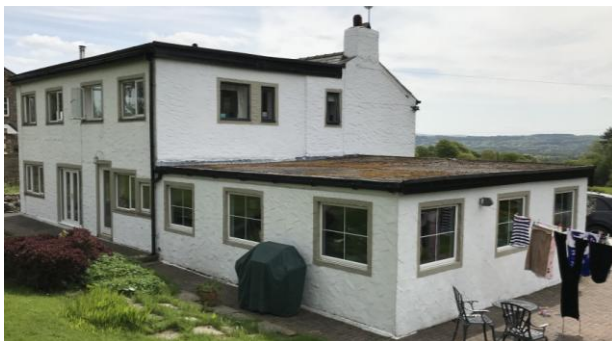
Rear and west side elevation

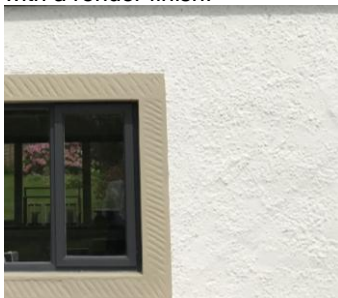
BAT ACCESS POINTS IN WALLS

All the render is in very good condition with no cracks or crevices which could allow bat access.

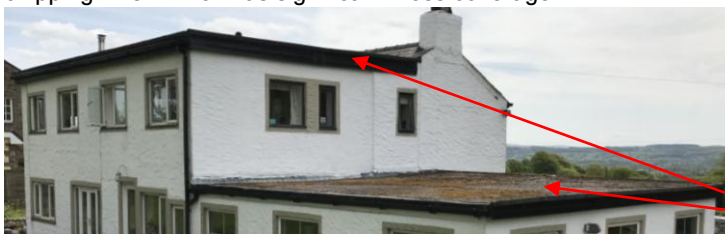
The flat roofs are felt, the two storey section has a projecting box timber fascia at the eaves, the garage has a boarded detail to the front south elevation and a projecting box fascia to the west elevation. The felt has a chipping finish which has significant moss coverage.

Flat roofs

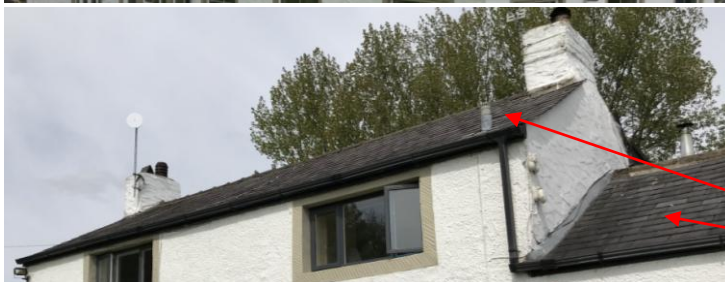
South elevation pitches

The slates of the main roof and single storey section are in reasonable condition with no significant gaps or slipped slates, the ridge slates were well bedded and the verges and flashings were tight fitting with no gaps. The flashings at the roof abutments were tight fitting. The box fascias were well sealed at the abutment with the wall.

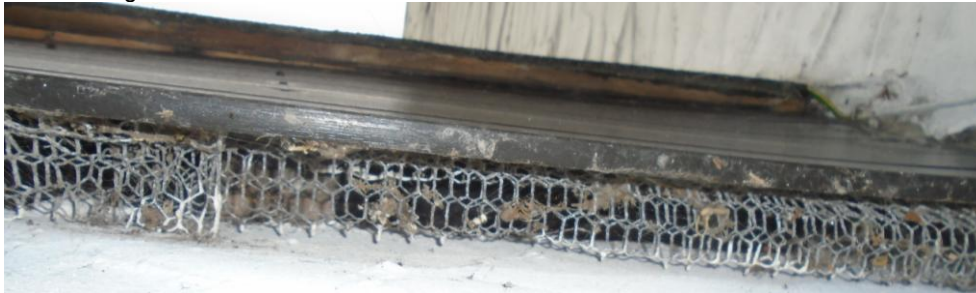
The boarded eaves detail to the front elevation of the garage was in reasonable condition the small void behind the boarding has been filled with mesh see below.

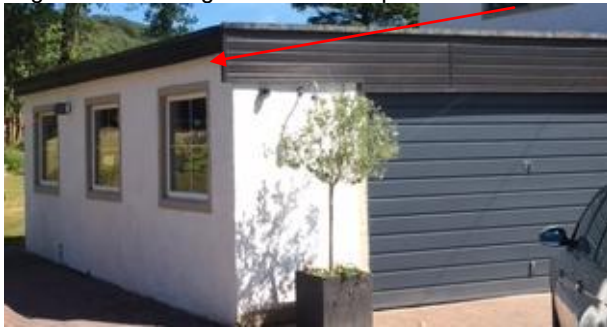
However the south west corner of the garage has a deeper crevice behind, however the endoscope result was negative with no signs of current or previous use.

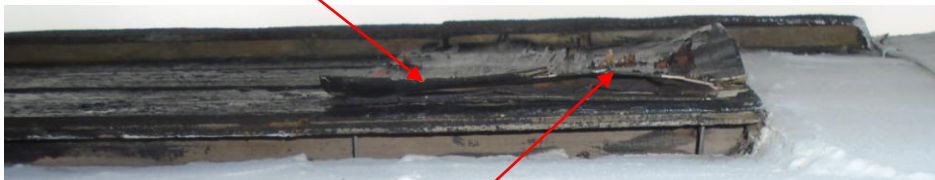
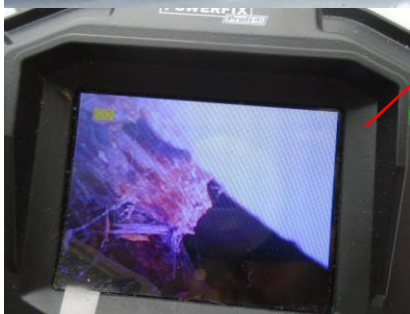
The two storey section had some sections in poor condition where the boards have peeled away from the wall. It was possible to closely inspect see below. The result was negative with regard to current presence nor where there any signs of past use .

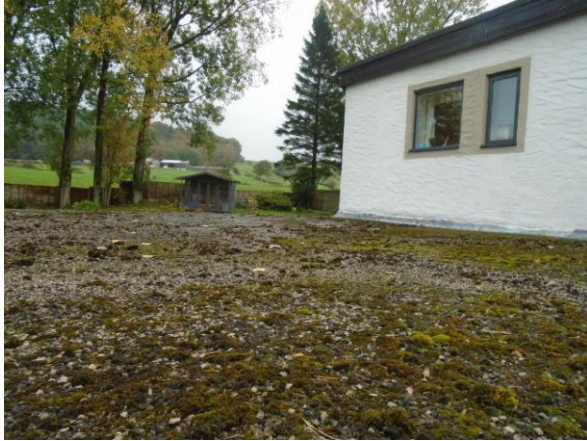
The Garage flat roof

There are no access points in the felt although it is in poor condition and there is water ingress into the building.

However it is recommended that the removal of the garage and flat roofs takes place during the winter months (late October - April) .

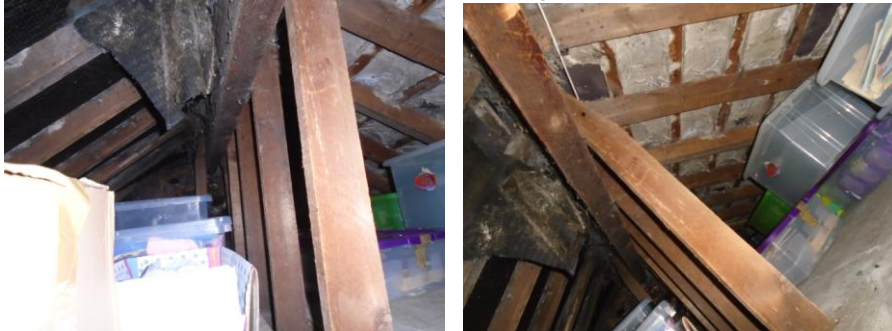
The main roof was divided into two spaces each accessible via a ceiling hatch. The void is small and boarded out for storage. The front pitch is slate fixed over battens and rafters, pointed at the abutments. The rear pitch which has been altered when the flat roof extension was added has felt underlay. All the timbers are in good condition with no rot, cracks or crevices.

All the surfaces are clean with no signs of droppings or insect remains.

Eastern end roof void.

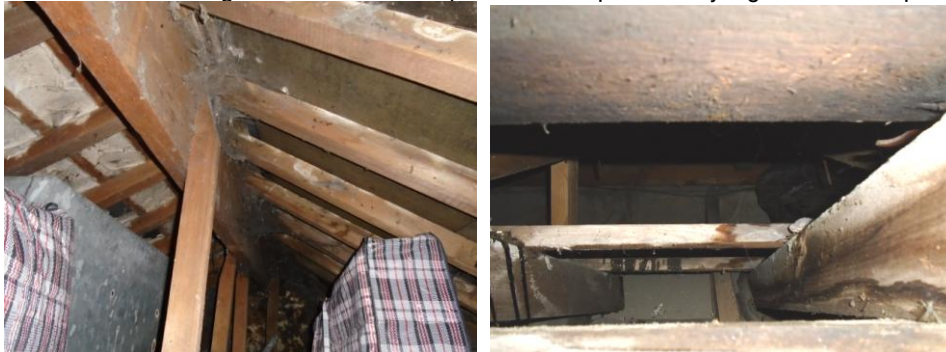
The west end of the roof void was similar to the east but the rear pitch has boarding over the rafters and a void is visible adjacent to the flat roof. As before the surfaces were clean and devoid of any dropping or insect remains. The timbers were in good condition. The spaces did not provide any high value roost potential for bats.

Western end roof void

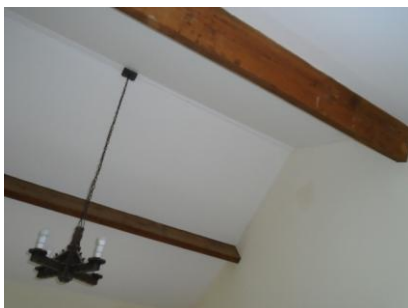
The single storey section does not have a roof void the rafters are lined to the underside, no access points for bats.
