Christ Church, Chatburn

As Existing, North Elevation with window labels

Existing and Proposed Glazing Protection

As Proposed, North Elevation with window labels

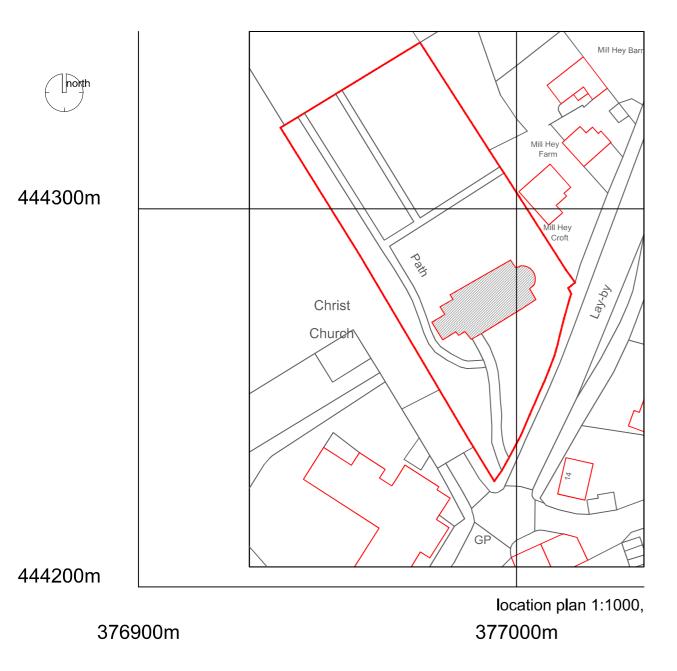
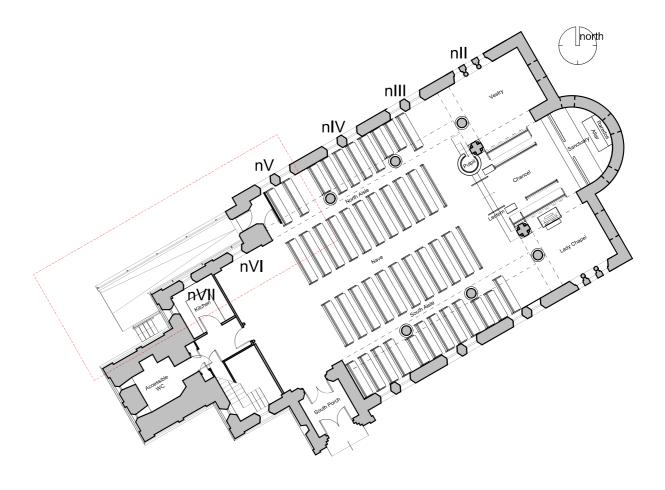
SCALE DATE DRWG. NO. REV. 1:200 and 1:1000@ A3 November 2018 2363/01/03

Site plan and plan of church

Plan 1:200, Pull out on 2363_01_05 Site = Footprint of Church ~ 420sqm

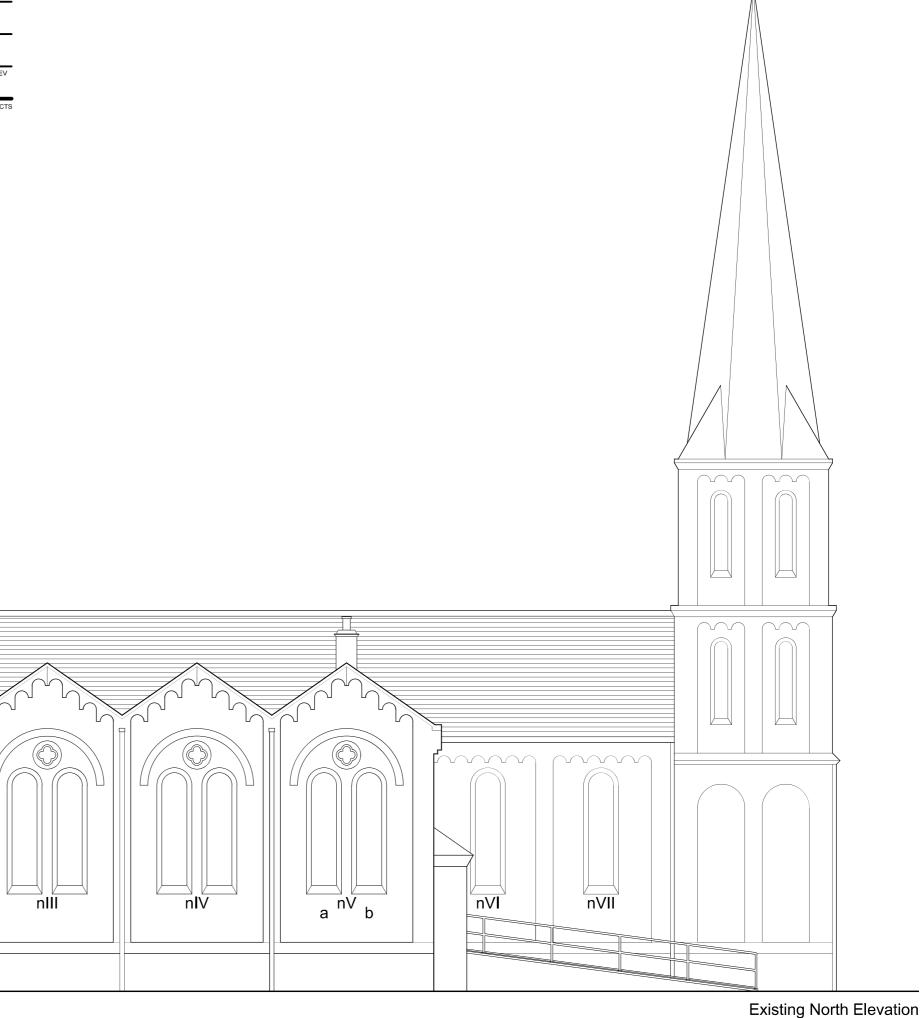
scale 1:100 @ A3 November 2018 DRWG. NO. 2363/01/04

Existing wire mesh Window Guards Windows nII, nIII, nIV, nVa, nVI

Existing secondary (glass) protective glazing window nVb

Existing plain glass window (excluded from works) window nVII

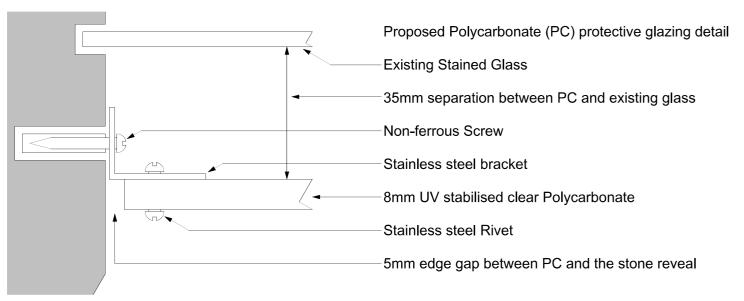
Current appearance of window on the north Elevation of one set of windows, the right window (currently with protective glass glazing) and the left window (currently with a painted wire mesh screen).

The windows currently suffer from vandalism caused by air rifle pellets,

Staining to the stonework caused by the wire mesh guards.

The proposal is to remove the existing protection and replace with a ventilated, UV stabilised, polycarbonate protective glazing. The Image (left) is of the protective glazing at St. Leonards Padiham taken 10 years after instillation.

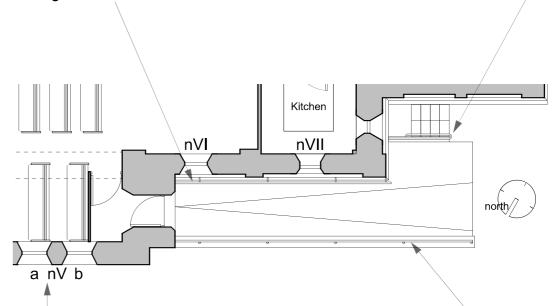
Part plan 1:100, indicated by pullout box 2363_01_03

Instilation of new handrail, attatched to the church wall, to match existing handrail height.

intilation of handrail around the Boiler house stairs, 2363_01_02

Removal of Exisitng: wire mesh Window Guards (Windows nII, nIII, nIV, nVa, nVI) and secondary (glass) protective glazing (window nVb). To replace with PC Protective Glazing, as detailed on 2363_01_05

Addition of full height stainless steel weld mesh attached to the existing handrail. 2363_01_02,06&07

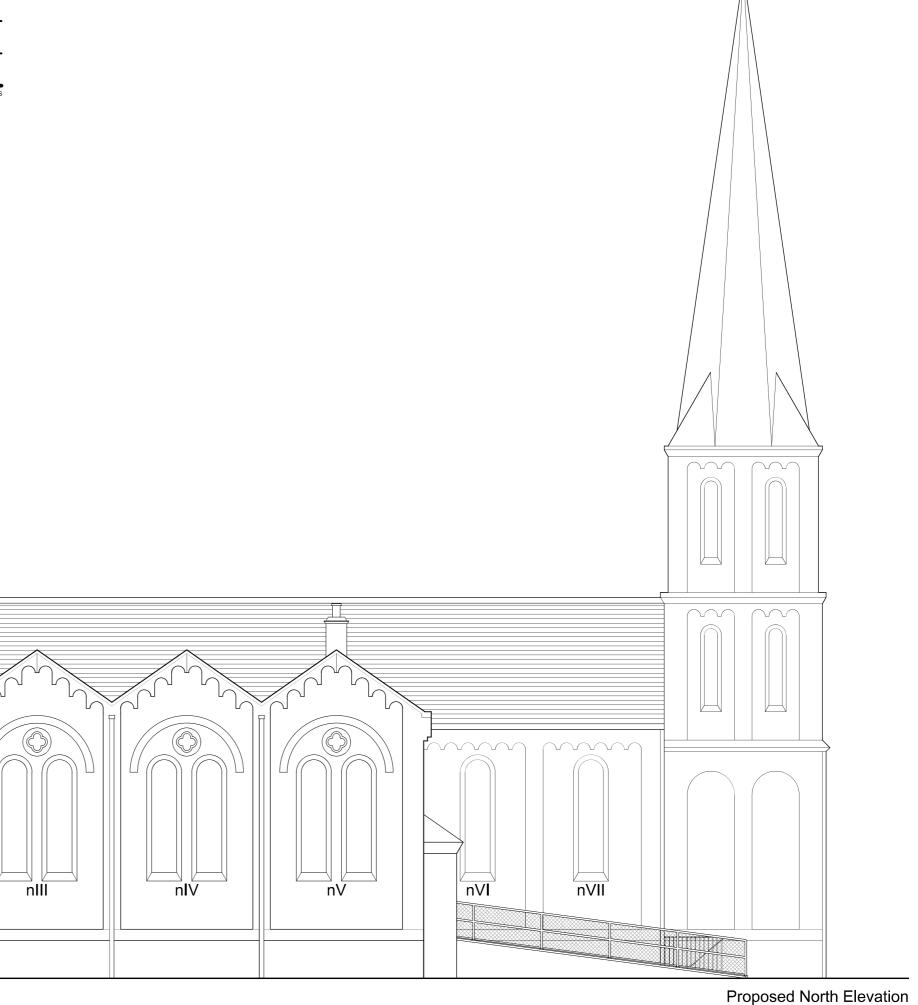
1:100 @ A3 November 2018 DRWG. NO. 2363/01/06

Addition of Protective Polycarbonate Glazing windows nII, nIII, nIV, nV, nVI

Addition of stainless steel weld mesh to existing handrail

Addition of handrail to the boiler house stairs

Addition of a second ramp handrail to match existing height

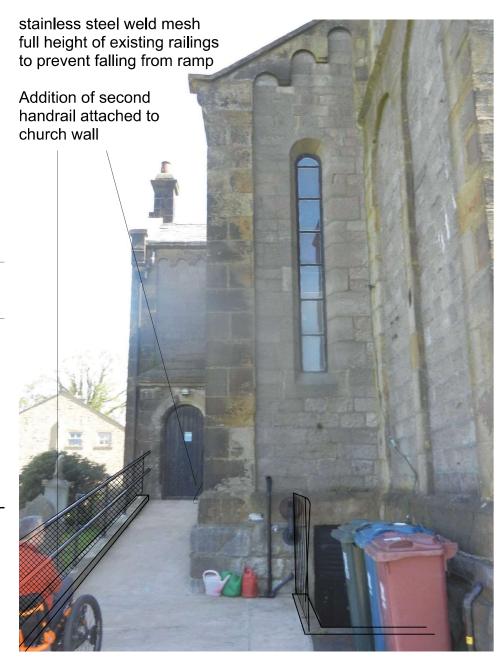
P01: Proposed view from North West corner of church

Addition of a second ramp handrail to match existing height

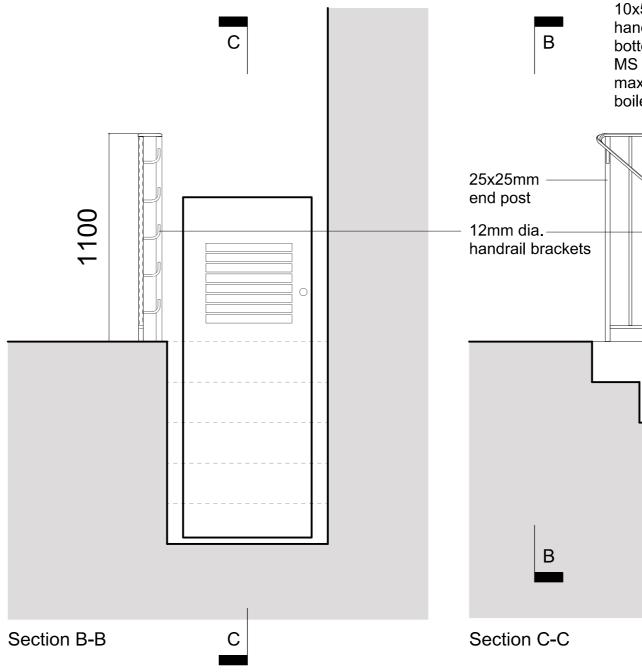
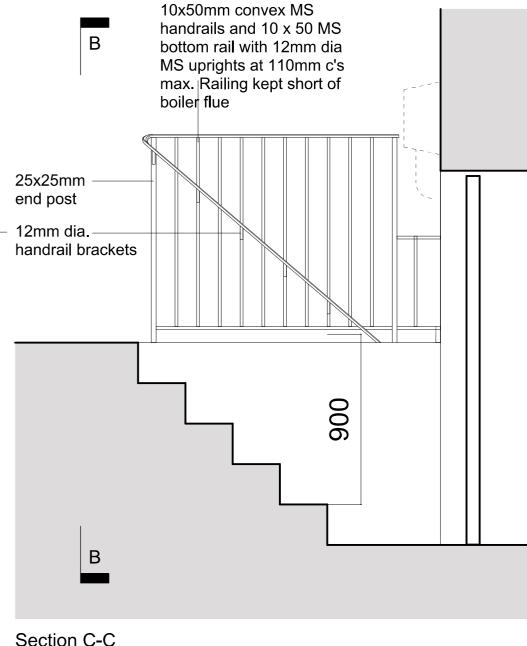
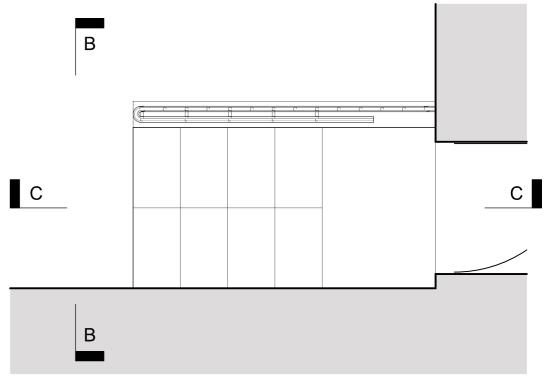
SCALE DATE DRWG. NO. REV
1:20 @ A3 November 2018 2363/01/08

As Proposed External Handrail Details
