**BAT SURVEY AT -  
10 St PETERS CLOSE  
CLAYTON LE DALE**

DATE AND TIME OF VISIT  
29<sup>TH</sup> Nov 2018

REFERENCE NO. 5646

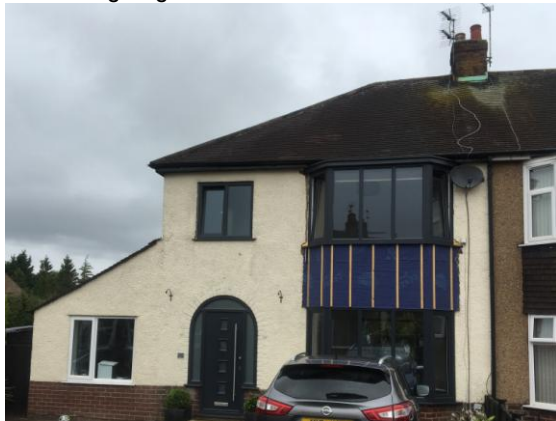
Front elevation

The building is a semi detached dwelling. Probably dating from the 1940's /50's. The side lean- to was originally built as a garage but has been converted to form accommodation.

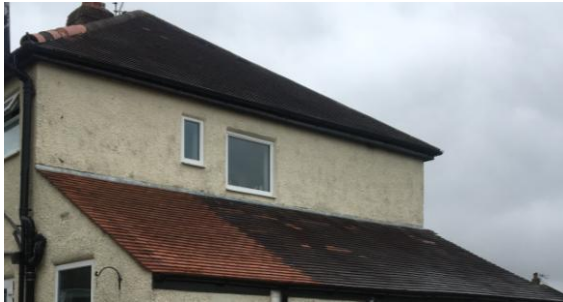
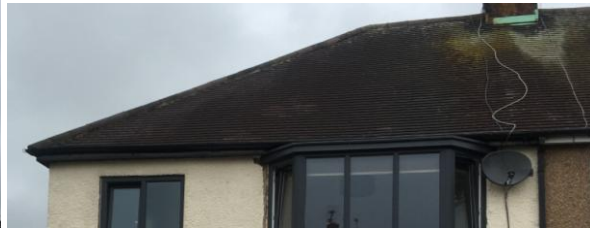
The main roof is a hipped construction with two number roof windows. There is a small overhang at the eaves which has a boarded soffit the finish is Rosemary tile.

The lean-to at the side has a flush fascia with a tiled finish as before.

There are no slipped tiles and all are very tight fitting. The ridge and hip tiles are well pointed and do not provide any access points. The timber soffits are in good condition and very tight fitting they do not provide any access points.

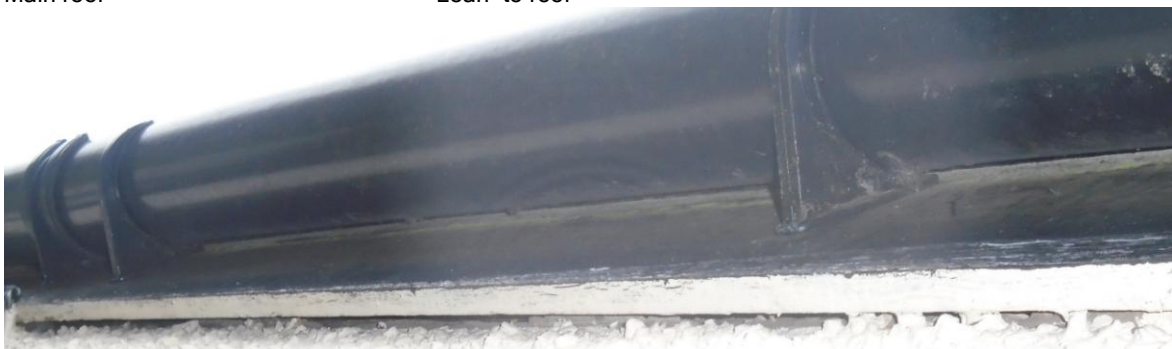
Lean-to fascia.

The timber fascia on the lean-to is fixed flush to the wall, however there are some slight gaps behind, close inspection proved that bats do not enter the space nor does it provide suitable roost habitat.

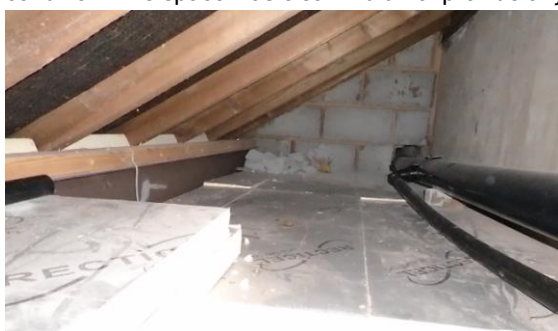
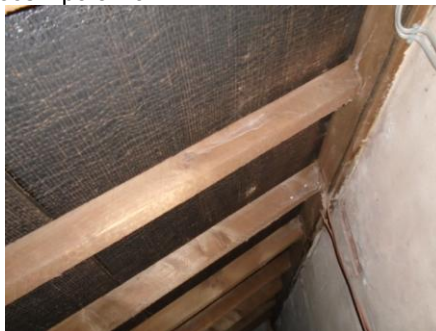
There is a small void in the lean -to which was accessed via a hatch, the timber rafters and felt were in very good condition. The space was clean it did not provide any roost potential.

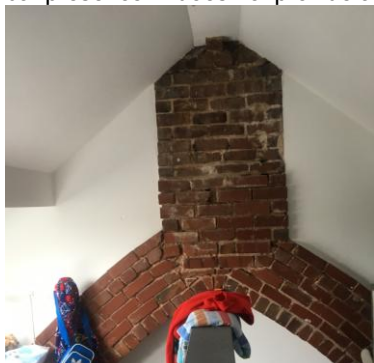
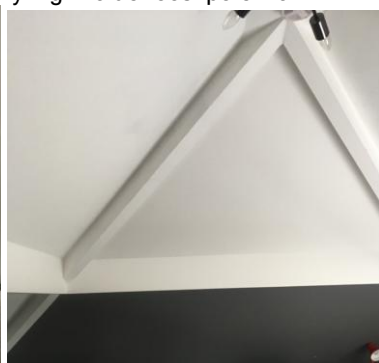
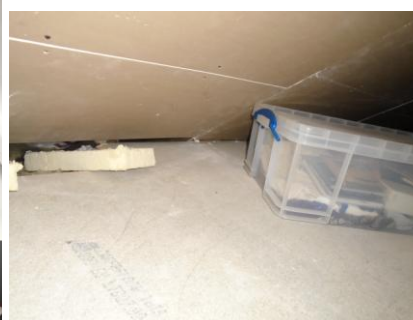
Main roof void

The main roof has been converted into bedroom accommodation with just a small eaves void accessed via wall hatch. The void is boarded out to the underside of the rafters and the floor it is clean and free from any signs of bat presence. It does not provide any high value roost potential.
