Arboricultural Constraints Appraisal

in Relation to Proposed Residential Development at

**Higher College Farmhouse, Lower Road,
Hothersall, Preston, Lancashire, PR3 2YY**

Title:
TREE CONSTRAINTS PLAN
in Relation to Proposed Residential Development

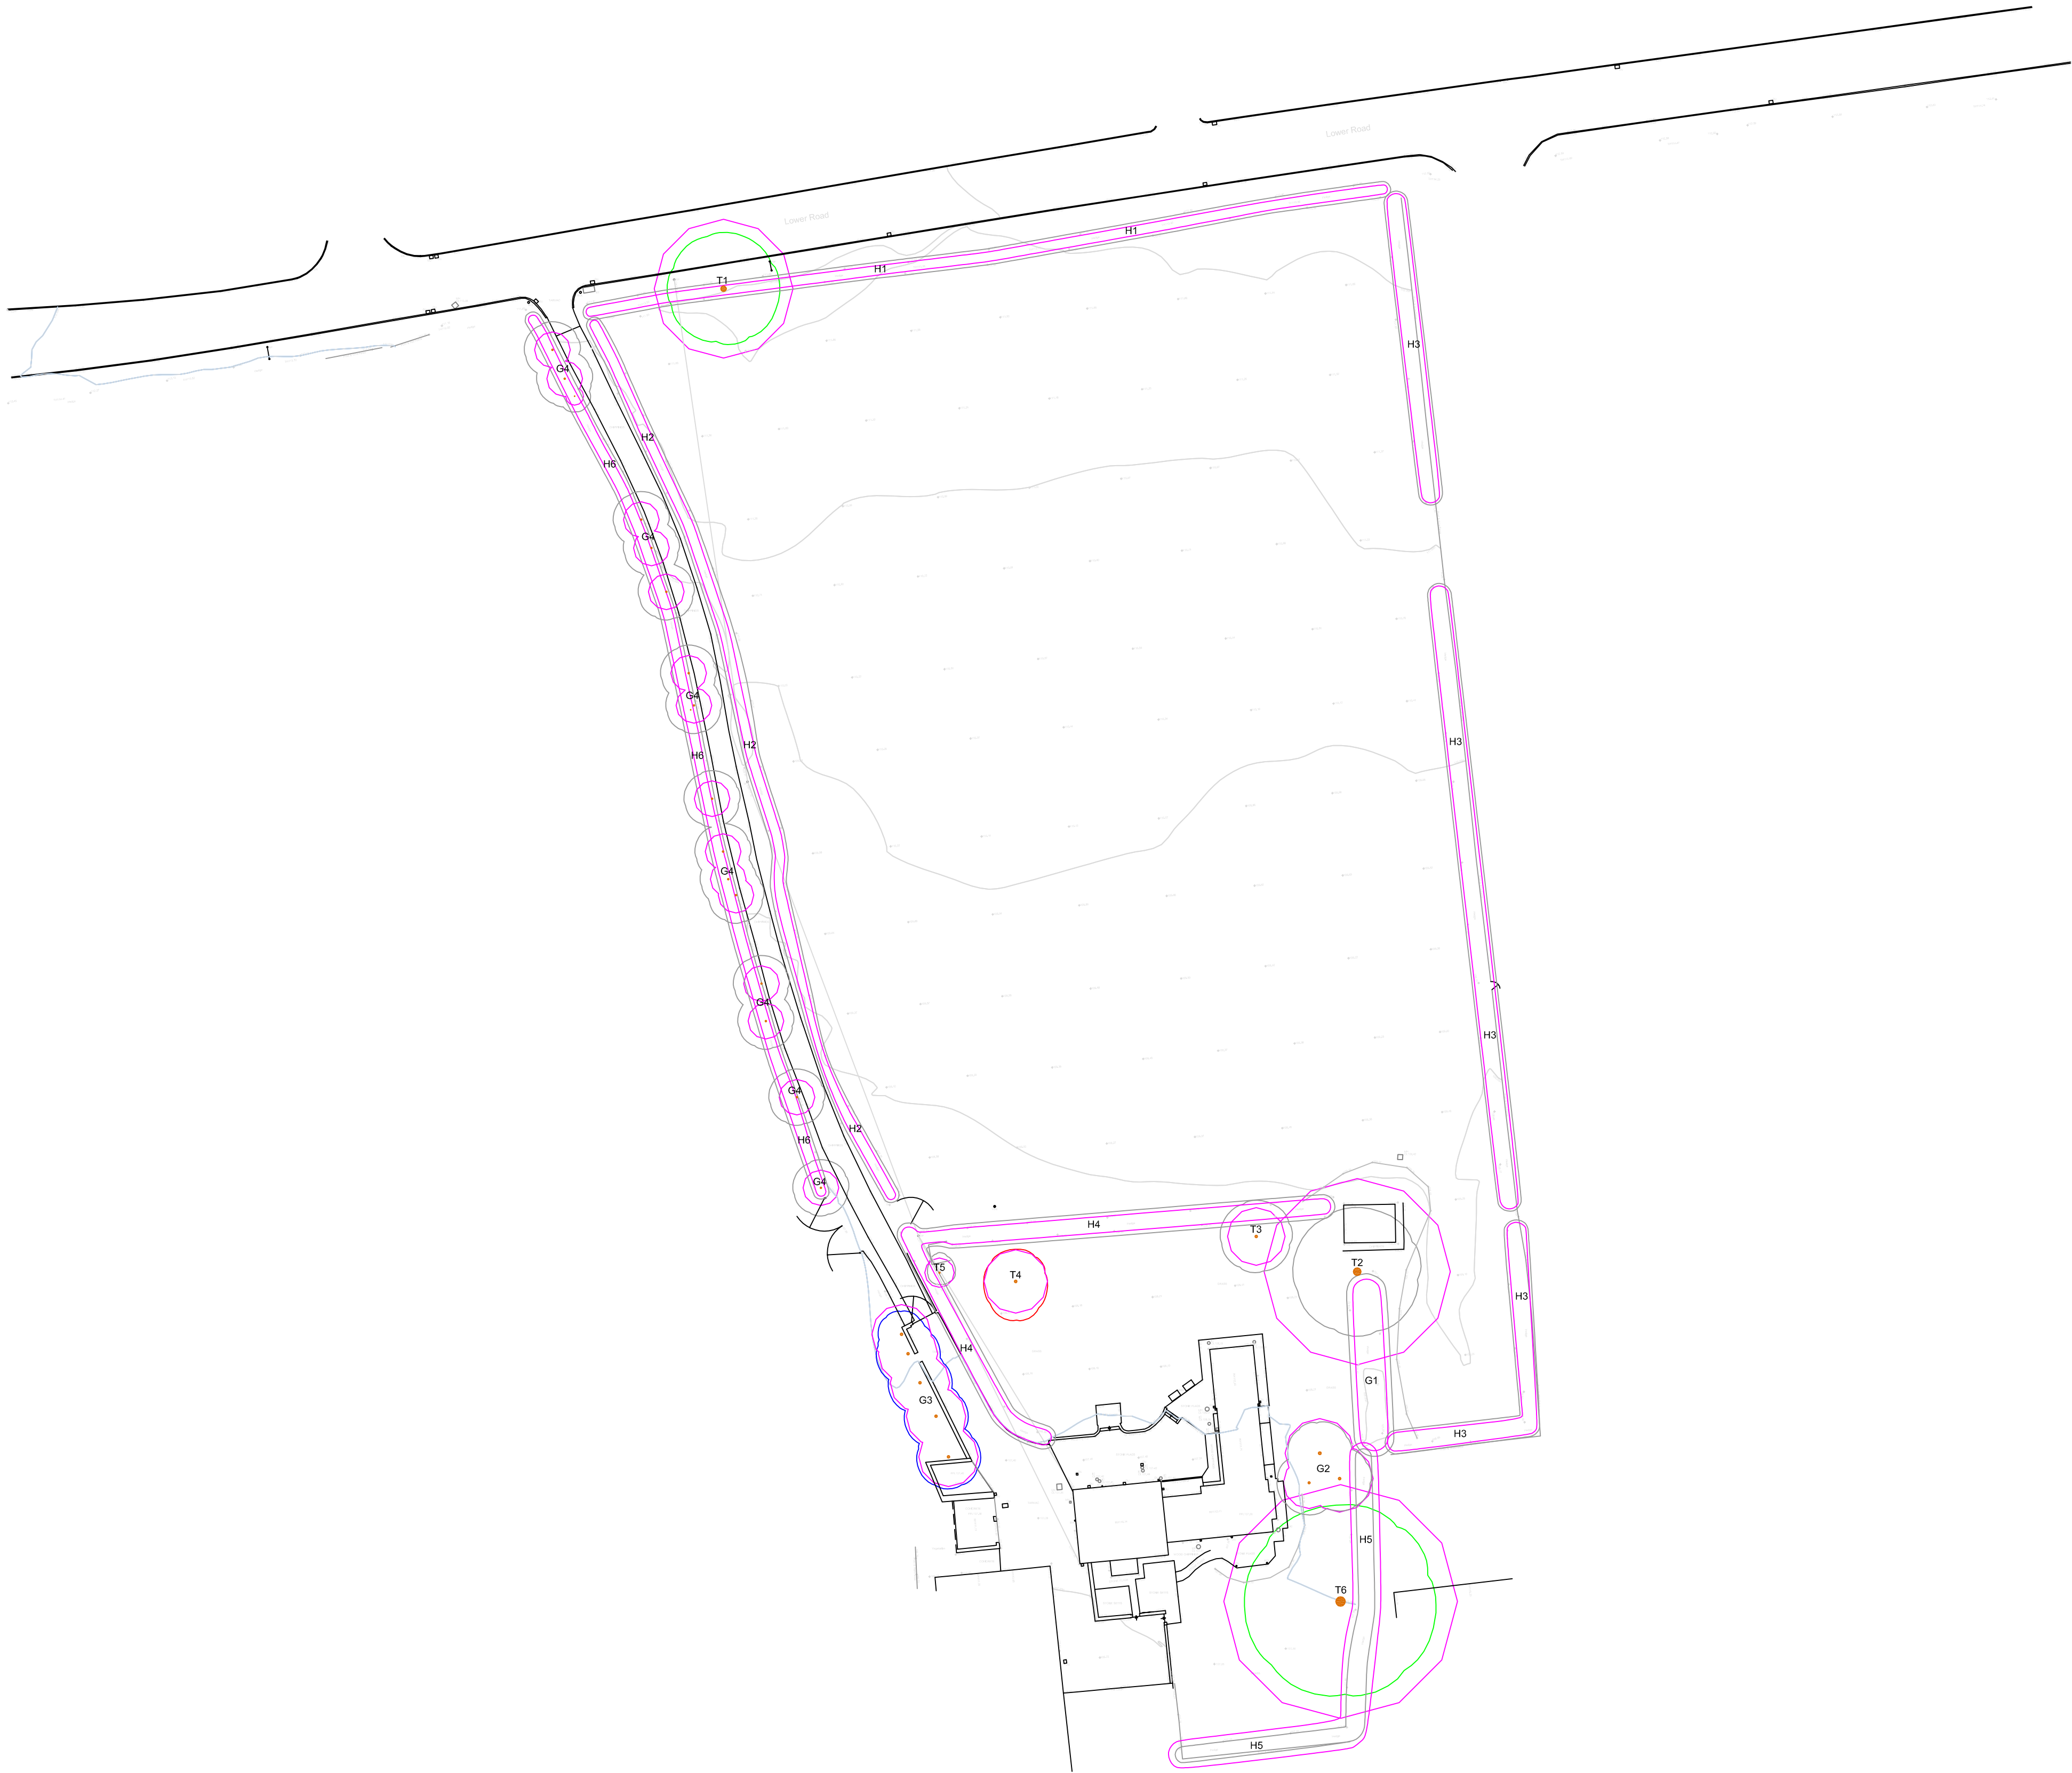
Ref: BTC1343-TCP

- RPAs
Area(s) of Ground Around Trees that Should be Protected Throughout Development Works with Protective Fencing to form a Construction Exclusion Zone
