BAT SURVEY AT -
9 CHURCH CLOSE
WADDINGTON

DATE AND TIME OF VISIT
3 rd Dec 2018 9.00 am

REFERENCE NO. 5745

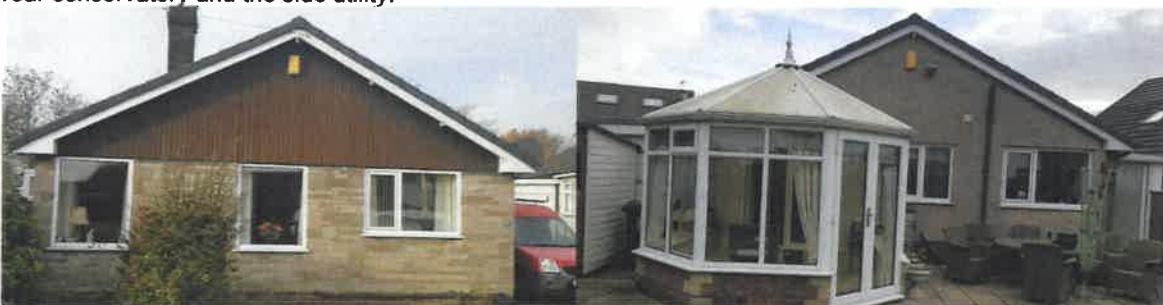
The property is a detached bungalow, probably dating from the 1960's/70's. It has had the later addition of the rear conservatory and the side utility.

Front elevation

Rear elevation

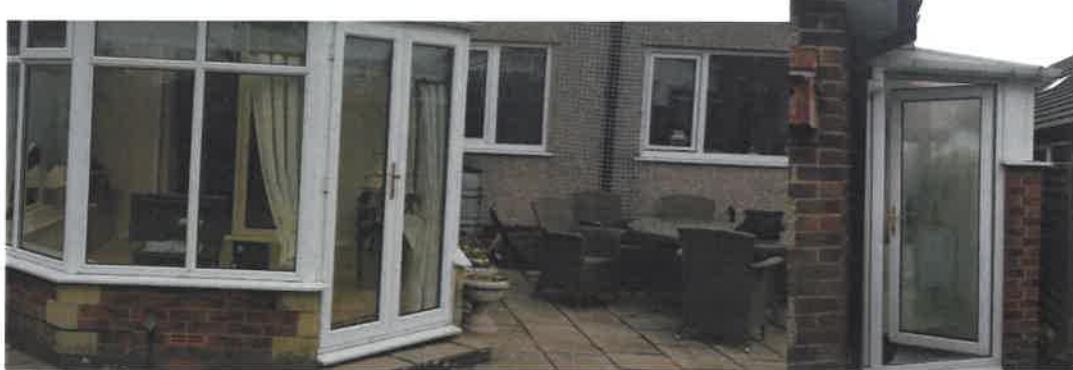
The base walls of the conservatory and utility are brick, the rear elevation has a pebble dash render finish. The front elevation is stone with timber boarded cladding to the gable. The side elevation of the garage is white painted smooth render finish.

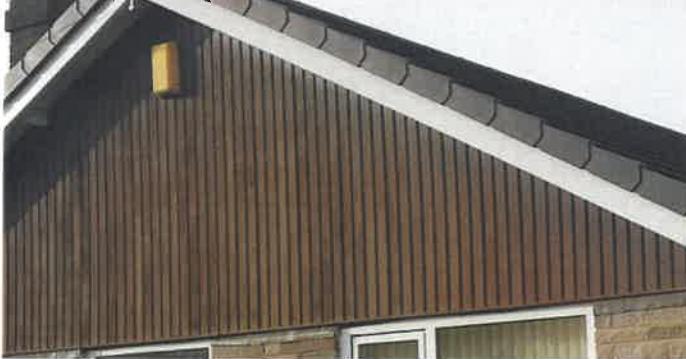
The walls have no cracks crevices or access points, all in excellent condition. The timber boarding is in good condition, flush with the wall, no gaps at the abutment of the boards with the soffits and no cracks or crevices.

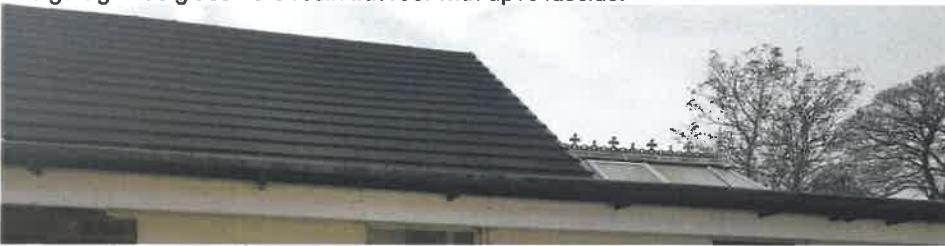
The main roof is a tiled pitch with upvc fascias, soffits and barge boards with upvc trim.

The garage has glass fibre resin flat roof with upvc fascias.

House and garage roof.

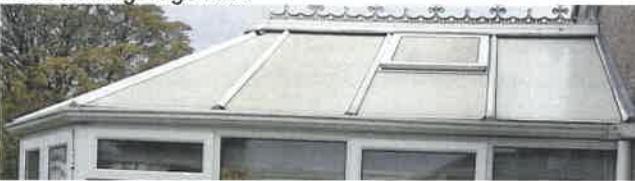
The conservatory and utility have a clear polycarbonate upvc framed roof. The conservatory is pitched and the Utility is a lean -to.

Conservatory

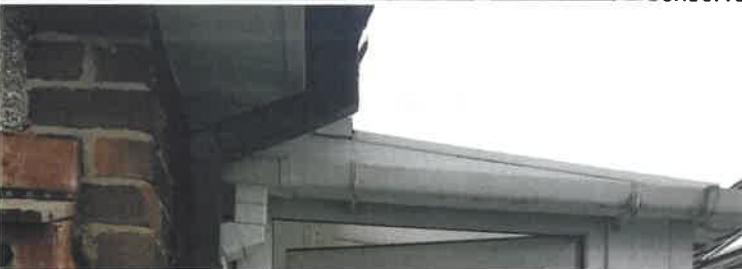
Porch roof

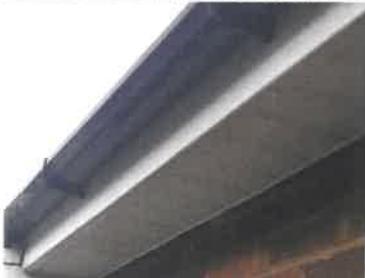
The tiles are in good condition and very tight fitting, the eaves soffits are very tight fitting at abutment with the wall as are the gable barge boards. No potential for access into this roof.

Eaves soffits

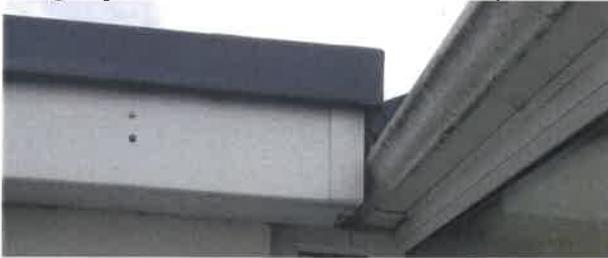
The garage roof, soffits and roof finish is all in perfect condition.

Garage fascia and conservatory eaves.

All lead flashings are in good condition and tight fitting.

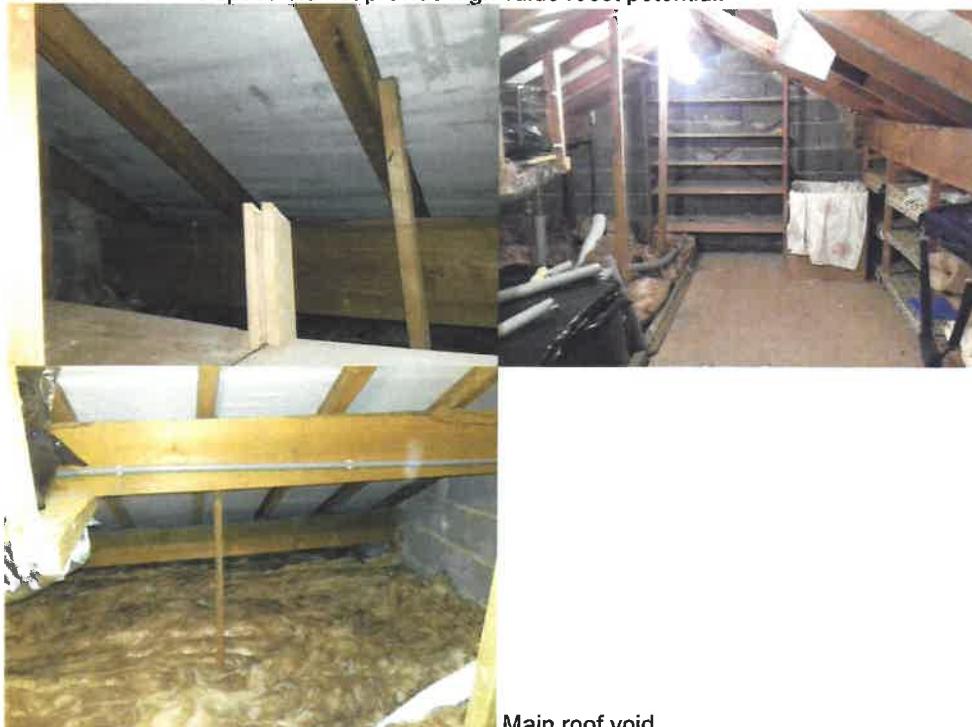
The main roof void was examined via a ceiling hatch. All the roof timbers were in perfect condition as was the felt. The insulation quilt between the joists and the boarding over the joists was clean with no dropping or insect remain debris. The space did not provide high value roost potential.

Main roof void

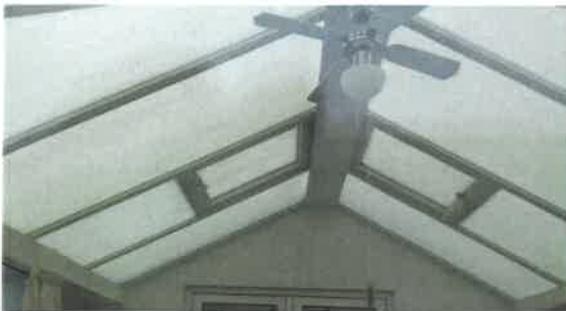
The conservatory and utility roof are well sealed and do not provide any crevices suitable for bats or access points.

Conservatory roof

The conservatory or utility roofs do not provide any potential for bat roosting.

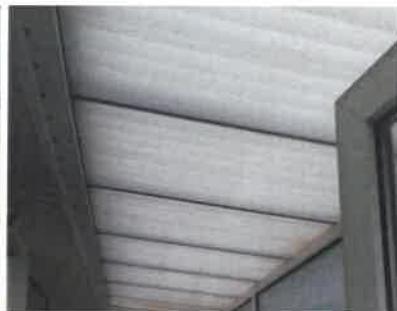
Utility roof
