**Preliminary Bat Survey Report for
House and Garage at 2 Ridge Court,
Longridge, PR3 3RZ
SD 6118 3774**

Commissioned-by:
Katie McDonald

Survey Date: 25/10/17

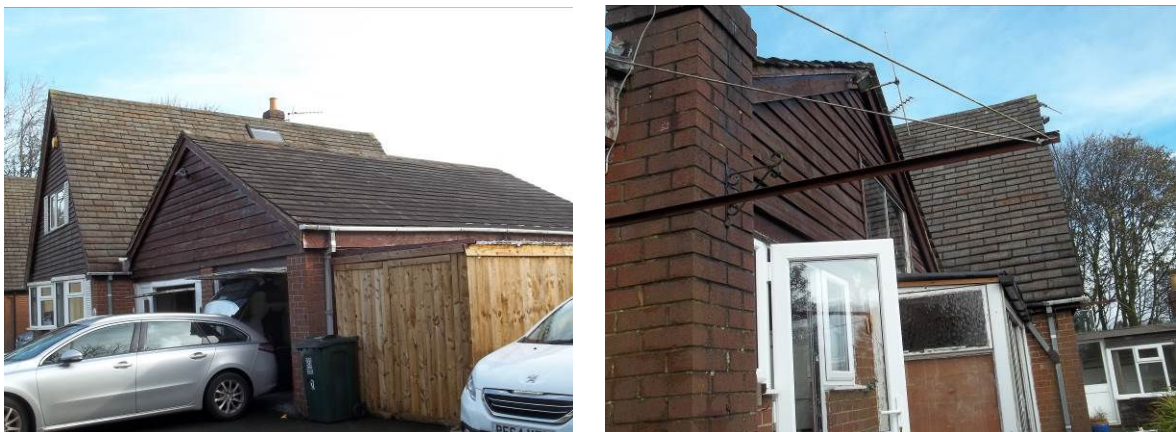
This is a large, double garage attached to a detached bungalow:

Front (north west) and rear elevations

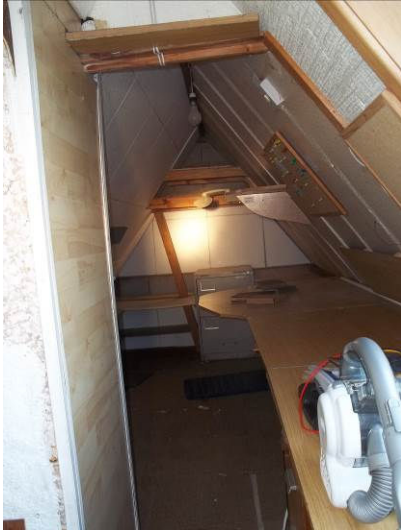
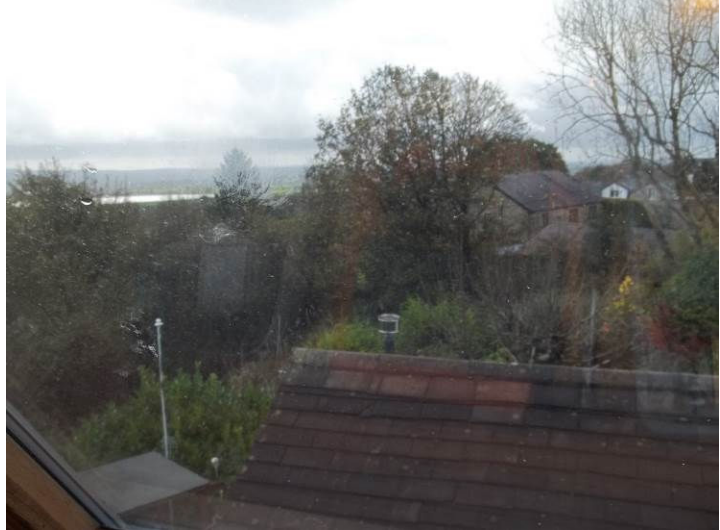
The bungalow has a narrow loft containing a velux window, which provides a view of the good bat feeding-habitat immediately adjacent:

Loft and view from velux window

The floor is boarded/carpeted and the roof has been insulated, largely by use of polystyrene blocks between the rafters.

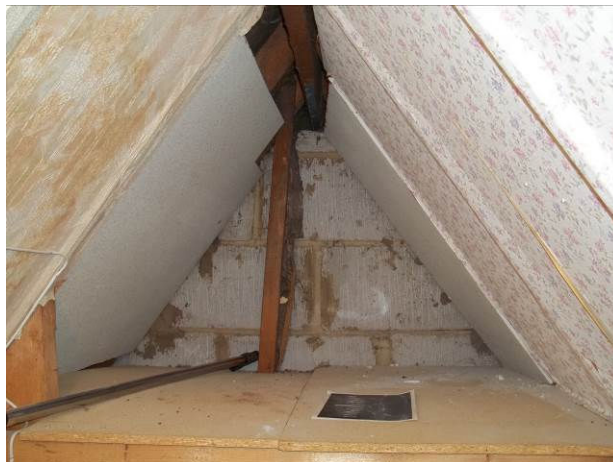
At the north-western gable wall about 6 droppings, typical of bat droppings, were also present. Two were in a cobweb stuck to the wall. They had been removed to allow a sample to be sent for dna analysis if necessary before the photograph below was taken:

Both buildings have dark-coloured, timber cladding with access available for bats to roost behind it. There is evidence in the loft at the timber-clad, north-west gable end of the house to suggest bats have roosted at the gable apex. The droppings appeared typical of the pipistrelle bat, though the droppings of whiskered/Brandt's bats are quite similar. Roosting at the gable apex in this type and age of property is characteristic of the pipistrelle however.

If a European Protected Species Licence is needed for removing the cladding on the house, and the species of bat involved hasn't already been confirmed via sound recordings at future survey work, the droppings obtained at this survey can be sent for dna analysis.

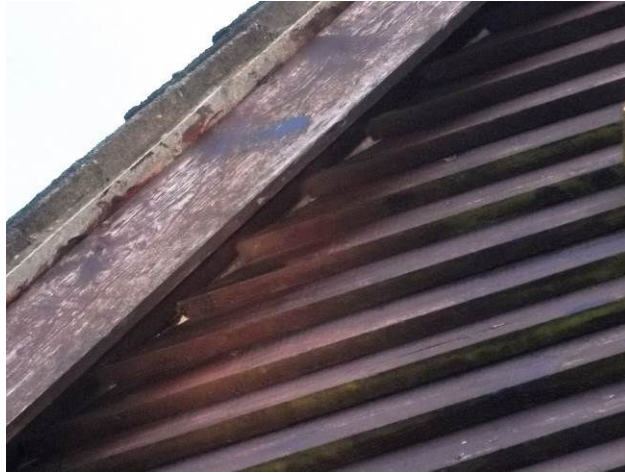
Externally the north-west-facing gable apex of the house is timber-clad. Although there are no gaps between the timbers along their length, there is a gap at the gable apex and there are gaps at the ends of the timbers:

In addition verge mortar-work will be reinstated at the rear gable and I understand it was hoped to remove the front cladding where bats are gaining entry to the house, and possibly roosting behind the cladding itself. Even if the cladding is retained, I understand it will need re-staining and the adjacent fascia board needs replacing.

If the cladding to the front gable end of the house is to be removed a European Protected Species Licence is likely to be needed to cover the work. This would apply also if any other roost discovered is to be destroyed.

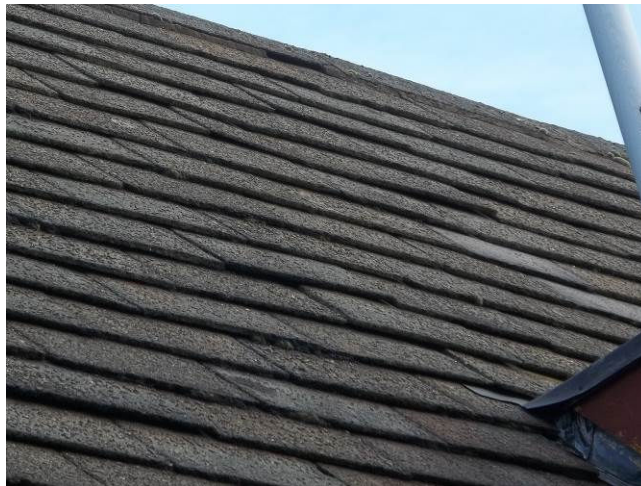
The roof tiles are quite thin, but a few are raised and there is at least one gap where mortar-work is missing from the ridge:

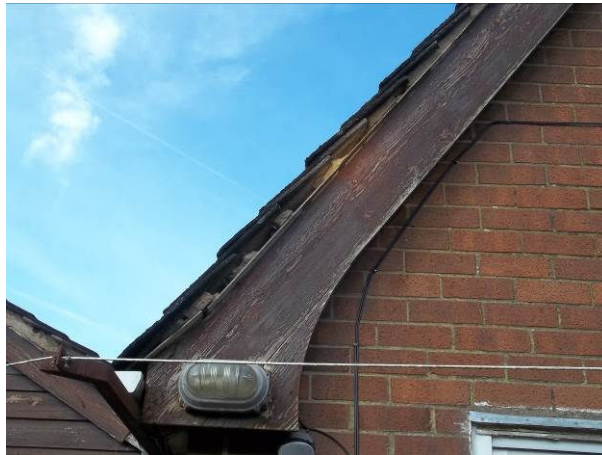
Some rear verge mortar-work to the house is missing:

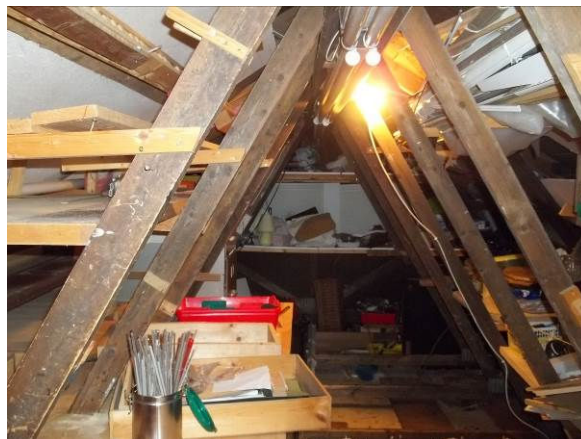
The garage has a large loft and much of it could not be inspected due to the number of stored items present.

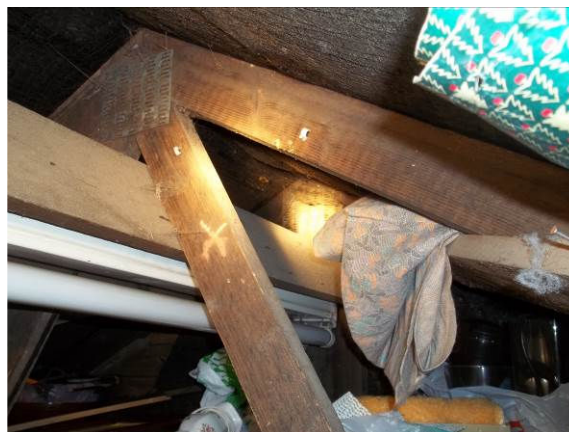
The floor is boarded and the roof lined with bitumastic felt, fixed above the trusses:

Internally, there was no obvious bat access available to the loft at the ridge. Much of the roof has been insulated in a makeshift manner using a variety of materials however, obscuring the felt.

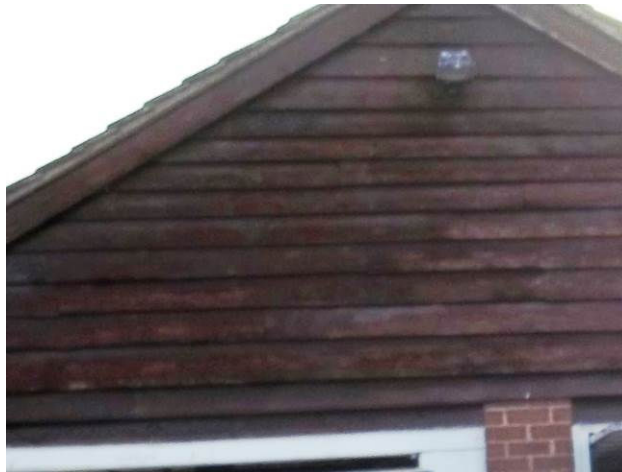
Externally both gable ends are timber-clad and there are gaps between the timbers that would allow bat access to the surface behind.

Cladding to the garage may be backed by board rather than brick, but bat access is easily possible and there is cladding to both gable ends.

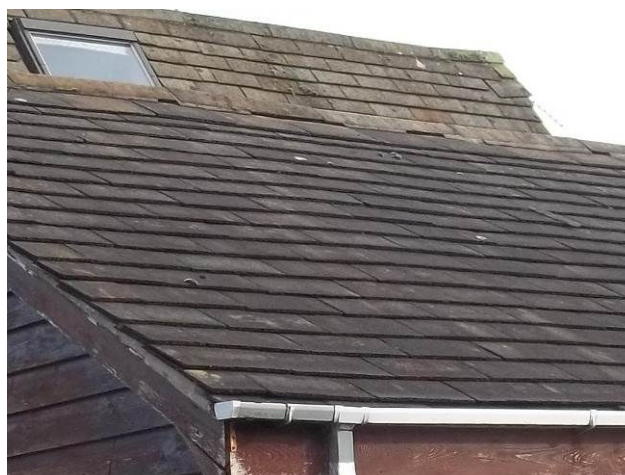
Some of the ridge mortar-work to the garage is missing:

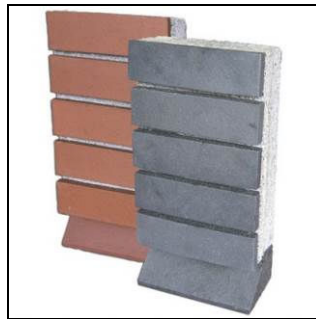
“Designed to be built into an exterior wall and is available in a variety of faces to match the building. Standard facings of red or blue brick - ideal for new builds - are normally available from stock, or boxes can be made to your specific requirements with a face of brick, stone, timber, or plain (for rendering). Supplied unpointed.”

Brick example of Ecosurv Habibat. Can also be faced with stone.

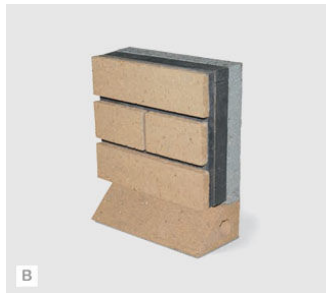
Enclosed Bat Box B

- Designed specifically for the pipistrelle bat
- Available in all brick types
- Discrete home for bats
- Various sizes
- Several roosting zones are created inside the box
- Bats are contained within the bat box itself
- Maintenance free with entrance at the base
- Ideal for new build & conservation work

Sizes	Durability
Eco Habitats for Bats - Technical Data: A	215mm x 65mm	F2 S2 - Fully Frost Resistant
Eco Habitats for Bats - Technical Data: B	215mm x 215mm or 215mm x 290mm	F2 S2 - Fully Frost Resistant
Eco Habitats for Bats - Technical Data: C	215mm x 215mm or 215mm x 290mm	F2 S2 - Fully Frost Resistant

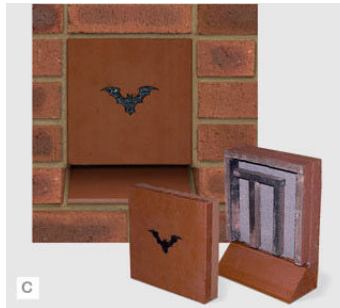
Enclosed Bat Box C with engraved motif

- Designed specifically for the pipistrelle bat
- Available in smooth blue, smooth gold & smooth red
- Attractive "bat" motif
- Discrete home for bats
- Various sizes
- Several roosting zones are created inside the box
- Bats are contained within the bat box itself
- Maintenance free with entrance at the base
- Ideal for new build & conservation work

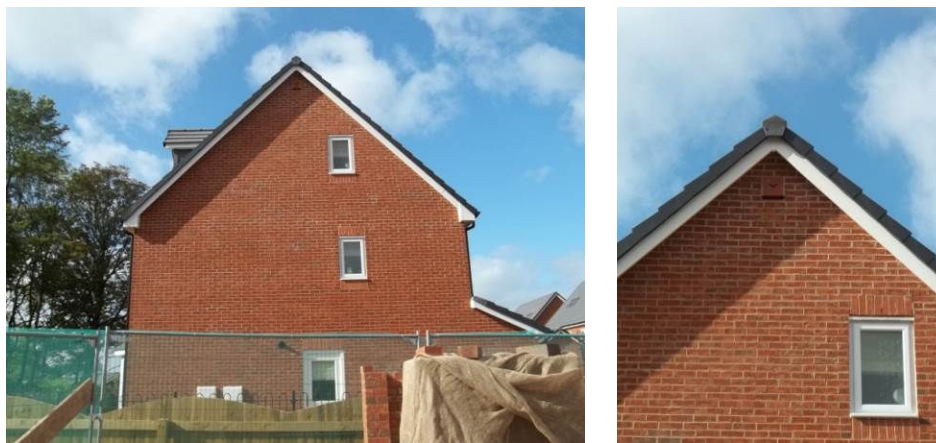
Above: typical unit in situ. Photo © Angela Graham

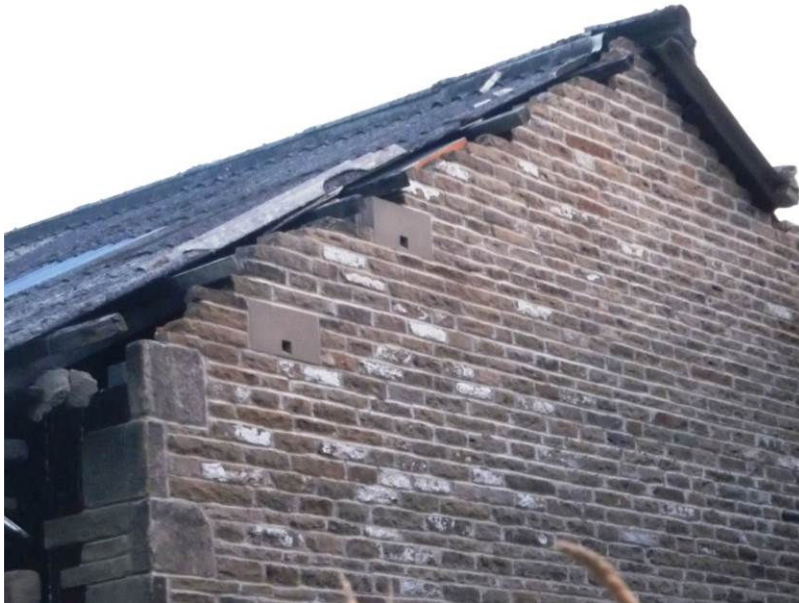
Example of Forticrete boxes in situ
