METHOD STATEMENT European Protected Species (Bats)

**Reasonable Avoidance Measures**

Wolfen Lodge, Fish House Lane, Chipping, PR3 2GR

29.11.2018

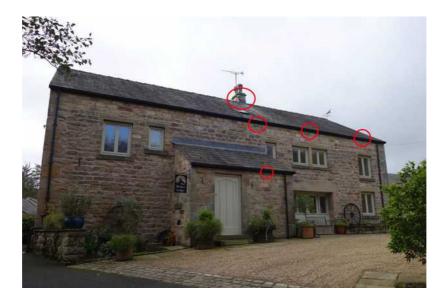
A follow up daytime survey on 23<sup>rd</sup> October 2018 identified areas of scattered pipistrelle droppings, and droppings adhering to wall surfaces that were consistent with areas identified as being used by roosting bats in earlier EED surveys.

Bat roost locations identified during surveys on frontage (North) of property.

The proposed development will have no effect on existing roost entrances which are located in the chimney areas and on the frontage of the property behind fascia boarding. Work will take place well away from these roost entrances.
