Re: EPS – Daylight scoping and dusk emergence survey: Wolfen Lodge, Fish House Lane, Chipping.

DAYLIGHT SCOPING AND DUSK EMERGENCE SURVEY

8 June 2017

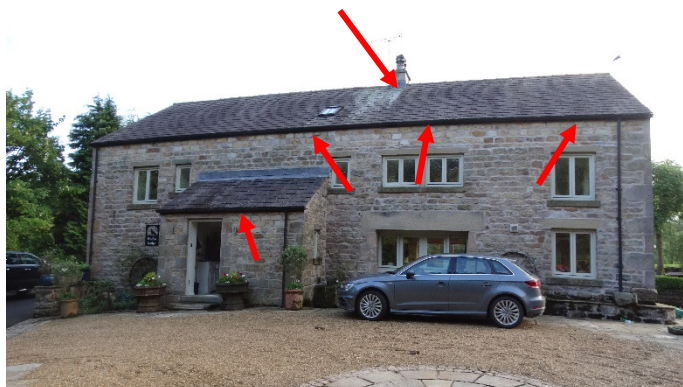
Figure 1: Front (east) elevation

Externally the building is very well maintained and all areas of stonework are mortar-pointed (figure 7). All windows and doors are D/G units which appear to be well-sealed and secure. The chimney has good lead work flashing although it should be noted that bats are roosting beneath the roof slates and leadwork on the front pitch; bats were seen emerging from a small gap beneath the flashing (located by red arrow in figure 1).

- (1) Under timber fascia boards along the front elevation (as located in figure 1 – red arrows)
- (2) Beneath roof slates and lead-work flashing around the chimney on the front roof pitch (figure 1)
- (3) A solitary pipistrelle was visible beneath the timber fascia on the front porch (as shown in figure 5).
- (4) Under timber fascia boards along the rear elevation (as located in figure 3 – red arrows)

Evidence of bat droppings on stonework is located in figures 1 to 7 above; there are small accumulations at ground level beneath soffits on the front elevation. It is understood the owners of the property are aware that roosting bats have been present on the front (east) elevation in previous years.

Compensation works must include bat access points to be maintained for roosting bats under the fascia soffits and leadwork flashings in addition to providing a number of bat access slates in new roof slopes.

Re-roofing / or replacement fascia boards must create 'like-for-like' access beneath new fascia boards enabling small crevice-dwelling bats (pipistrelles) to re-enter the roof verges*. By providing small access gaps under the fascias, bats can continue to roost in the small batten cavities around the roof verges.

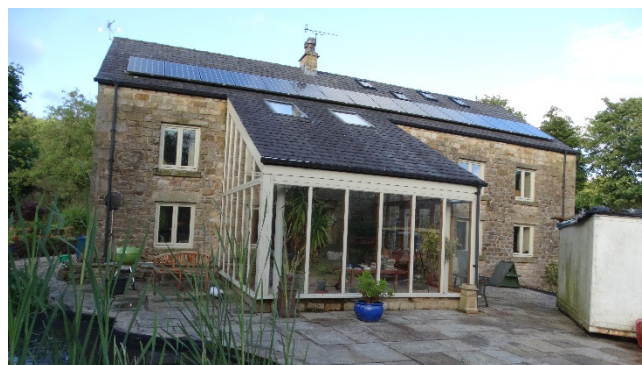
Figure 2: Rear (west) elevation

To the rear of the house is a timber-framed lean-to garden room with glazed windows and cat-slide roof (figs 2 and 3) with two Velux-type roof lights. The lean-to structure abutts the stonework and is very well sealed and secure (figure 9). The building has a 16 No. PV solar panels on the rear pitch of the roof and there are 4 No. Velux-type windows over the loft conversion (figure 2).

Removal of existing fascias, roof slates and underlays on the rear (west) elevation and front (east) porch should be undertaken outwith the critical period (May to August). The **optimal time** for roofing works is during the Autumn and Spring.

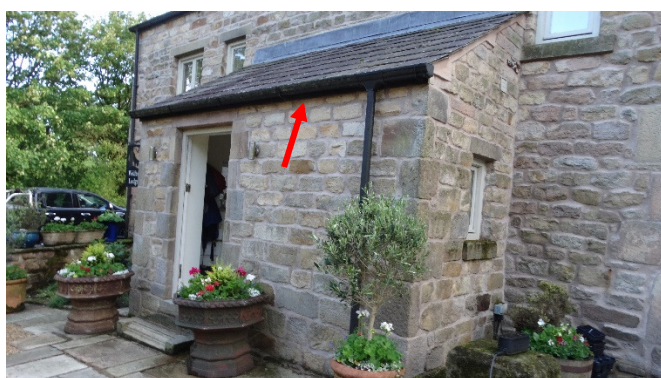
Figure 5: Entrance porch front elevation

The single storey front entrance porch (figure 5) has a mono-pitch slate roof and there is no roof void.

A common pipistrelle emerged from beneath the fascia on the front porch at 22.16; a solitary male was then heard foraging and calling (lekking) around the house and front garden for the remainder of the survey.

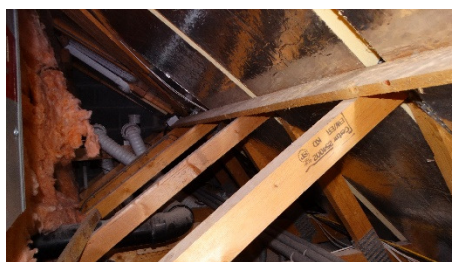
Figure 8: Rear eaves void

There is no evidence of access by roosting bats within the roof void (figure 8) although roosting bats are present within several roof areas as follows:
