Stone Barn at Waddow View,
Waddington Road, Clitheroe BB7 2HX

UPDATED LICENSED BAT SURVEY AND ASSESSMENT

March 2018

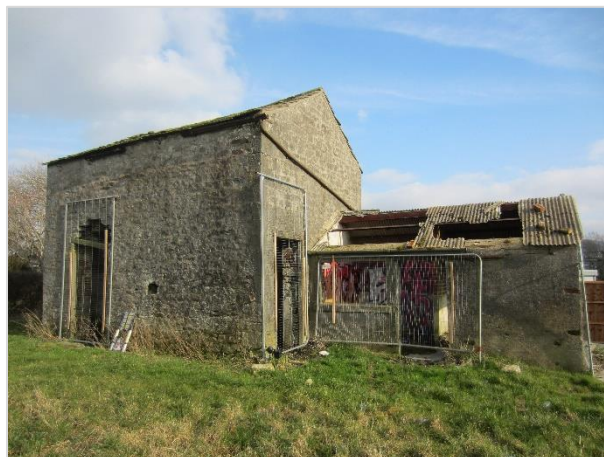
Insert 1: West and south elevations of the stone barn

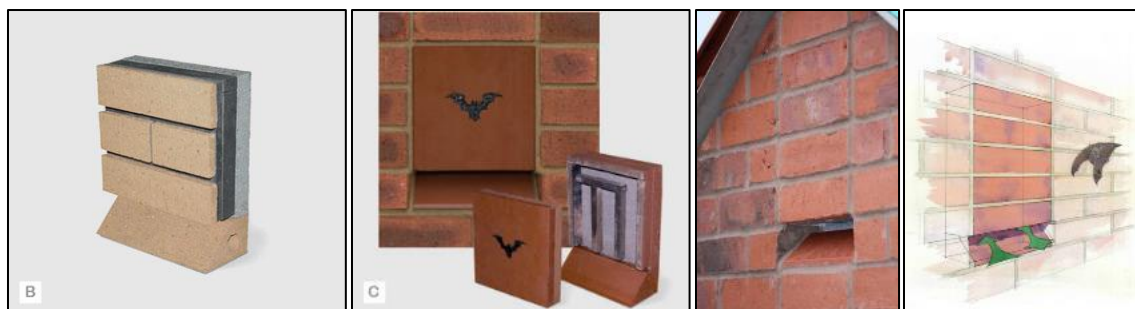
Insert 1: Example of commercially available bat access panels
(Left and centre left: IBStock products and Right and centre right: Habibat products)

- 5.3.4 As habitats suitable for the attraction of foraging bats will be retained and enhanced at the site it is recommended that the development incorporates the installation of at least 10³ commercially available bat access panels at the new buildings.
- 5.3.5 The bat access panels should be sited at least four metres above ground level, ideally facing or close to areas of landscape planting or existing linear features (i.e. the drain). The access panels should not be positioned over windows or doorways where bat droppings may become a nuisance. Once the development layout has been finalised, an ecologist will advise on appropriate positions for the bat access panels. Suitable bat access panels are available from NHBS Ecology (www.nhbs.com) or Wild Care Shop (www.wildcareshop.com) and are presented at **Insert 1**, below:

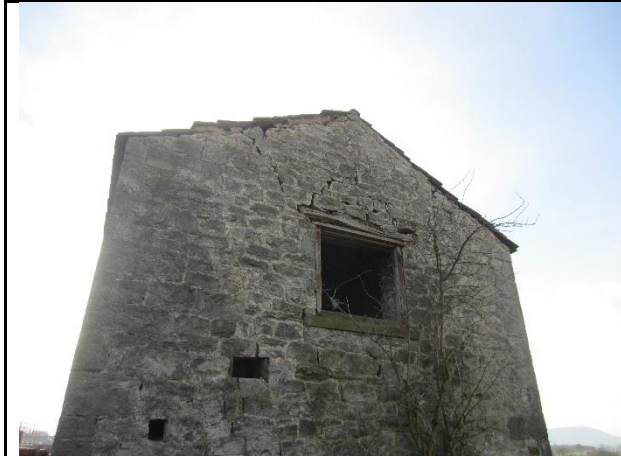
- 3.2.6 Features with potential for use by crevice roosting bats at the barn comprise:
- Within cracks and holes at the stone elevation walls, particularly on the north facing gable end, refer to **Photos 1** and **2**;

Photo 1: North elevation of stone barn showing gaps in the stonework and beneath the window lintel

- 5.1.1 To comply with the current guidelines, demolition works at the barn must be preceded by a bat emergence / re-entry survey. The survey can be carried out during suitable weather conditions between May and

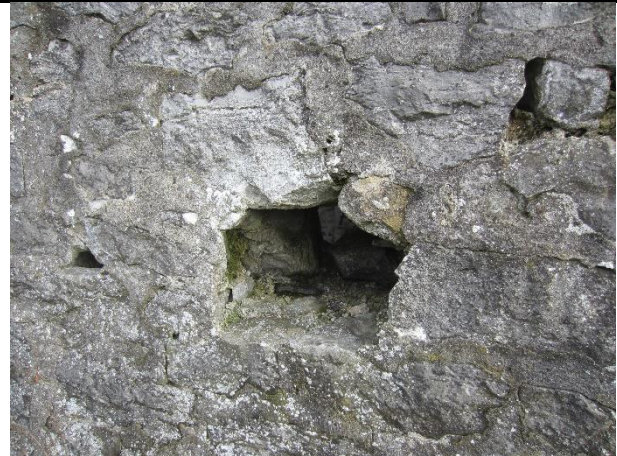
Photo 2: Gaps in the stone work

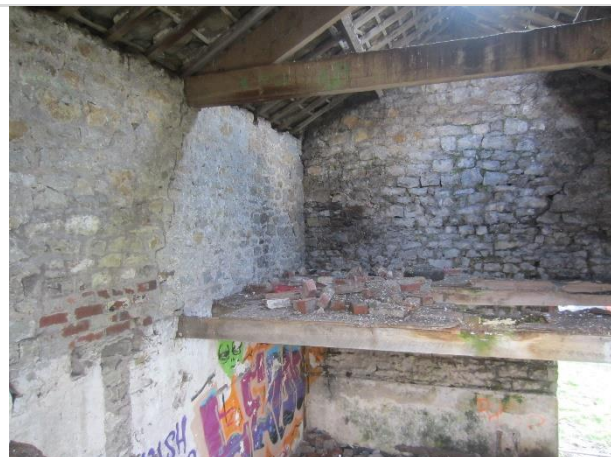
- 3.2.3 The barn is in a dilapidated condition, holes are present in the roof and there is damage to the stonework around the doorway and window apertures. Internally the floor of a timber boarded hayloft is rotten and partially collapsed. Comparison of the current conditions with photographs taken in 2014 indicate that the condition of the barn has deteriorated in recent years.

Photo 3: Interior of stone section showing dilapidated timber hayloft

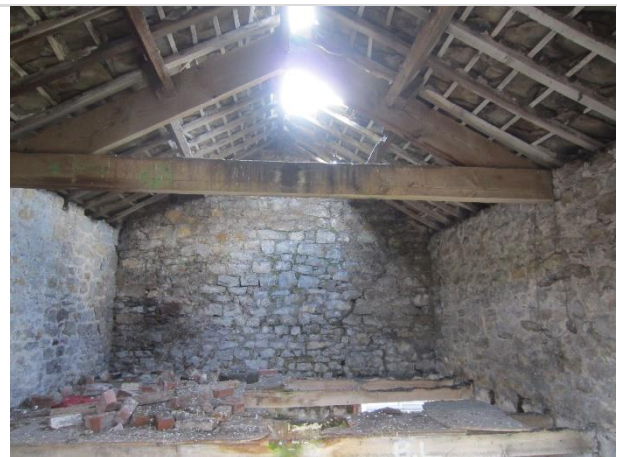
- 3.2.4 Owing to the exposed and dilapidated condition the use of the barn by void roosting bats is reasonably discounted.
- 3.2.5 The visible internal sides of the stone walls are well-pointed and provide no opportunities for bat access. The brick wall sections are well-pointed; no opportunities for bat access were found, refer to **Photo 5**. No gaps, cracks, open mortise joints or other opportunities for bat access were observed at the timber roof truss inside the barn.

- 3.4.1 No evidence of use of the barn by barn owl was recorded.
- 3.4.2 A flock of 8 feral pigeon were flushed from the barn and piles of droppings over the ground floor and floor of the timber hayloft indicate use by roosting (and possibly nesting) feral pigeon, refer to **Photos 3** and **4**.
- 3.4.3 No other old (or active) bird nests were recorded at the barn.
- 3.4.4 A single hole approximately 3.5 metres from ground level on the north facing stone elevation wall of the barn was filled with bird droppings, indicating use by a roosting passerine bird.

Photo 4: Interior of stone barn showing mortared / pointed internal walls and feral pigeon droppings

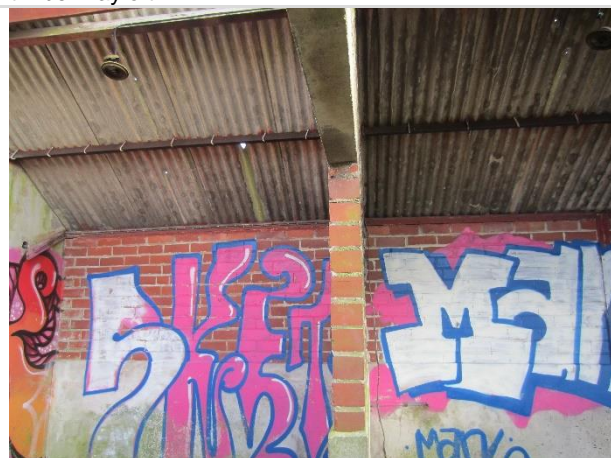
- 3.2.8 The stone barn is assessed to be of low suitability for use by individual / low numbers of crevice roosting bats. The brick annex is of negligible suitability.

Photo 5: Interior of brick annex; no opportunities for roosting bats

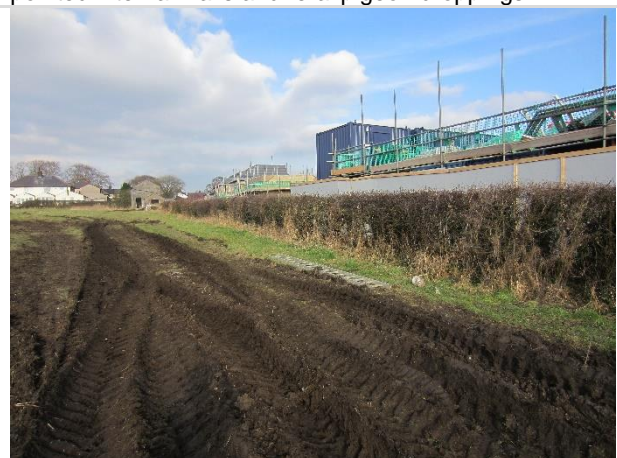
Photo 6: Hedgerow to east of barn and adjacent construction site (facing north)

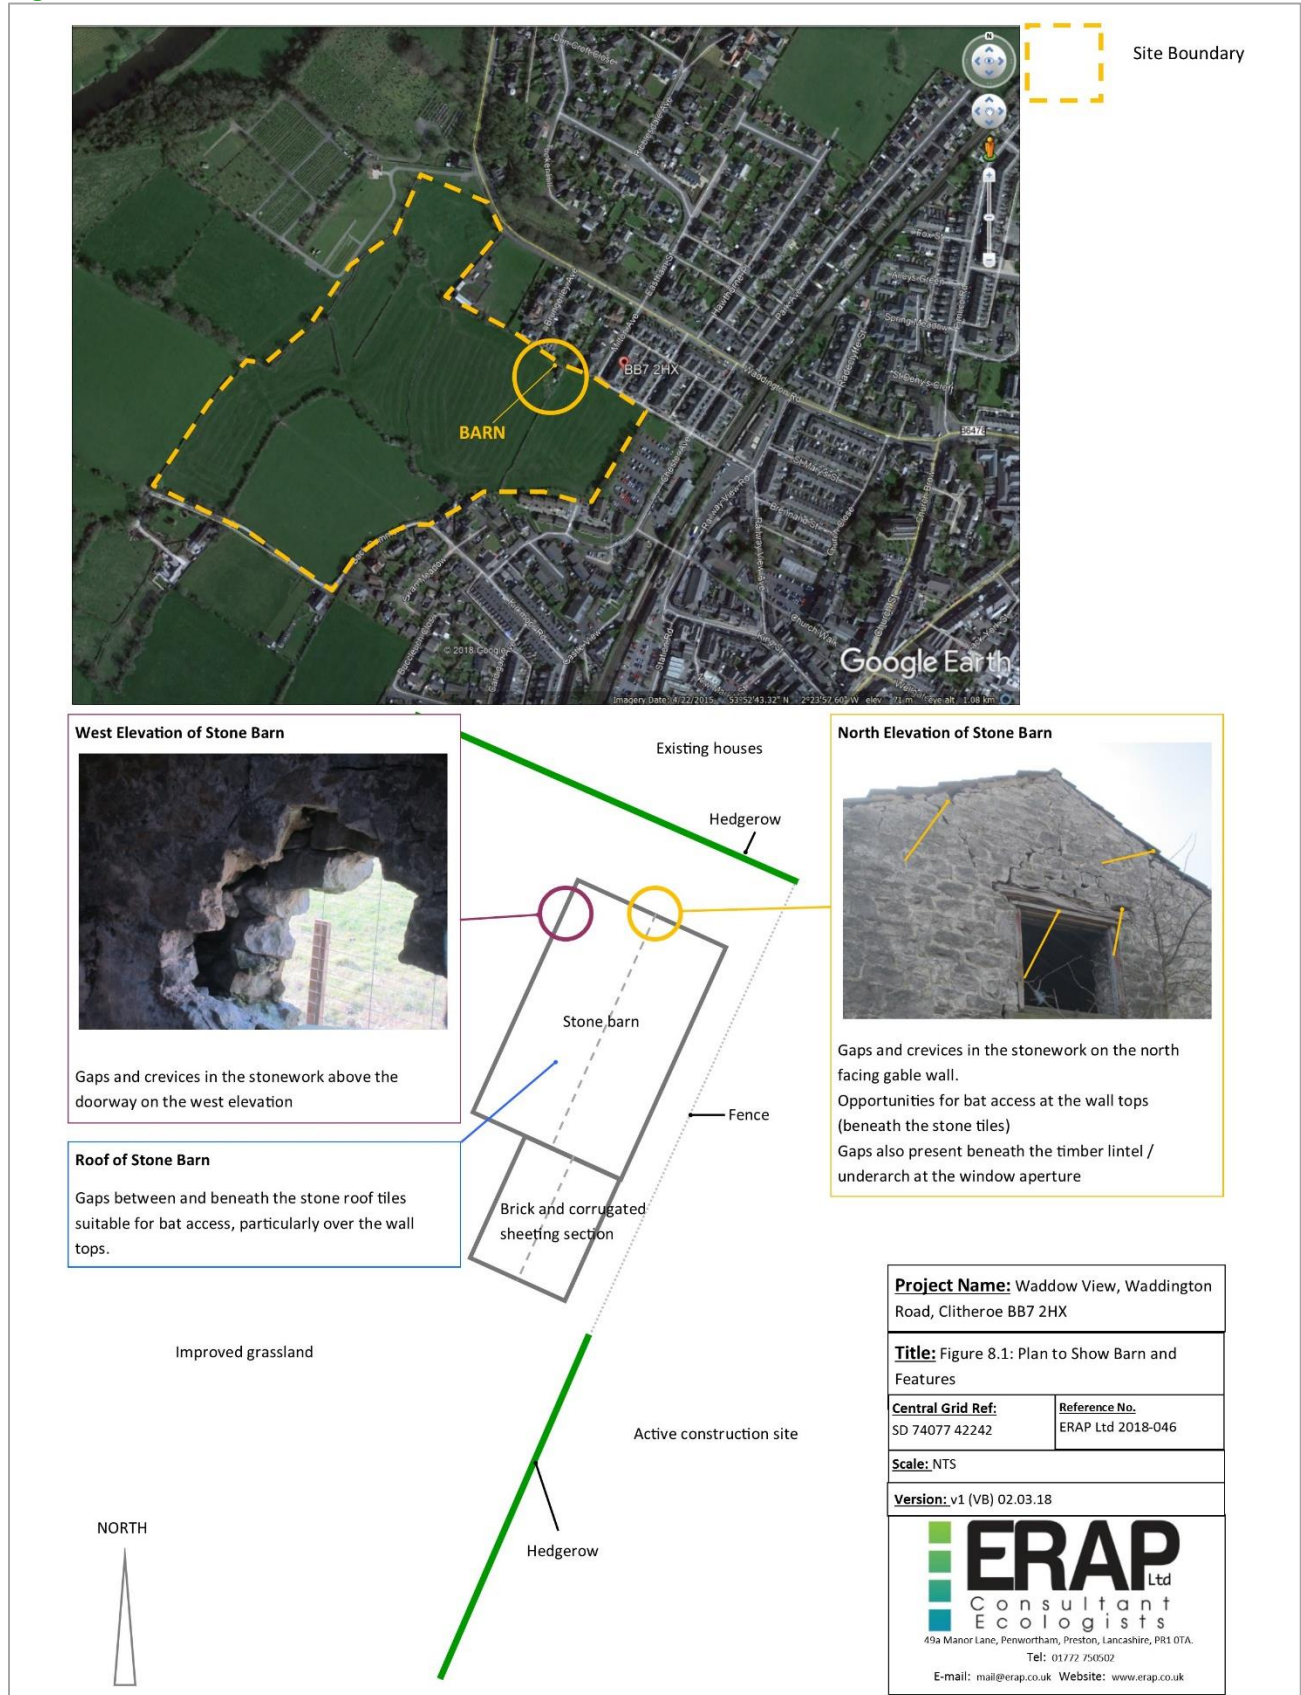
Figure 8.1: Plan to Show Barn and Features

1.2.2 Immediately north of the barn is existing residential development off Milton Avenue. Land to the east is an operational construction site. South and west of the barn is a field of improved grassland with hedgerows extending from the barn to the west and south, refer to **Figure 8.1**.

- Gaps in the underarch and around the timber frame above the window aperture on the north elevation wall and the doorway on the west elevation, refer to **Figure 8.1**;
