Barn at Waddow View, Waddington Road, Clitheroe BB7 2HX

RESULTS OF DAWN RE-ENTRY BAT SURVEY

October 2018

[ERAP (Consultant Ecologists) Ltd ref: 2018-046b]

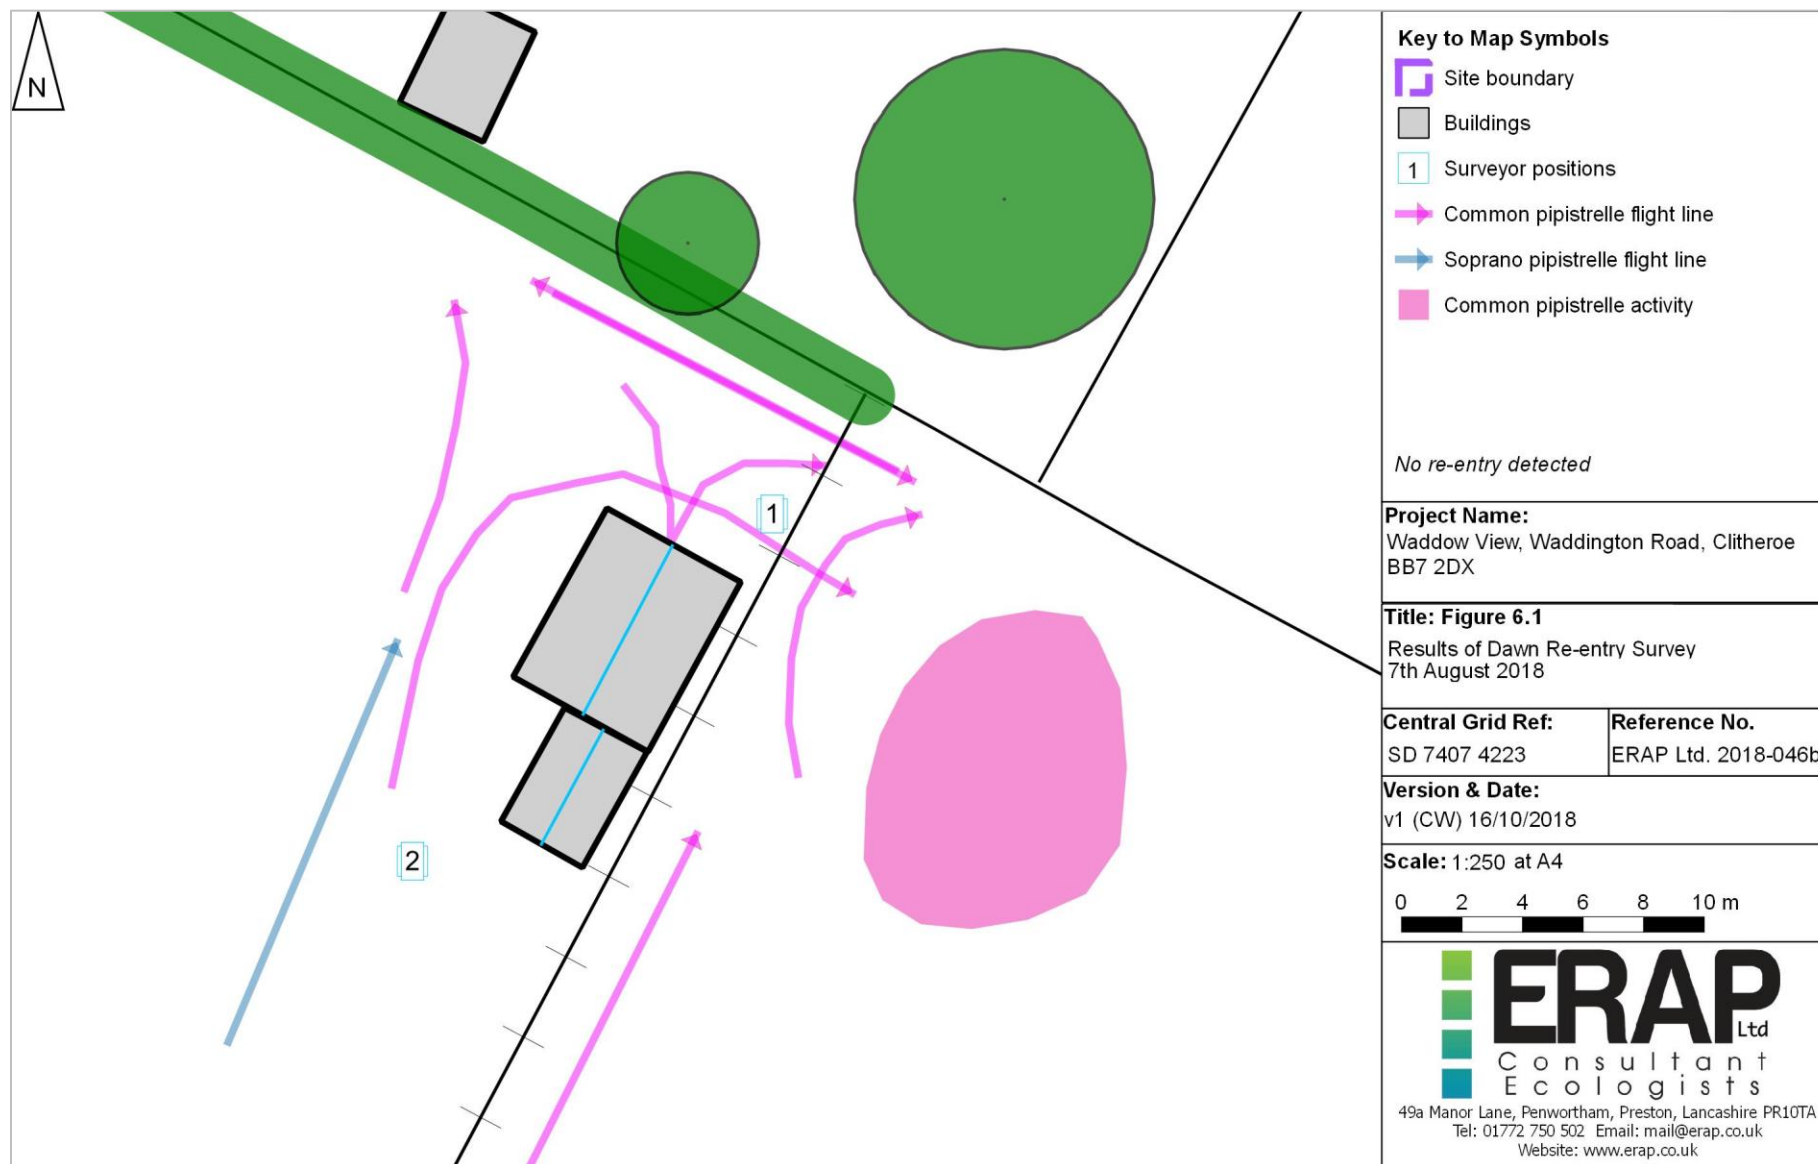
Figure 6.1: Dawn Re-entry Survey 7th August 2018

- 2.1.5 Surveyor positions are annotated on **Figure 6.1**. Any bat emergence or re-entry activity was recorded. All surveys were conducted under suitable conditions. The dates of the surveys, surveyors and equipment used and weather conditions present are presented at **Table 2.1**, below.

- 3.1.1 No bat re-entry (or emergence) was detected at the barn during the survey.
- 3.1.2 Common pipistrelle (*Pipistrellus pipistrellus*) were detected flying along the hedgerows near to the barn between 03:46 and 05:05, with the last call recorded 28 minutes before sunrise. One soprano pipistrelle (*Pipistrellus pygmaeus*) pass was recorded at approximately 04:38. No other bat species were recorded.
- 3.1.3 Surveyor positions and all observed bat activity are annotated at **Figure 6.1**, appended. Raw data are appended at **Table 6.1**.
