GREENDALE VIEW, CHATBURN ROAD, DOWNHAM:

HERITAGE APPRAISAL

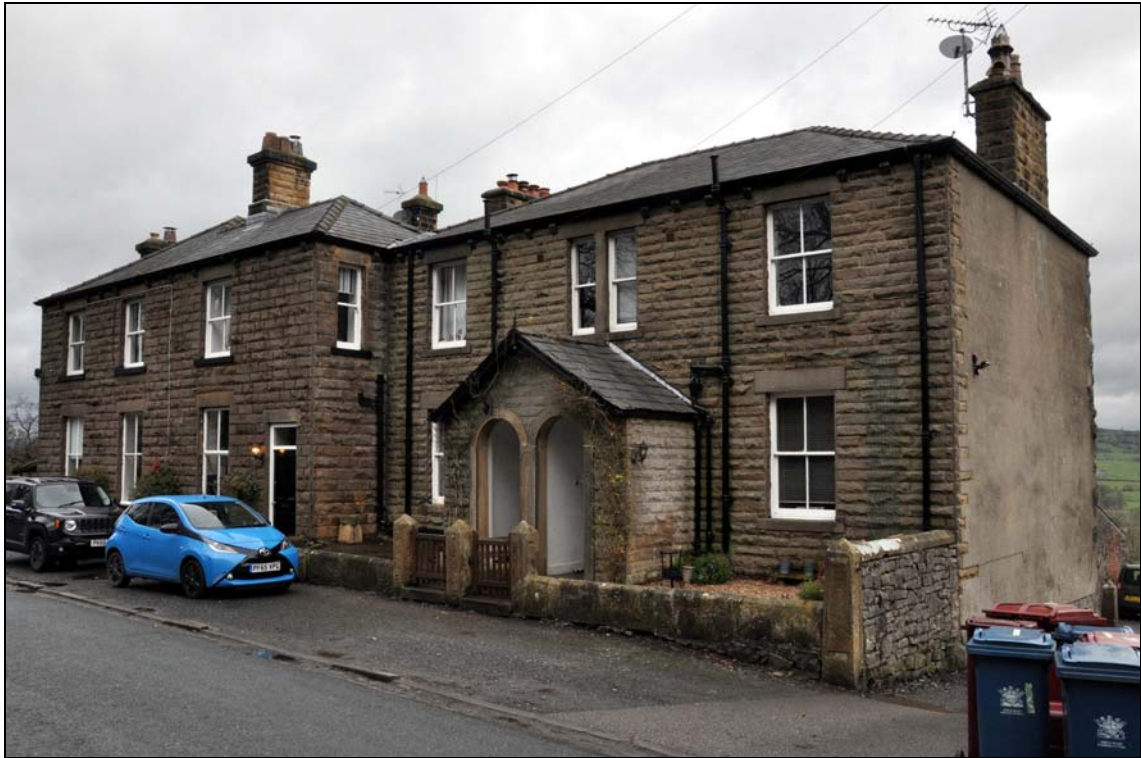
- 5.1 The original pair of semi-detached houses built in 1875 appear to have formed dwellings for the members of the middle or professional class, rather than being intended for commercial use. The façade is of coursed, rock-faced sandstone with ashlar dressings, and a gabled porch encloses both entrances. Windows are large, four-pane sashes typical of the period and the blue slate roof is hipped, with pair of chimney stacks at the ends. The east elevation is rendered, and the rear, north side is of limestone rubble, with squared limestone quoins, although window lintels here are sandstone. There is a full height basement storey, confined to this rear side only.

Photo 1: Semi-detached houses of 1875 (at right)

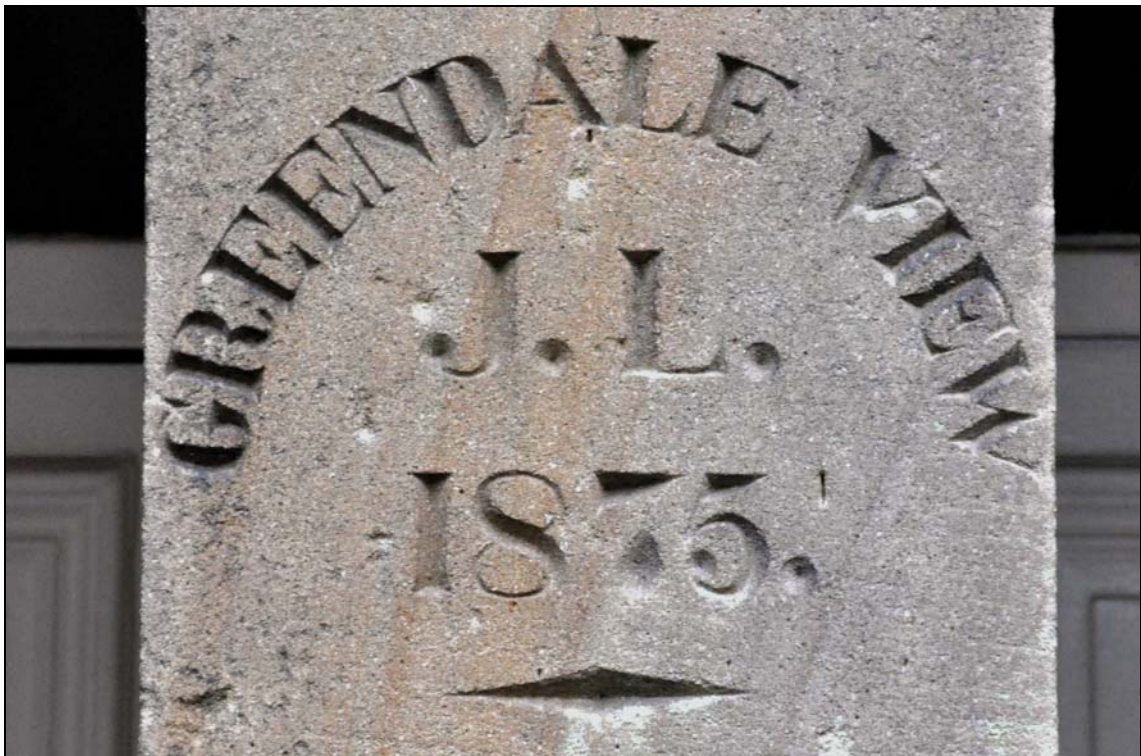
Photo 2: Dated porch jamb, semi-detached houses

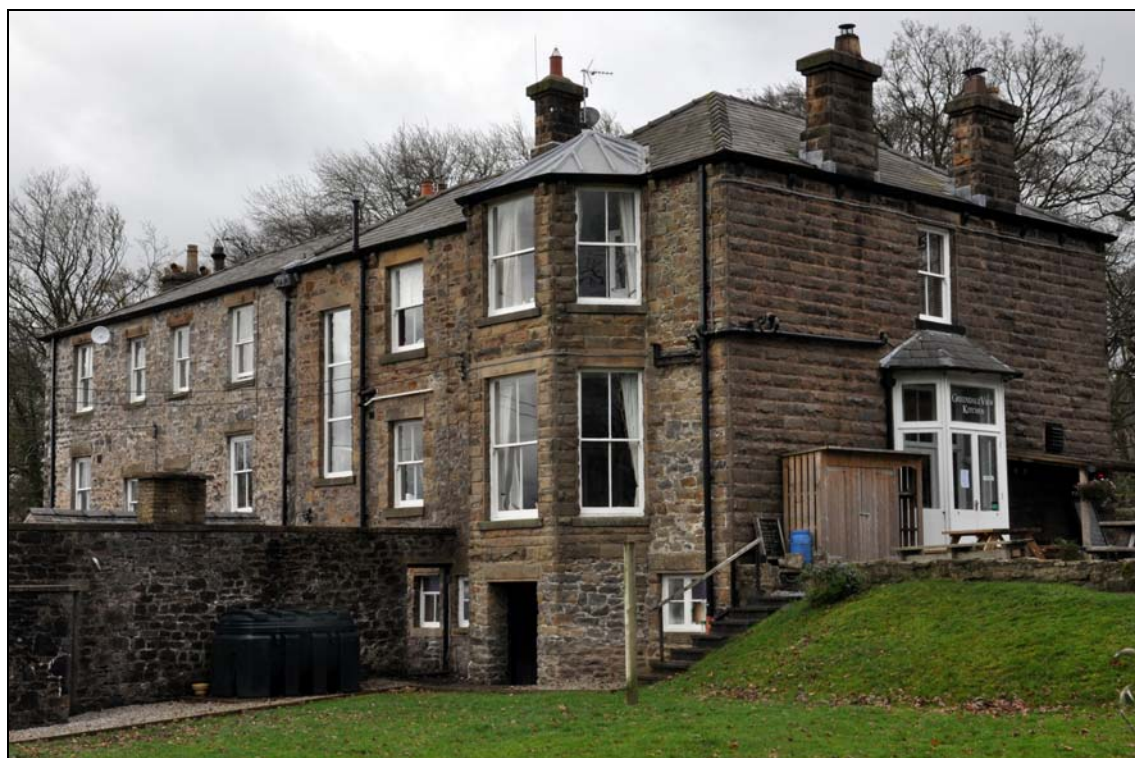
- 5.2 The western addition of the late 1870s or early 1880s is slightly larger in scale than the two semi-detached houses, and is set forward from them, with a west-facing front overlooking the garden. It seems that it was intended to provide the

principal day and guest rooms of the temperance hotel, which also incorporated the existing two dwellings to the east, presumably for use by the proprietor and staff. In construction detail, the west and south sides of the extension are broadly similar to the 1875 frontage. The rear, most of which is faced with a mixture of limestone and sandstone rubble, has a projecting, canted bay, to take advantage of the far-reaching views over the Ribble valley; the west porch is a 20th century addition.

Photo 3: Temperance hotel addition, looking south-east

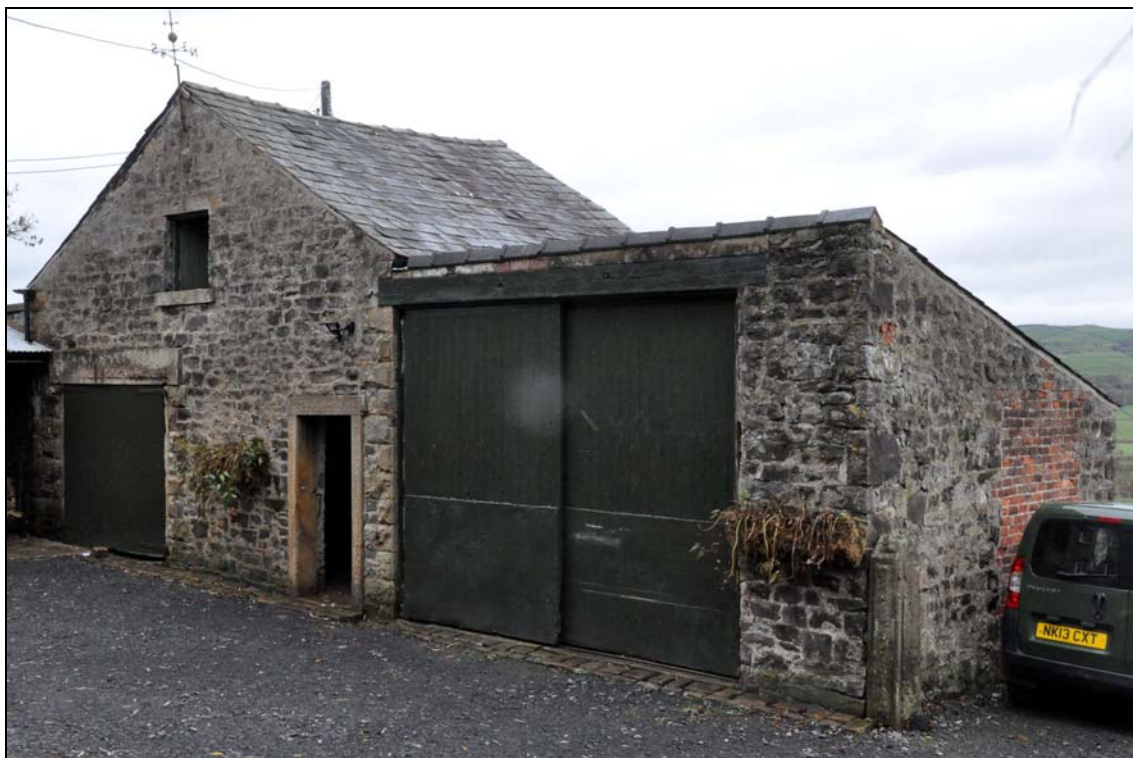
- 5.4 The largest of the outbuildings is a trap house with stable and hay loft, built from limestone rubble with sandstone dressings, and with blue slate roof and tile ridge. It has a gabled, south-facing front, in which there is a wide doorway with massive sandstone lintel, a smaller, pedestrian doorway to the stable to the right, and a forking hole to the loft. This front appears unaltered, and retains a weather-vane at the ridge, although the pair of doors to the trap house have been over-boarded or replaced. The rear has two windows which are the result of alteration, and presumably post-date the addition of the lean-to below. There is also a mucking-out hole in the rear of the stable, now located within the lean-to.

Photo 4: Two storey trap house and stable, with later trap house or motor garage to right

- 5.5 The building proposed for conversion is an addition on the east side of the stable, and appears to have been built as a second trap house or motor garage, which, to judge from historic maps, dates from before 1910, though this is not conclusive and it may be later. In comparison with its earlier neighbour it is relatively plainly built, with timber lintel over the pair of full height, timber sliding doors to the front elevation, and walls faced with limestone rubble, containing an area of brick infill (a former doorway), on the east side. The blue slate roof is of a single pitch, and continues down over a later rear lean-to, to the north. It has ridge tiles at the south side, overlying a course of bricks above the timber lintel.

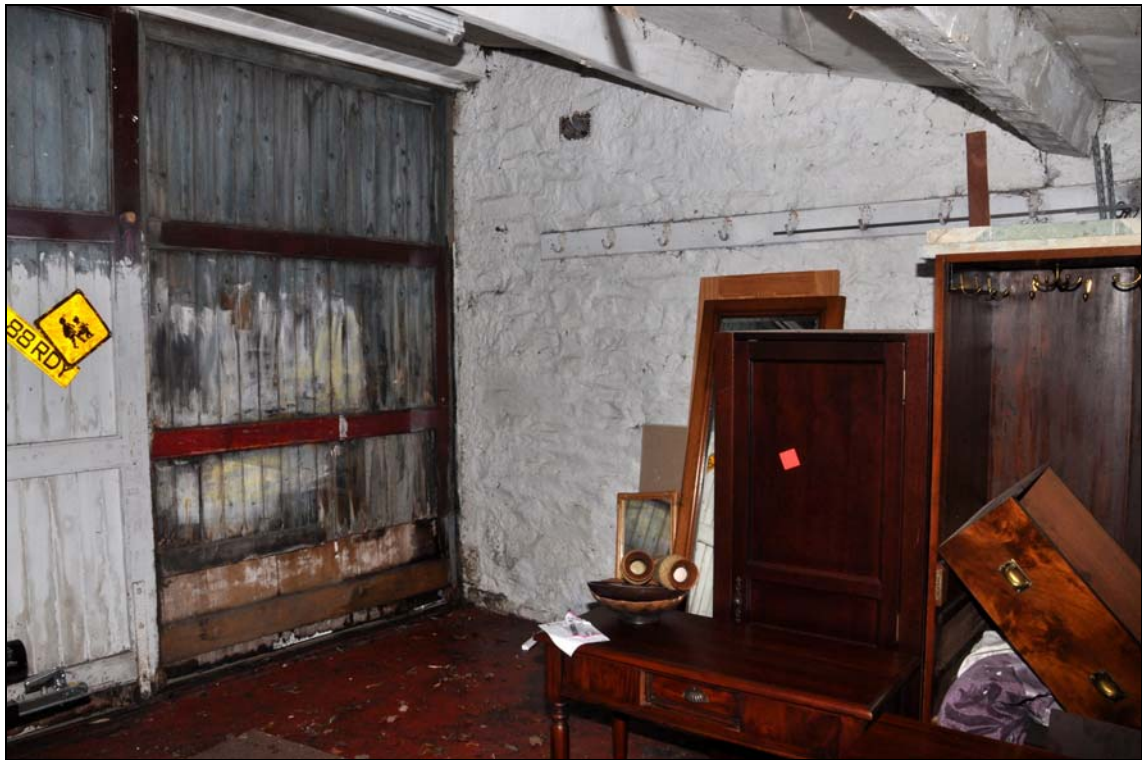
- 5.6 The interior of this unit forms a single space, with concrete floor and whitewashed walls, open to the roof. The latter is carried on two large softwood purlins. A row of metal hooks along the west side of the room might relate to harness storage, but there are no other fixtures visible. An inserted doorway in the rear wall leads into the later lean-to.

Photo 5: Interior of building proposed for conversion

Photo 6: Interior of building proposed for conversion (view towards the rear)

- 6.3 In particular, the unit which is proposed for outdoor guest accommodation is a relatively late addition to the group, whose wide front opening with sliding timber doors, and single pitch roof, reduce its heritage significance. The interior has a row of nondescript metal hooks to the west side, which might indicate accommodation for horse-drawn transport, but this is not of more than passing interest, and could be re-located in conversion, with no impact on heritage significance. The proposed change of use of this unit, with any accompanying minor alterations to accommodate it, would not reduce heritage significance of the building or the group.

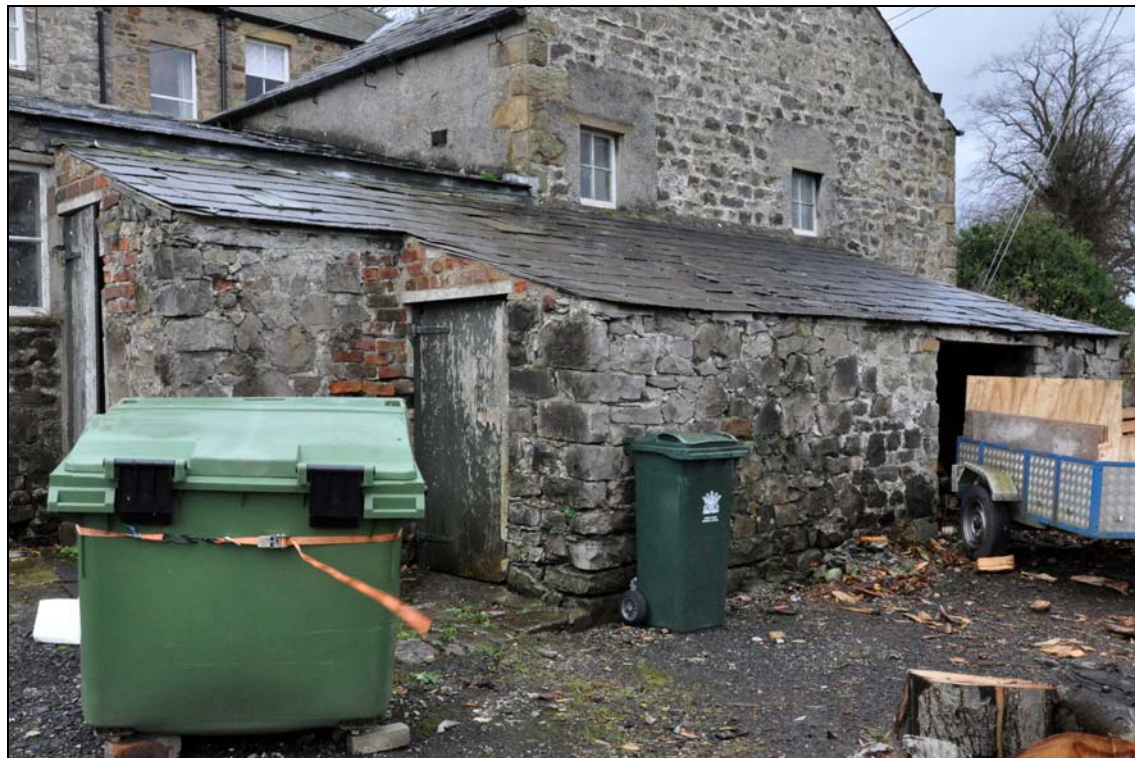
- 5.7 The lean-to which runs along the rear of both trap houses is L-shaped in plan, and comprises three separate rooms. It has limestone rubble walls and blue slate roof. The smallest, easternmost room was probably a privy for use by staff,

to judge from its size, but the functions of the two other rooms are unknown. The west room has a plain opening in the north side, notable for its lintel of re-used hardwood, but lacks any door. This L-shaped addition seems to be of a single main phase, with minor alterations, and to date from the early 20th century.

Photo 7: Later lean-tos to rear

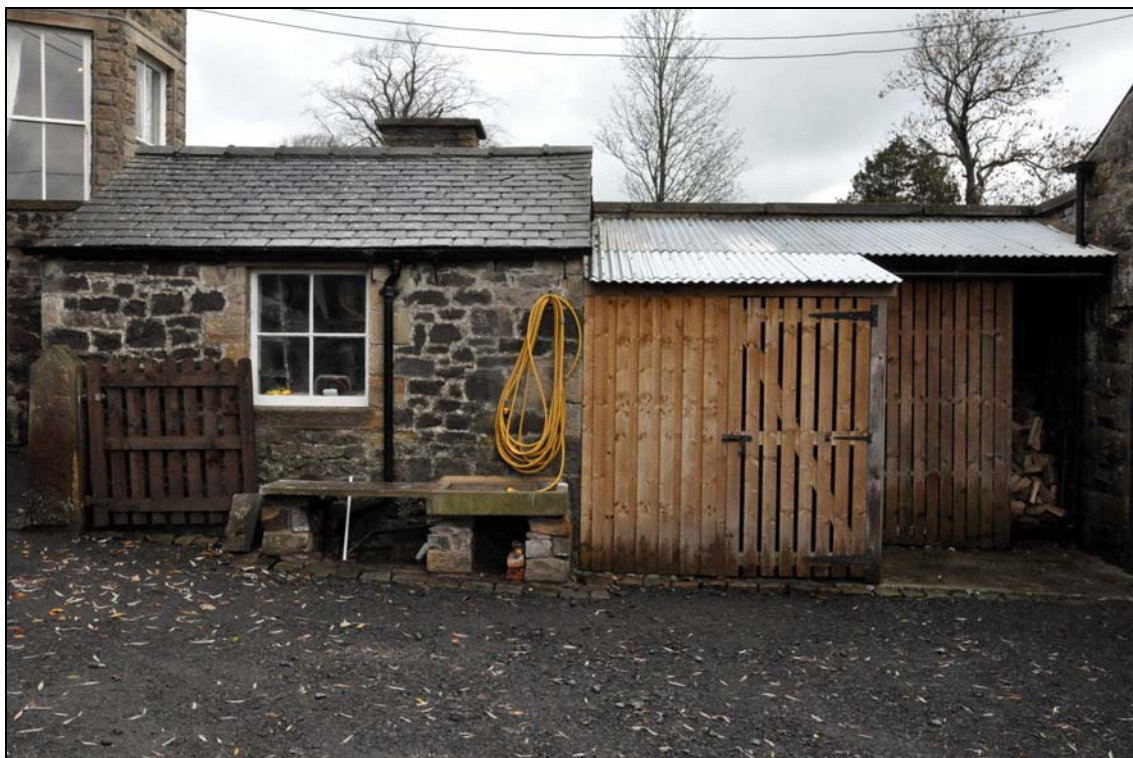
- 5.8 The fourth outbuilding within the main group is a small wash-house, built against the tall wall forming the west side of the courtyard. It has limestone rubble walls with sandstone dressings, blue slate roof with tiled ridge, and a low stone chimney stack to the west elevation, which forms part of the courtyard boundary wall. A modern roof links it to the trap house/stable to the north.
- 5.9 A small, low outbuilding at the south side of the yard faces the rear of the 1875 semi-detached houses, and appears to be a pair of privies to serve their inhabitants, but is not shown on any of the historic maps. Another privy, again omitted from early maps, stands at the north-west corner of the gardens to the east of the courtyard.

Photo 8: East side of wash house
