**BAT SURVEY AT -
LOWER YEW TREE FARM
ALSTON**

DATE AND TIME OF VISIT
19th Jan 2019 9.30am

REFERENCE NO. 5051

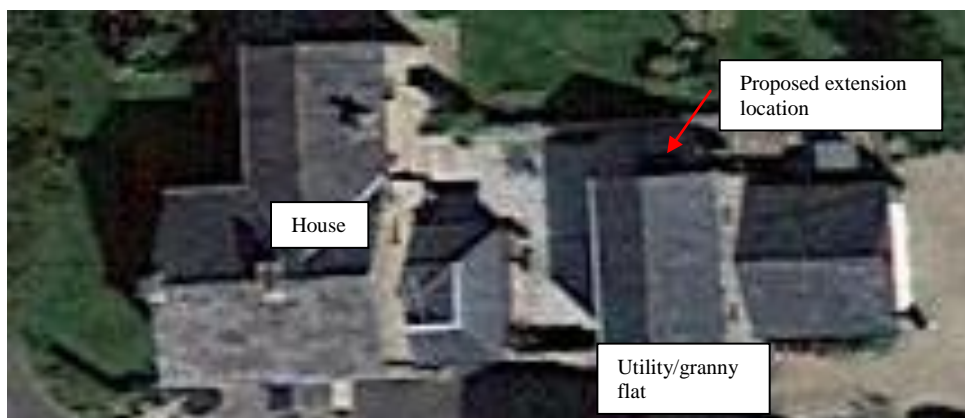
Disturbance of existing roof at the verge of the existing.

The exterior of the building particularly the north gable being affected by the extension, was closely inspected for any droppings, staining or grease marks to indicate any bat access into the building. None was found nor were any access points.

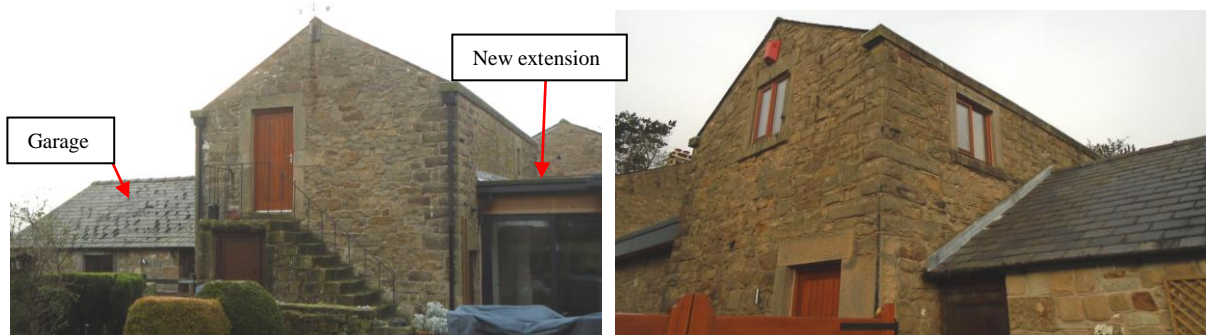
North gable

South gable and part east elevation

The property is a farmhouse dwelling which has been recently extended with single storey extension to connect the house with the detached utility and granny flat. There is a single storey garage attached to the east elevation.

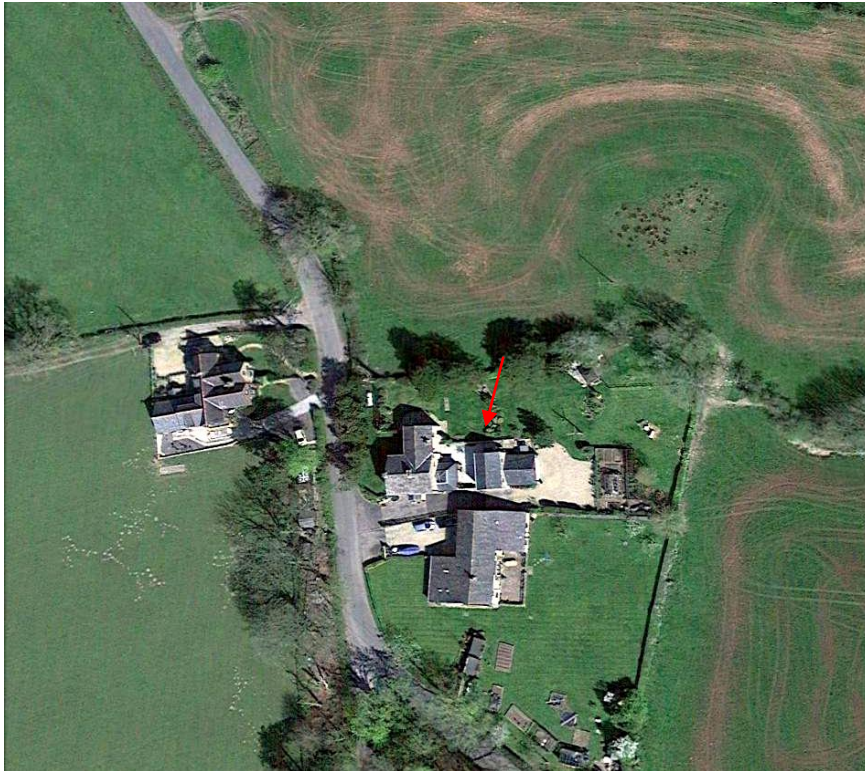
The walls are random stone with quoins, with flush pointing.

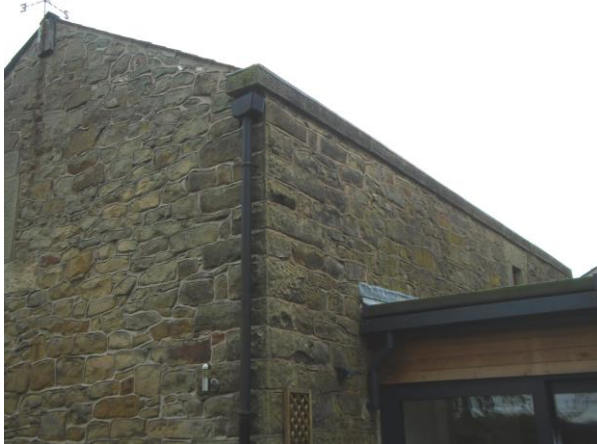
The walls and pointing are all in perfect condition with no cracks, crevices or access points for bats.

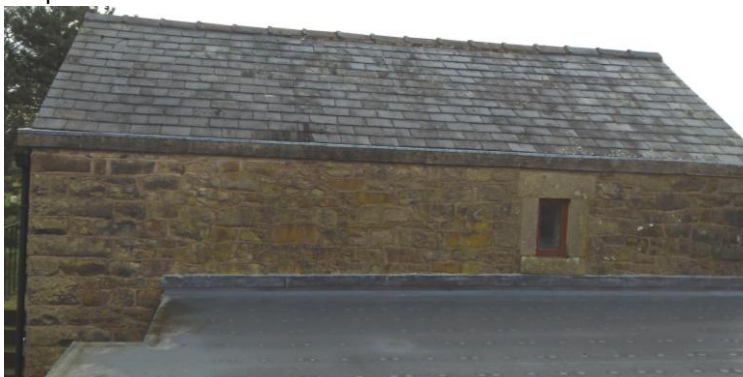
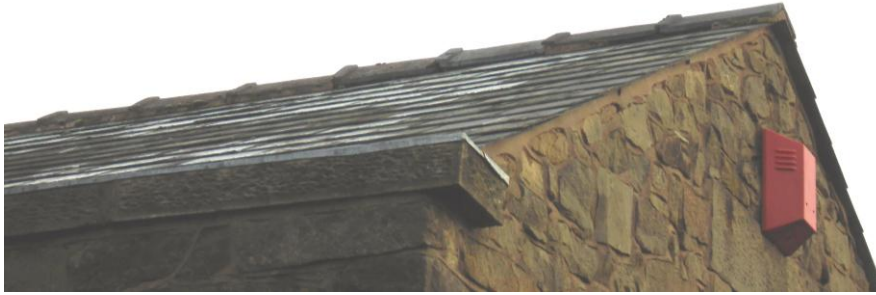
The roof is pitched with a blue slate finish and ridge tiles. The gutters are lead lined stone and the gable verges are pointed.

The slates are very tight fitting with no gaps. The verge and ridge pointing is in reasonable condition with no significant cracks or crevices.

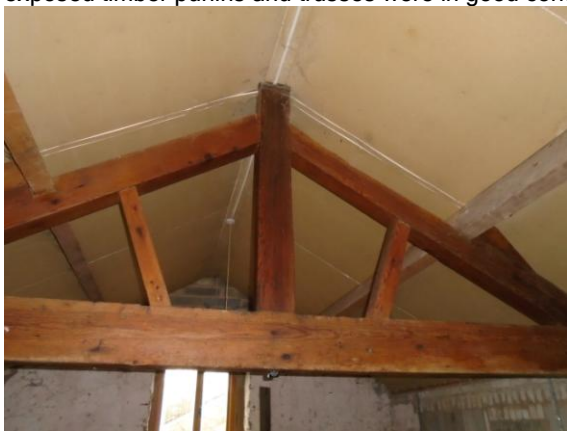
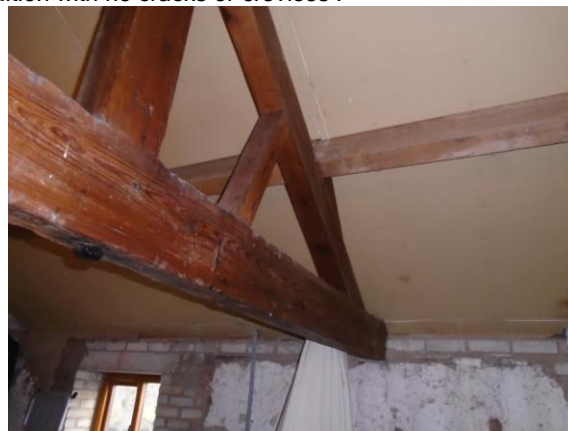
The first floor of the building was open to underside of the roof, the rafters were lined with plaster board. The exposed timber purlins and trusses were in good condition with no cracks or crevices .
