## Preliminary Roost Assessment Bat Survey

60 Mayfield Avenue, Clitheroe, Lancashire BB7 1LE

Struan Robertson

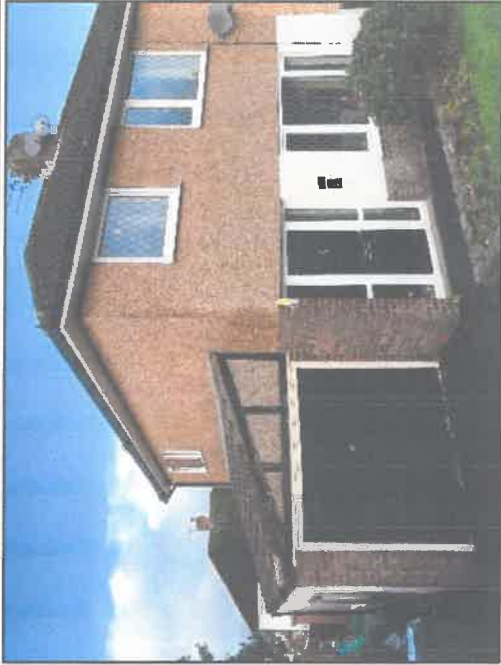
| <p>Building B1 Description</p> <p>B1 is a two-storey brick built and pebble-dashed semi-detached house, built approx. 60 years ago. There is a single storey lean-to garage to the south-west elevation.</p> | <p>Photo 1: Street view of B1, a pebble-dashed semi-detached house with a single storey lean-to garage.</p> |

The main roof is of a hipped construction, and therefore has three pitches of similar dimensions; covered with concrete "Marley" tiles, probably original. There are no obviously broken or lifted tiles visible on the east or south pitches. The ridge tiles are in reasonable condition, with no obvious missing mortar. There is one vented ridge tile to the upper ridge, which could allow access for bats to the ridge cavity.

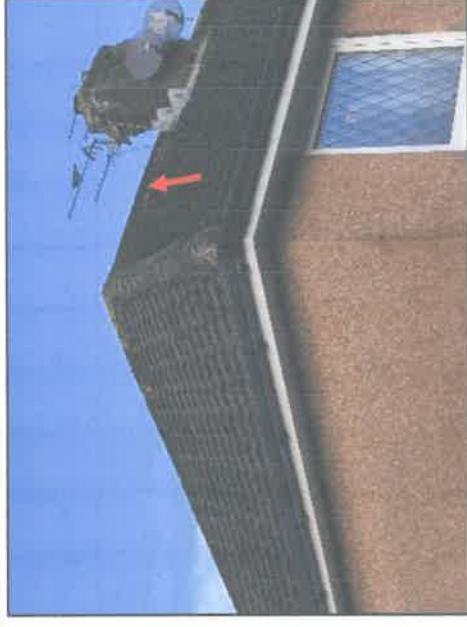
The chimney is shared with the adjoining property and is in a reasonable state of repair, with no gaps in the mortar, or lead flashing.

Photo 2: Southeast corner of B1, showing two of the 3 roof pitches, shared chimney, and vent in the ridge tile on upper ridge.

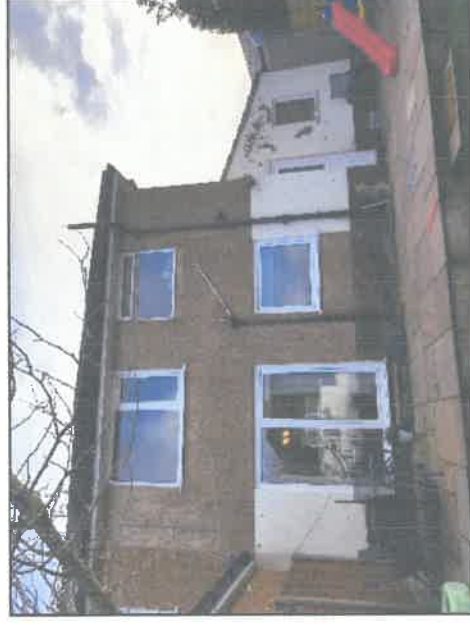
Windows are uPVC and tight fitting. The front door located on the south elevation is uPVC and tight fitting, as are the rear sliding patio doors.

Photo 3: Northwest elevation of B1.

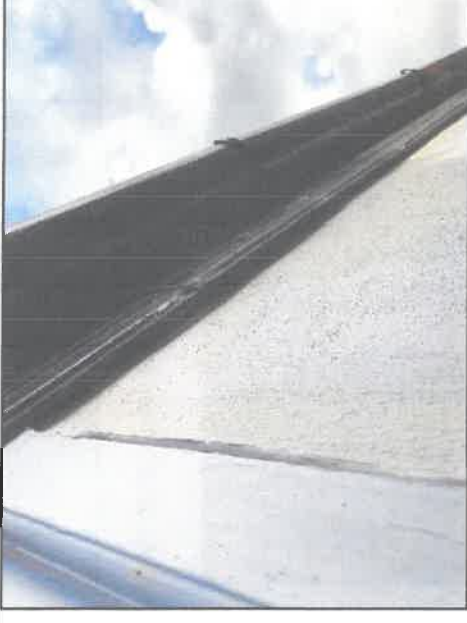
The lean-to garage has a single pitched concrete tile roof, in a reasonable state of repair. The windows are timber framed and tight fitting. The “up-and-over” garage door to the front (southeast) elevation is timber framed and tight fitting. The barge board down the side of the building (west elevation) has a gap to the brickwork behind running the full length. There are no smudge marks or urine stains associated with historic/frequent use by bats.

Photo 4: Showing the gap behind the barge board on the west elevation of the lean-to.

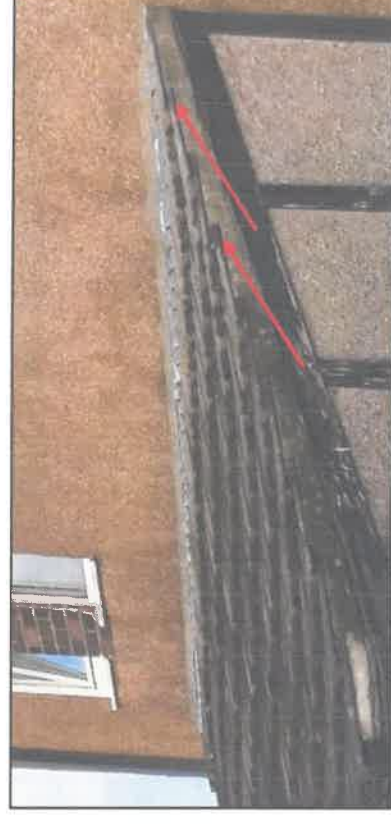
There are a few gaps between the roof tiles to the front elevation, but again no evidence of use by large numbers of bats.

Photo 5: B1, front (south) elevation, showing the gaps in the roof tiles at the leading edge.

All of the gaps referred to above are known to be utilised by crevice dwelling bat species such as pipistrelles and myotis species.

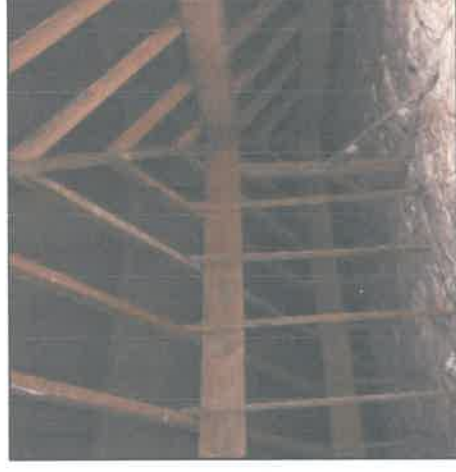
Internally there is a loft space above the whole of the main building. All areas that were safe to enter were inspected (refer to limitations in section 2.3 above). The loft measures approximately 4m long, 4m wide and 1.6m in height to the ridge. Timber beams are present within the main loft area and there are dense cobwebs indicating that no bats have been flying with this space recently.

Photo 6: Interior of loft space showing roof construction

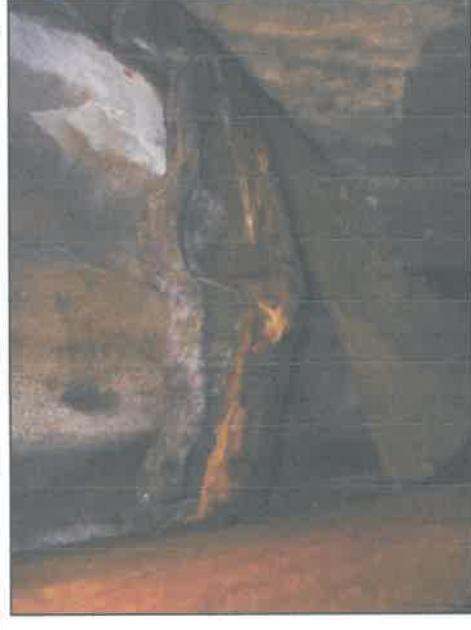
The roof is lined with bitumen felt that is tight fitting in the main, but with three tears visible on the north west elevations. The supporting timbers have given way and pierced the felt, leaving large gaps to the tiles above. There is evidence of water ingress, but not signs of lifted tiles or open gaps to the outside.

Photo 7: Close up of broken roof timber and felt, exposing the underside of roof tiles.

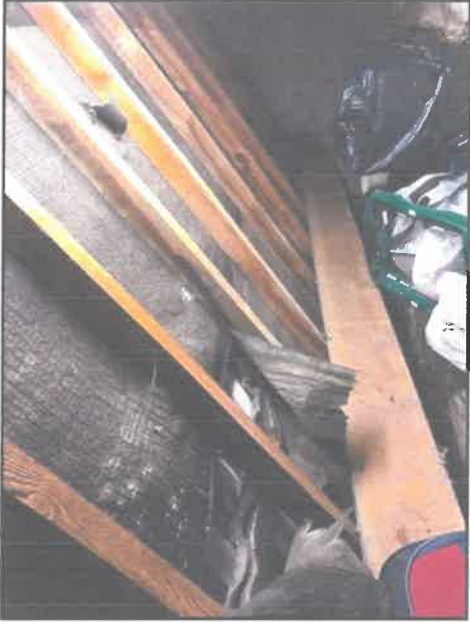
| <p>This roof pitch is not visible from the ground, due to the constraints of the garden, and slope of the ground (refer to limitations in section 2.3 above). Should there be any lifted roof tiles on this pitch, bats would have access to the loft space through the gaps in the felt.</p> | <p>Photo 8: North west roof pitch interior.</p> |

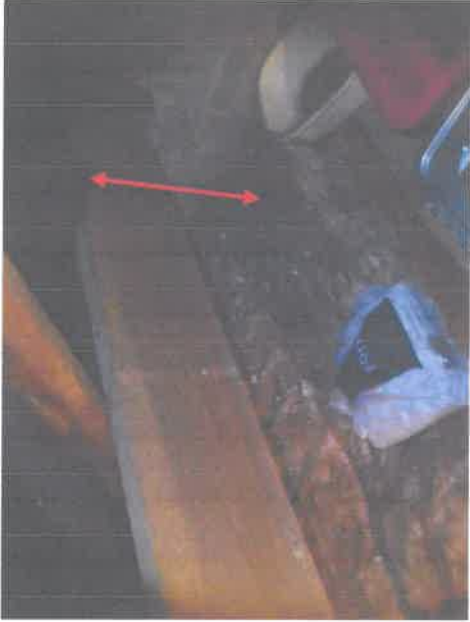
| <p>There is large amounts of dirt and debris on the fibre insulation beneath the gaps in the felt, but no bat droppings.</p> | <p>Photo 9: Dirt and debris from the torn roofing felt above..</p> |
