# **PROJECT: 2630 CHIPPING HOUSING**

## **REPORT: 501 ARBORICULTURAL SURVEY**

PREPARED BY TPM LANDSCAPE LTD

Revision B (Updated Survey November 2018)

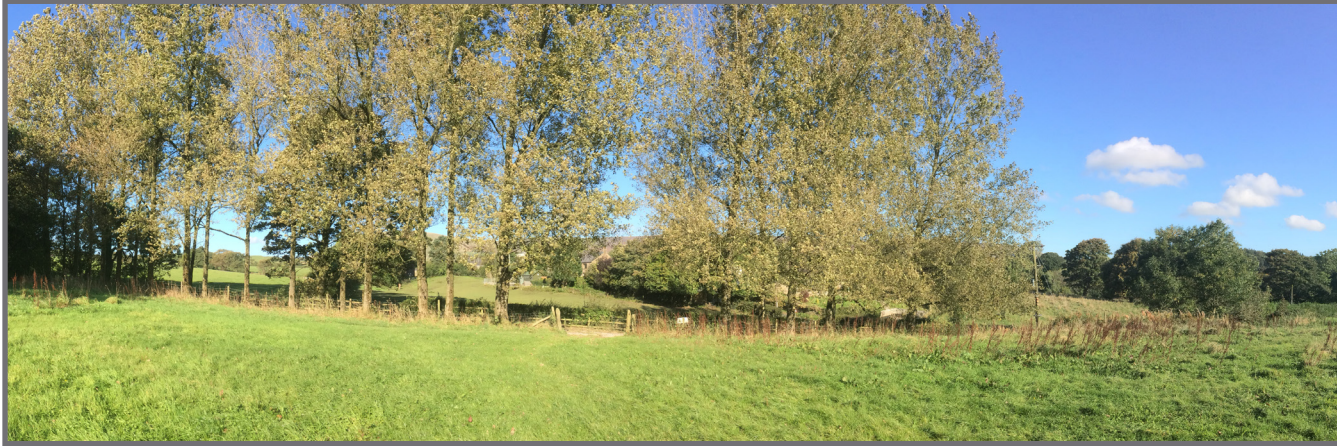
G11 Black Poplar group on western boundary

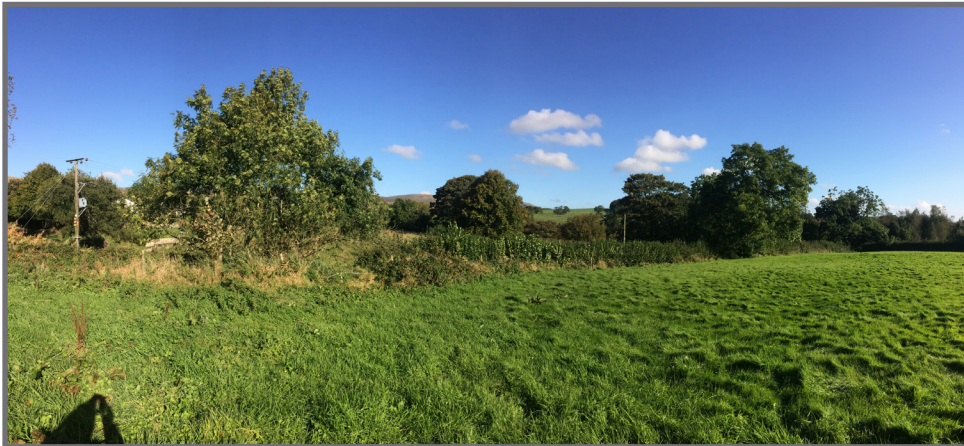
Northern boundary and H8 with T7 in the fore ground

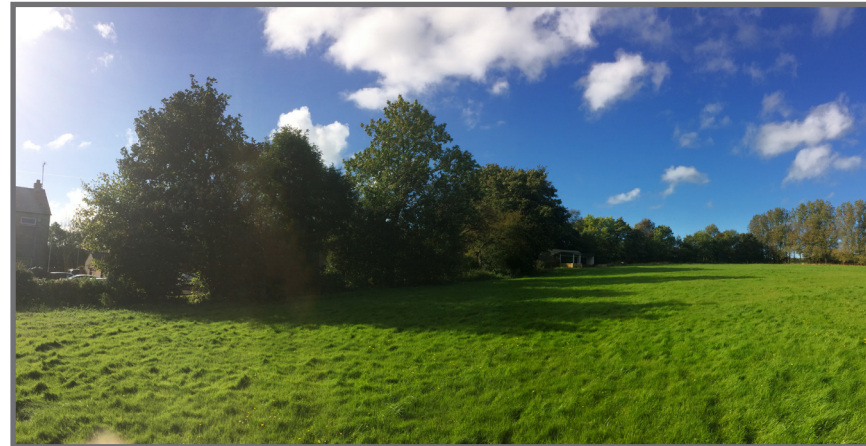
Southern Boundary groups

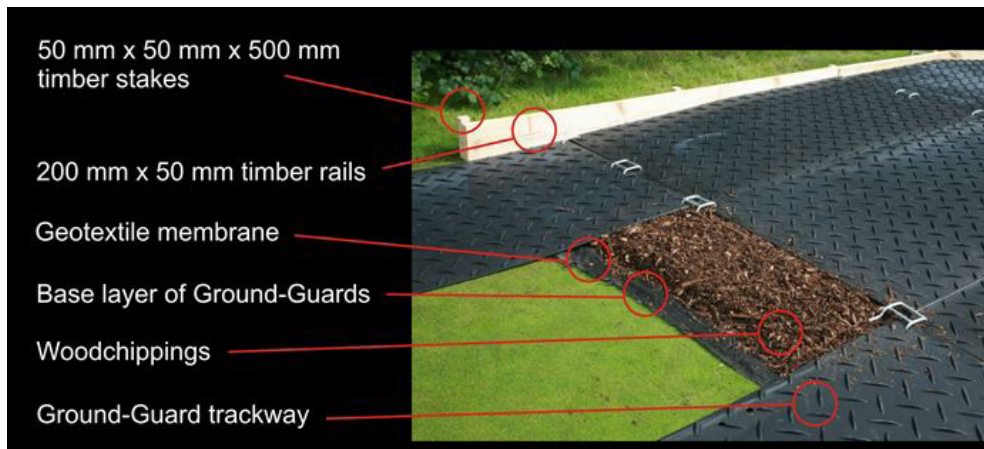
Figure 4 - example of ground guards

The most common method of ground protection is the use of a compressible layer as illustrated in figure 4 on the previous page. This method will support pedestrian-operated machinery up to a gross weight of 2t. It consists of a base geo-textile membrane, a base ground guard layer, approximately 150mm depth of woodchip and a surface ground guard track way.

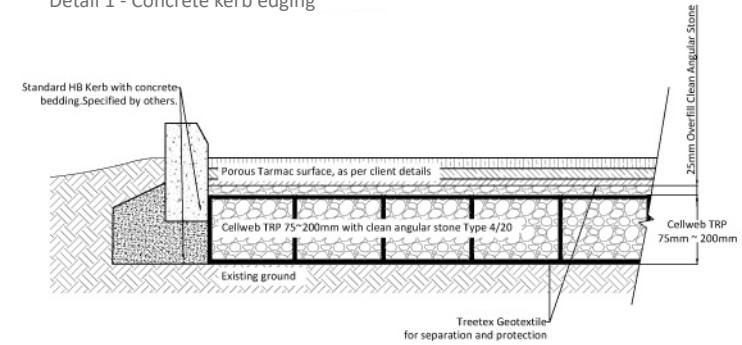
Detail 1 - Concrete kerb edging

Note: Subbase could be required depending on the existing ground CBR % and the type of traffic on the surface.

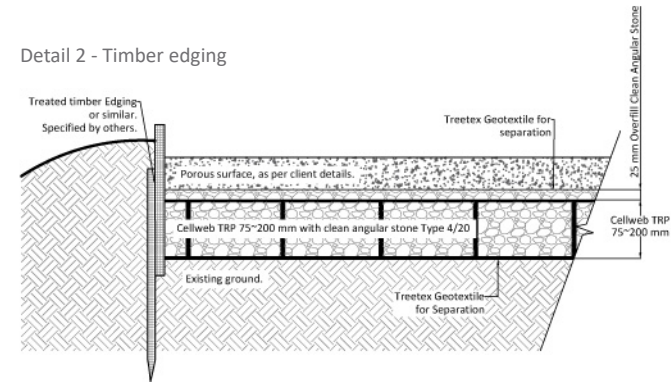
Figure 5 - No-Dig Construction Details over RPA

Detail 2 - Timber edging

NOTE: No-dig construction details as detailed by Geosynthetics

Areas of proposed surfacing over the RPA should be carried out to a 'No Dig' construction method in line with detailed construction details from an engineer. Geotextiles and porous surfaces to be used. Surfacing should be constructed over existing levels to avoid excavations within the main body of the RPA.
