**BAT SURVEY AT -  
OUTBUILDING AT  
BEECH HOUSE  
ALSTON**

DATE AND TIME OF VISIT  
27<sup>th</sup> Apr 2017 9.30am

REFERENCE NO. 5335

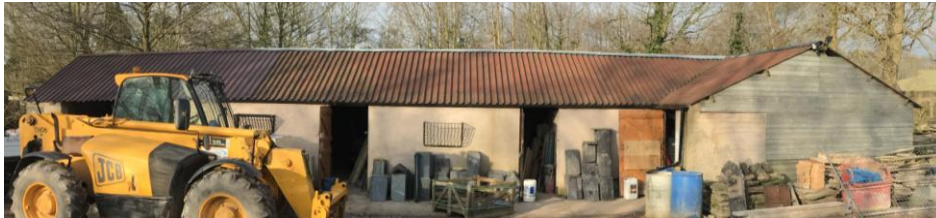
## **TYPE OF BUILDING**

The building is a single storey L shaped store outbuilding currently used for storing building materials.

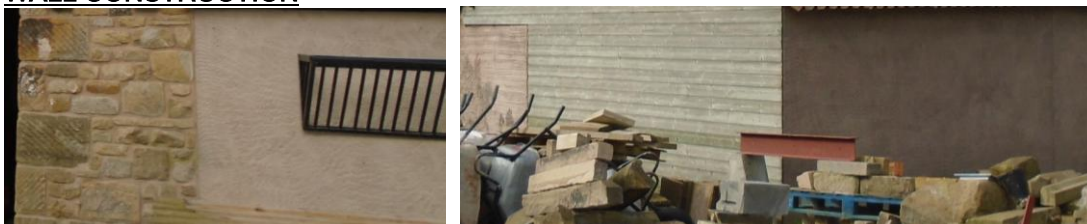
### **WALL CONSTRUCTION**

The building is a combination of natural stone with block backing, rendered block and horizontal timber boarding fixed over timber frame.

All the walls are in good condition with no cracks or crevices suitable for bat access, the timber sections however have gaps at the abutment with the roof sheets which provide access to the interior of the building.

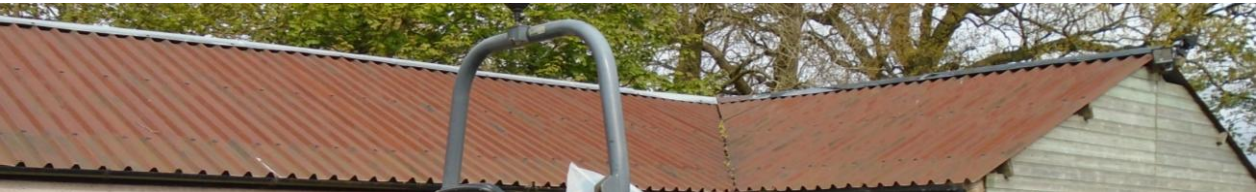
**ROOF CONSTRUCTION**

The roof is a simple L shaped pitch covered with profile steel sheet.

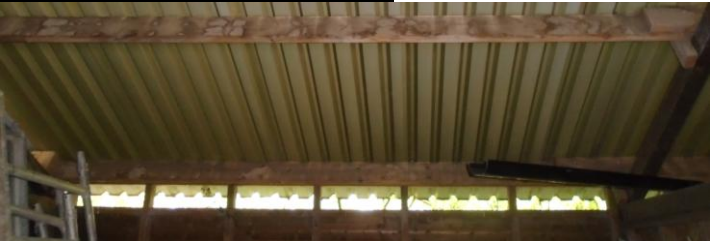
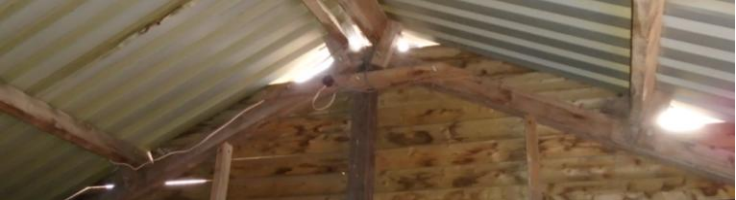
**BAT ACCESS POINTS IN ROOF**

The steel sheets are in reasonable condition with most laps tight fitting. The only access points being at the eaves and gable abutments with the wall.

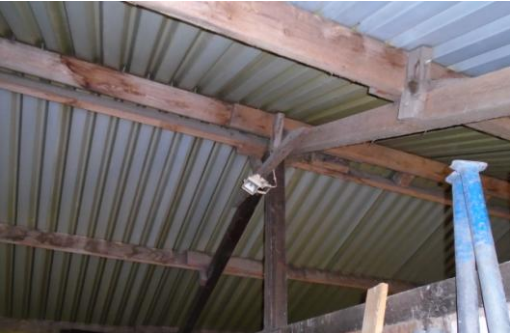
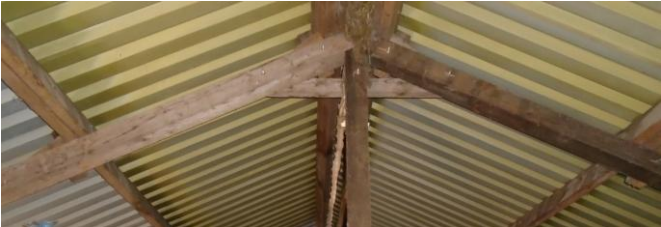
**ROOF SPACE**

The roof structure is small section timber trusses and purlins they are relatively new timbers in good condition, which do not provide any potential bat habitat.
