320190173P

**BAT SURVEY AT -
5 WADDOW GROVE
WADDINGTON**

**DATE AND TIME OF VISIT
27th Feb 2019 3.30pm**

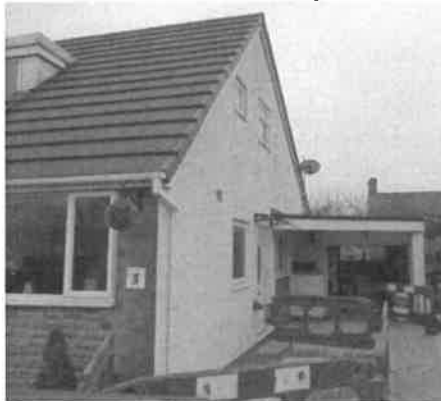
Front and side elevation

The house is a semi 1 ½ storey house Currently inhabited, probably dating from the 1970's .

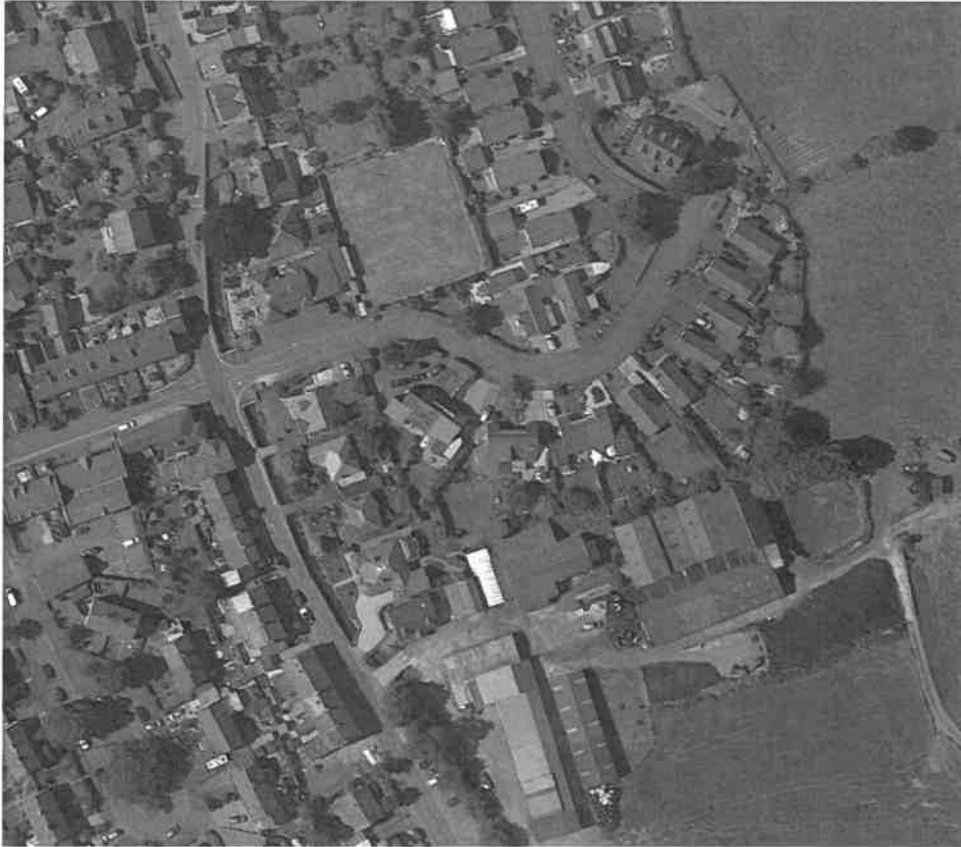
The house is surrounded to the north and sides with houses of a similar age and type, all having small gardens to the front and rear. The rear boundary of the house is adjacent to a farm and its associated buildings, large acreage pastureland surrounds the farm.

There are no mature trees within a 50m radius and this S.E side of the village is not well connected to any high value foraging potential in the greater area. The nearest tree line following the road is 85m to the S.W there are no areas of standing water within 500m of the site but Waddington brook runs 63m to the west.

The area generally provides a medium to low level of forage habitat.

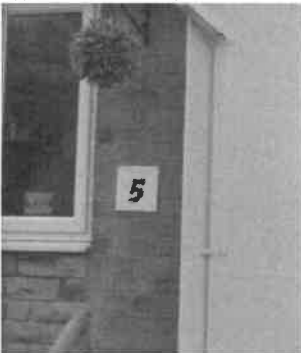
The front elevation is a combination of brick and stone, the side elevation and garage is render and the rear elevation is brick.

All walls are in perfect condition with no access points or any cracks or crevices which could provide roost habitat for bats.

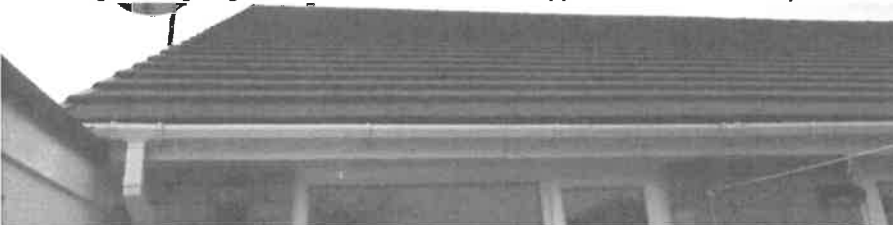
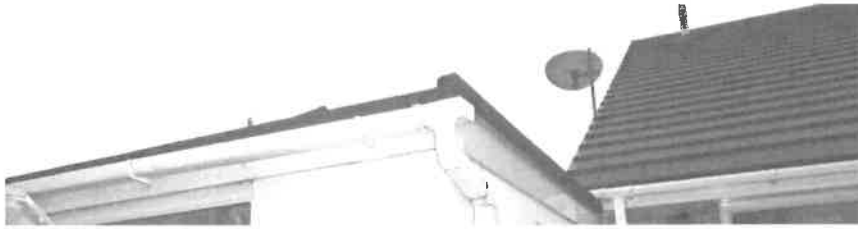
Flat roof

The pitched roof has a tile finish with upvc fascias, verge detail and soffits. The roof was replaced approx 18 months ago. The garage has a felted flat roof which appears to have been replaced around the same time.

The flat roof is in perfect condition with tight fitting fascias. There are no access points in the roof nor any crevices .

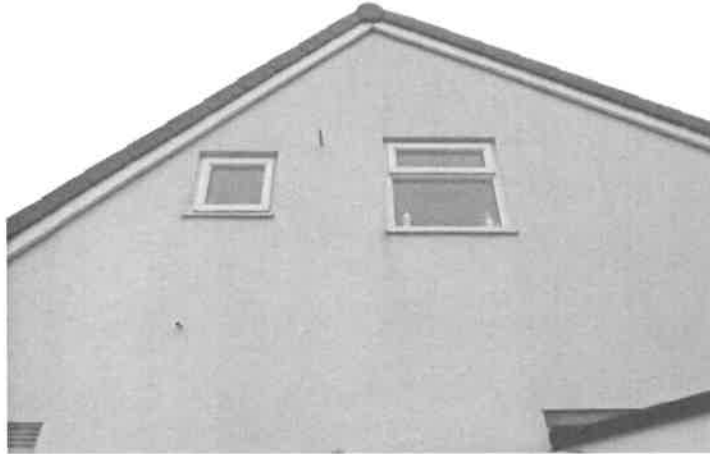
Verge of main roof

The barge boards and upvc detail to the gable wall is tight fitting with no access points or any crevices. Both roof structures being so recently replaced do not provide any potential roost habitat.

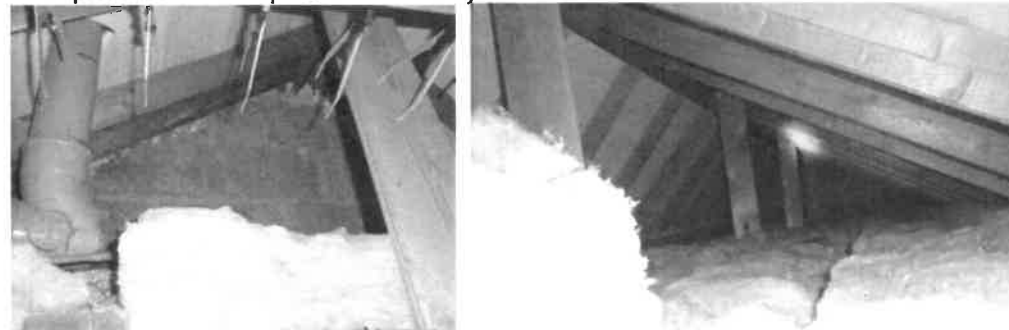
The roof space was inspected from the access hatch, it was not possible to enter the space due to an aerial directly over the opening. The timbers and underlay were all in perfect condition. The visible sections of the insulation quilt were clean with no signs of droppings or insect remains. However there were some signs of staining on the gable wall directly under the ridge. This staining did not look fresh and there were no current signs of bat presence and the space is not currently accessible .

Evidence of current bat presence in the roof void was negative but with some evidence of historic use. The garage floor was examined for any staining, droppings or insect remains. The result was negative.

The main roof void did not appear to have any possible access points all junctions were tight fitting and the areas near the staining in the roof void were sealed with foam.

The proposed alterations will not affect any local bat population. Mitigation is not essential however as there is some evidence of historic use, it is suggested that roost potential is reintroduced by incorporating a bat slate in the roof pitch near to the ridge.

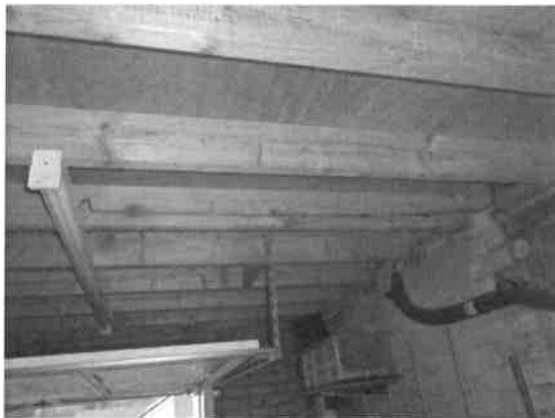
There is no enclosed roof void in the garage the timber joists and timber deck are visible, all the timbers are in good condition. There was no potential roost habitat in the roof.
