Proposed re-roofing works at Wilkinson Farmhouse, Simonstone, Burnley BB12 7NX

Thank you for your request for a bat survey. I understand that the above property is a listed building and requires a bat survey prior to any proposed re-roofing works.

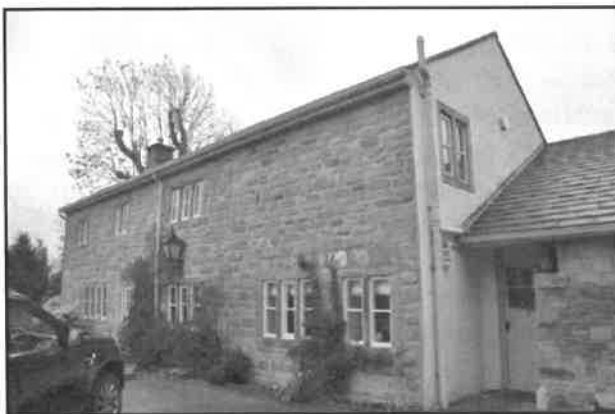
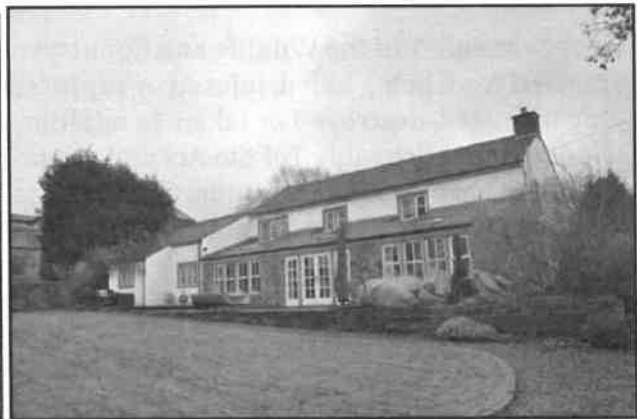
Wilkinson Farmhouse is a detached, occupied, two storey dwelling with single storey extensions to the north and west elevations. The main roof and single storey to the north are covered with concrete tiles and a stone ridge. The single storey extension to the north is covered with slate and lead flashing. There are gaps associated with the main roof, at the ridge and due to occasional lifted tiles. There are also gaps along the roof edges, in particular at the gable ends. Some of these gaps have potential be used by bats for gaining access and possibly for roosting.

View of Wilkinson Farmhouse, east elevation (lhs) and west elevation (rhs).

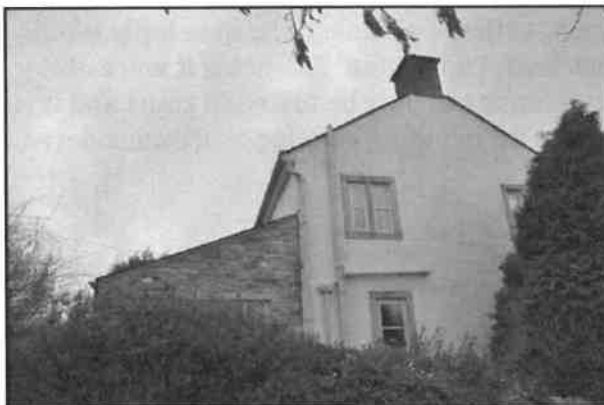
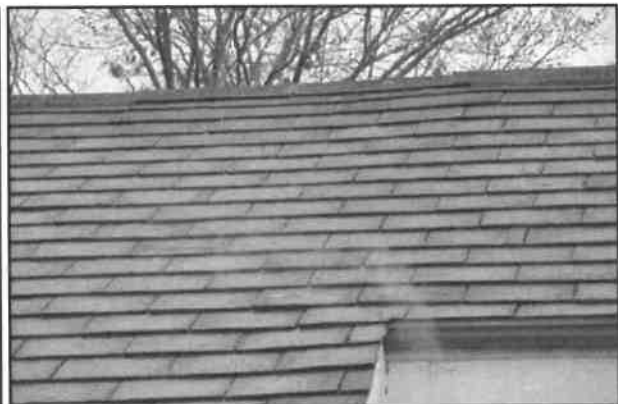
It is advised that although there is no evidence to suggest that bats are present within the building there are some features present (gaps associated with roof coverings and roof edges) that bats could utilise and in this location and landscape setting. These features have low potential for bats to use throughout the year.

View of south gable, gaps are present along the roof edges (lhs) and view of main roof. There are gaps present along the ridge and between occasional lifted tiles (rhs).

As a precaution, it is advised that proposed roof works should not take place during the winter months (November to March) so as to avoid the most sensitive times for bats during their hibernation period.

It is advised that all personnel involved in proposed roof works should be carefully advised about bats by an appropriate person, so that all works are undertaken with a clear understanding about legal aspects, precautions to be adopted and what to do if a bat is found.
